**Device** TC23x  
**Marking/Step** ES-AC, AC  
**Package** see Data Sheet

**No. 063/18**

This Errata Sheet describes the deviations from the current user documentation.

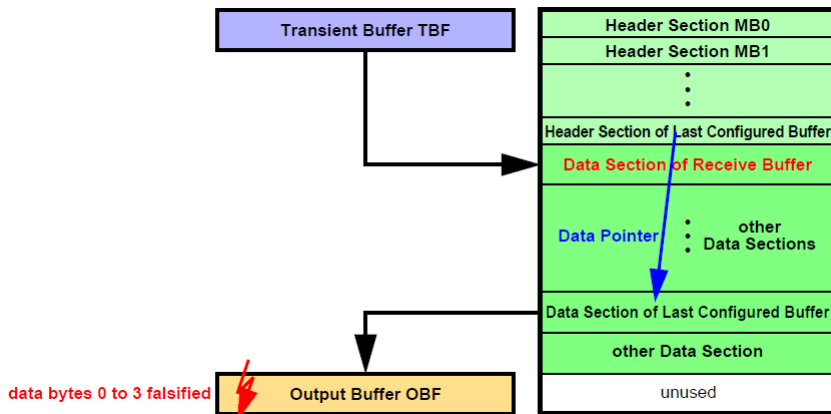
**Figure 1 Message buffer transfer from Message RAM to OBF**

When the message buffer has its payload configured to maximum length (**PLC** = 127), the OBF word on address 00h (payload data bytes 0 to 3) is overwritten with unexpected data at the end of the transfer.

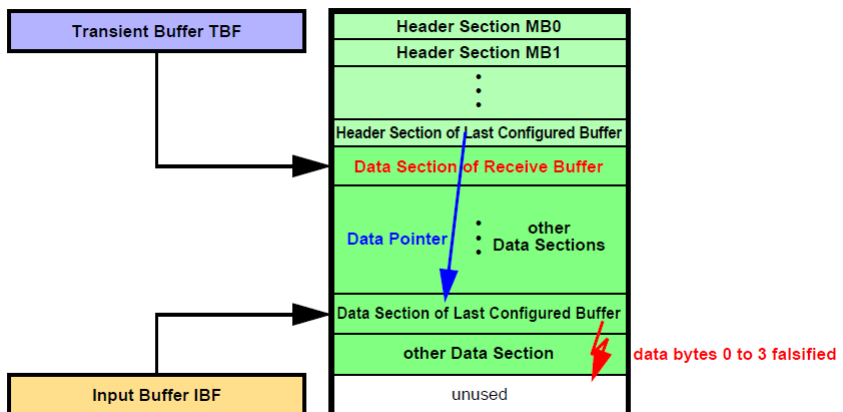
**Figure 2 Message buffer transfer from IBF to Message RAM**

After the Data Section of the selected message buffer in the Message RAM has been written, one additional write access overwrites the following word in the Message RAM which might be the first word of the next Data Section.

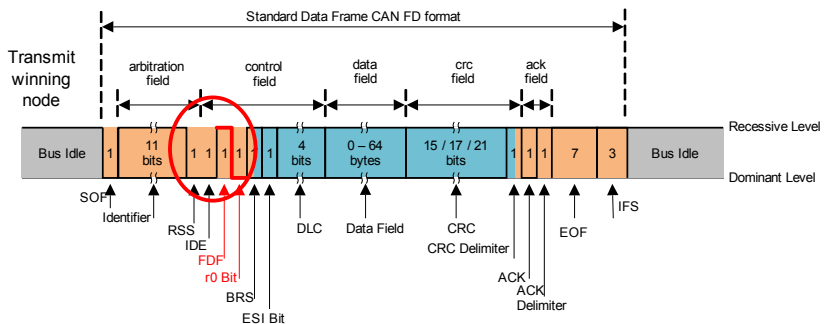
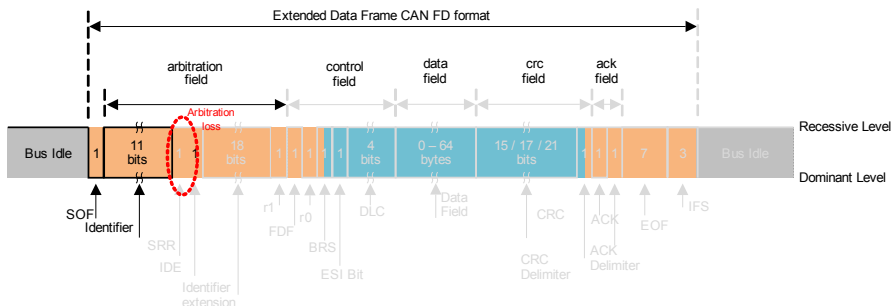
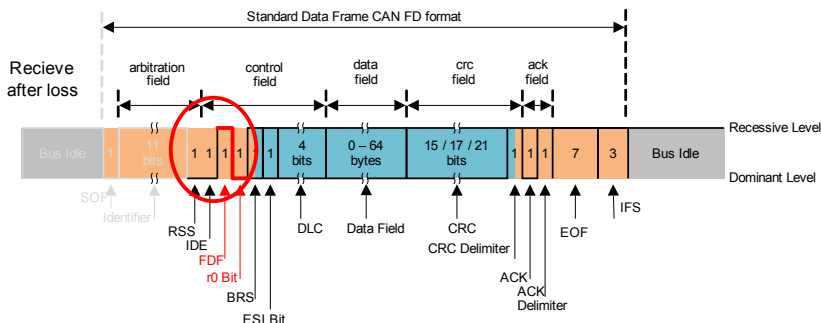
The device is producing more error frames within a network than a device with a hardsync at the FDF bit.

This workaround is not 100% solving the “Missing Hardsync” issue, but setting the SJW to the highest possible value will hide the problem in most cases.

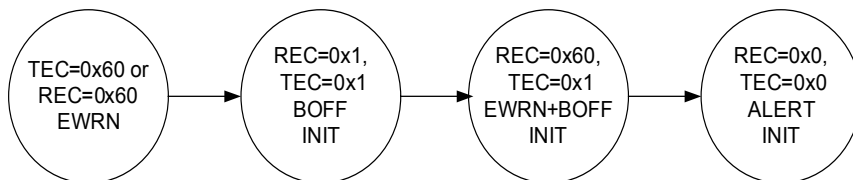
**Figure 8 Alert Interrupt Behavior in case of Bus-Off**

When the threshold for error warning (EWRN) is reached (default value of Error Warning Level EWRN = 0x60), then the EWRN interrupt is issued. The bus-off (BOFF) status is reached if  $TEC > 255$  according to CAN specification, changing the MultiCAN module with REC and TEC to the same value 0x1, setting the INIT bit to 1<sub>B</sub>, and issuing the BOFF interrupt. The bus-off recovery phase starts automatically. Every time an idle time is seen, REC is incremented. If REC = 0x60, a combined status EWRN+BOFF is reached. The corresponding interrupt can also be seen as a pre-warning interrupt, that the bus-off recovery phase will be finished soon. When the bus-off recovery phase has finished (128 times idle time have been seen on the bus), EWRN and BOFF are cleared, the ALERT interrupt bit is set and the INIT bit is still set.

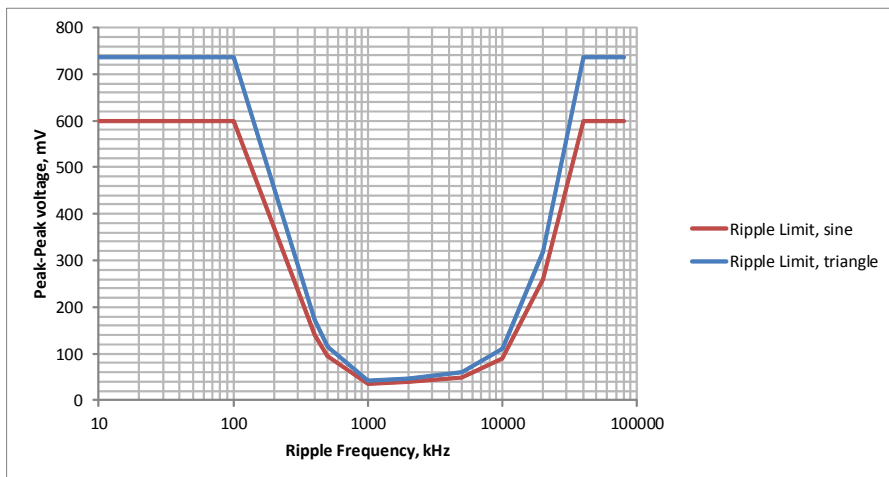
**Figure 12 Ripple Voltage vs. Frequency Characteristic**

The internal back-up clock is sensitive to specific power supply voltage disturbance/ripple caused by a voltage ripple intrinsic to DC-DC converters. Specific conditions such as insufficient filtering of the ripple may lead to improper behavior of the start-up scheme of the back-up clock, and thus stuck-at state during the start-up of the microcontroller until this condition is removed.

The diagram reflects acceptable ripple level during the cold start of the microcontroller at the VDDP3 supply of the PMS subsystem. For devices in QFP-144, QFP-100 and QFP-80 packages the ripple is reflected for pin 69, pin 47, and pin 37, respectively.

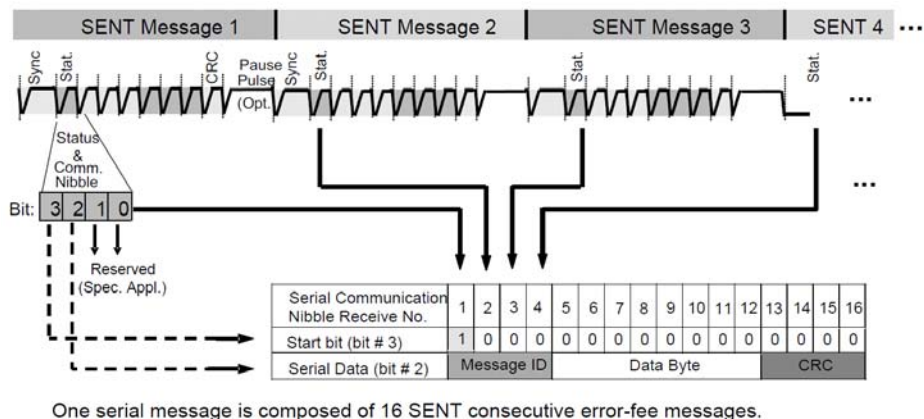
**Figure 13 Short Serial Message, Serial Data Encoding over 16 messages**

**Figure 13** shows a corrected version of this figure.
