**Device** TC29x  
**Marking/Step** ES-BC, BC  
**Package** see Data Sheet

**No. 030/19**

This Errata Sheet describes the deviations from the current user documentation.

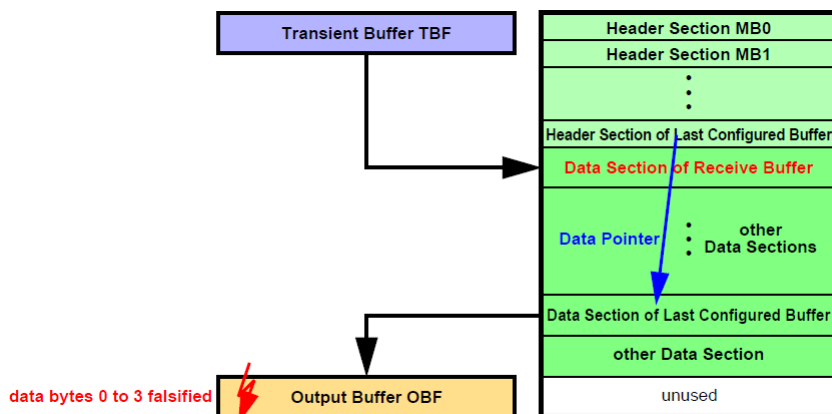
**Figure 1 Message buffer transfer from Message RAM to OBF**

When the message buffer has its payload configured to maximum length (**PLC** = 127), the OBF word on address 00h (payload data bytes 0 to 3) is overwritten with unexpected data at the end of the transfer.

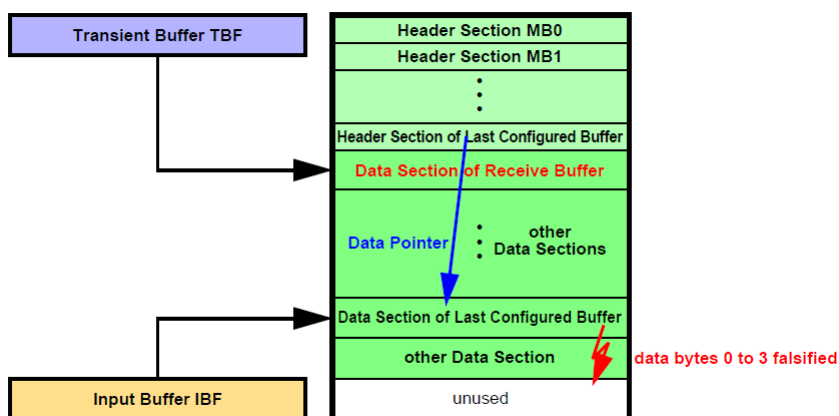
**Figure 2 Message buffer transfer from IBF to Message RAM**

After the Data Section of the selected message buffer in the Message RAM has been written, one additional write access overwrites the following word in the Message RAM which might be the first word of the next Data Section.

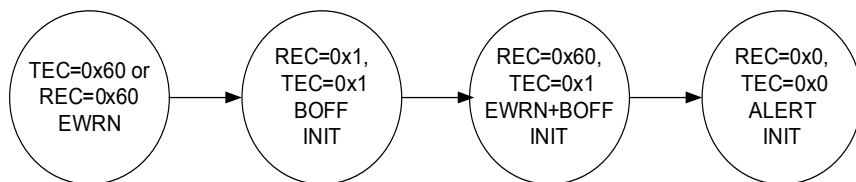
**Figure 7 Alert Interrupt Behavior in case of Bus-Off**

When the threshold for error warning (EWRN) is reached (default value of Error Warning Level EWRN = 0x60), then the EWRN interrupt is issued. The bus-off (BOFF) status is reached if  $TEC > 255$  according to CAN specification, changing the MultiCAN module with REC and TEC to the same value 0x1, setting the INIT bit to 1<sub>B</sub>, and issuing the BOFF interrupt. The bus-off recovery phase starts automatically. Every time an idle time is seen, REC is incremented. If REC = 0x60, a combined status EWRN+BOFF is reached. The corresponding interrupt can also be seen as a pre-warning interrupt, that the bus-off recovery phase will be finished soon. When the bus-off recovery phase has finished (128 times idle time have been seen on the bus), EWRN and BOFF are cleared, the ALERT interrupt bit is set and the INIT bit is still set.

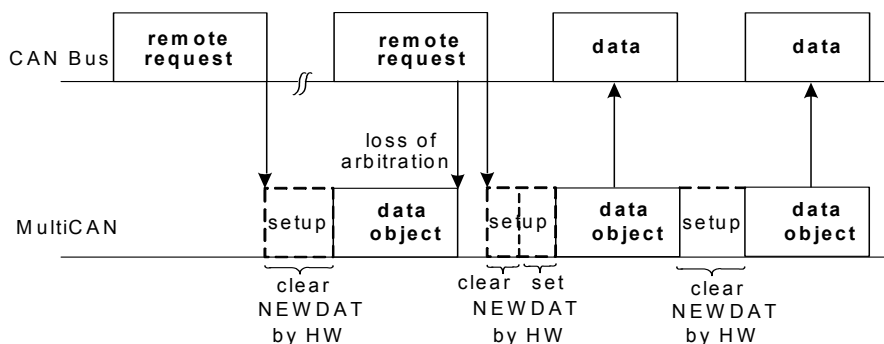
**Figure 8 Loss of Arbitration**

When the appropriate message object (data frame) triggered by the first remote frame wins the arbitration, it will be sent out and NEWDAT is not reset. This leads to an additional data frame, that will be sent by this message object (clearing NEWDAT).

There will, however, not be more data frames than there are corresponding remote requests.

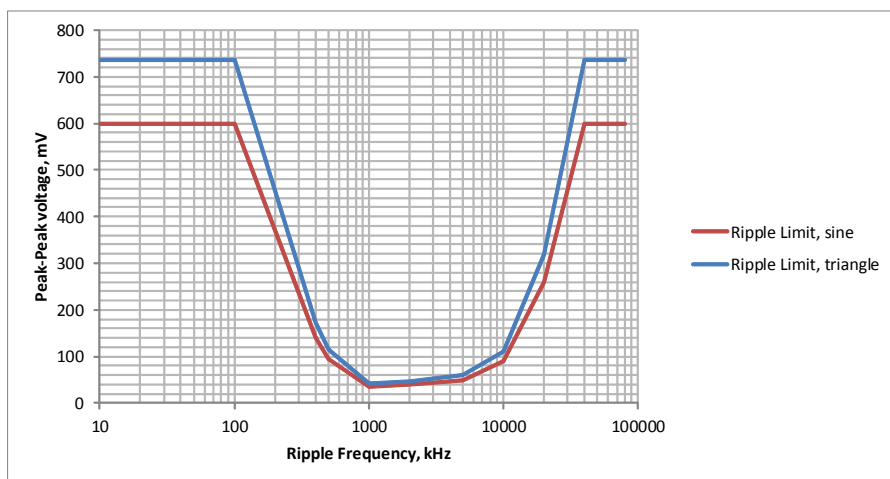
**Figure 11 Ripple Voltage vs. Frequency Characteristic**

The internal back-up clock is sensitive to specific power supply voltage disturbance/ripple caused by a voltage ripple intrinsic to DC-DC converters. Specific conditions such as insufficient filtering of the ripple may lead to improper behavior of the start-up scheme of the back-up clock, and thus stuck-at state during the start-up of the microcontroller until this condition is removed.

The diagram reflects acceptable ripple level during the cold start of the microcontroller at the VDDP3 supply of the PMS subsystem. For devices in QFP-144, QFP-100 and QFP-80 packages the ripple is reflected for pin 69, pin 47, and pin 37, respectively.

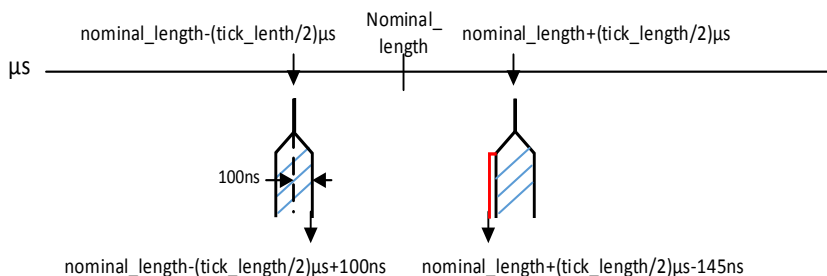
**Figure 13 SENT Tolerance of this Design Step**

- The lower border is  $\text{nominal\_value} - (\text{tick\_length}/2) \mu\text{s} + 100 \text{ ns}$
- The upper border is  $\text{nominal\_value} + (\text{tick\_length}/2) \mu\text{s} - 145 \text{ ns}$ .

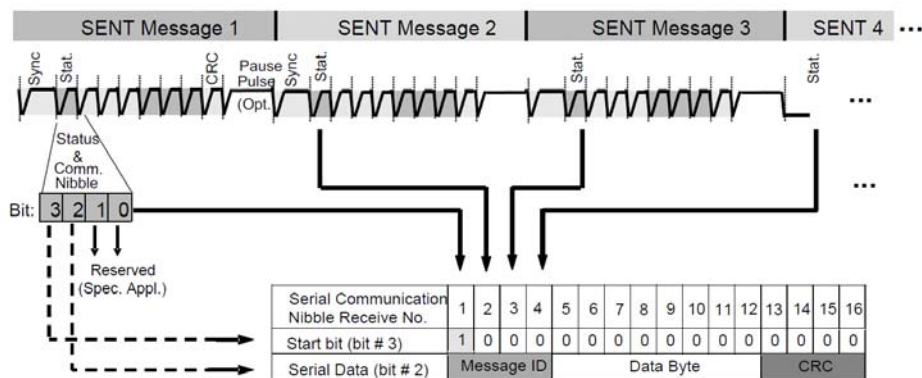
**Figure 14 Short Serial Message, Serial Data Encoding over 16 messages**

**Figure 14** shows a corrected version of this figure.
