80C186XL/80C188XL EMBEDDED MICROPROCESSORS SPECIFICATION UPDATE

Release Date: January, 2002

Order Number: 272895.003

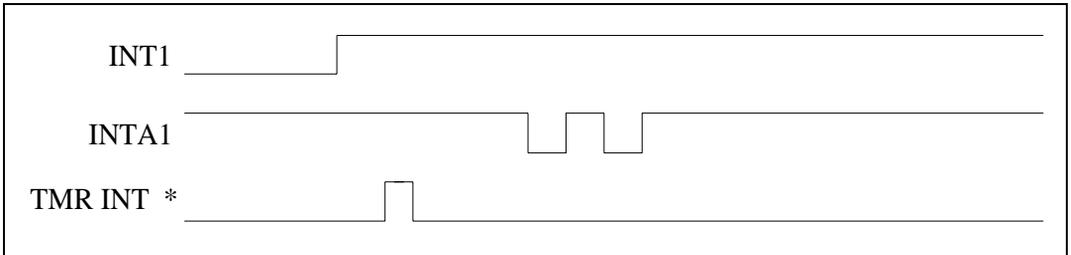
Figure 1. Correct INT1 Acknowledge Sequence with Higher Priority Timer Interrupt

Correct operation of the device acknowledges the interrupt on INTA1# after an interrupt on INT1. Normally, this occurs even if there is a higher priority interrupt after INT1 but before the acknowledge (Figure 1).

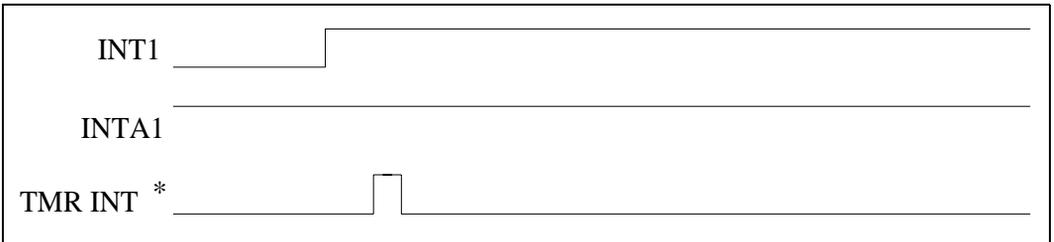
Figure 2. Incorrect INT1 Acknowledge Sequence with Higher Priority Timer Interrupt

The errata occurs when a higher priority interrupt occurs between INT1 and its expected acknowledge. The processor completes internal interrupt acknowledge cycles as seen on the status lines but no acknowledge cycle is sent on the INTA1# output (Figure 2).

*Note: This interrupt could be any of the following: DMA, Timers, Serial, INT0, or INT2.

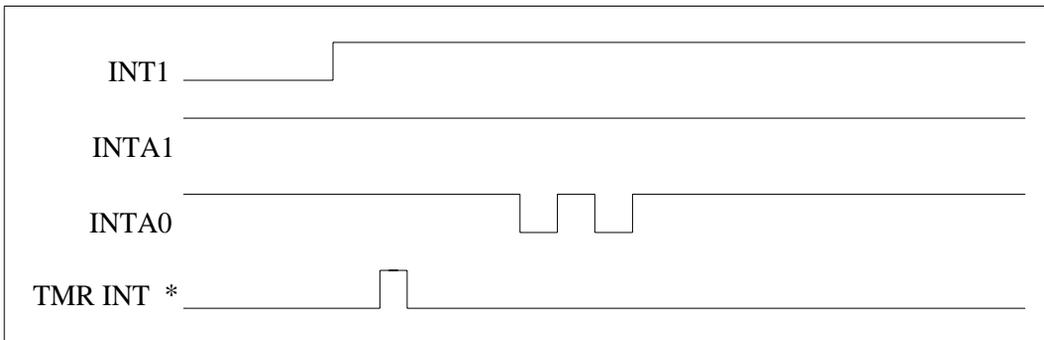
Figure 3. INT0 And INT1 Acknowledge Failure Due to Higher Priority Timer Interrupt

If INT0 and INT1 are configured in cascade mode and a higher priority interrupt occurs between INT1 and its expected acknowledge, then the acknowledge will appear on INTA0# instead (Figure 3).

*Note: This interrupt could be any of the following: DMA, Timers, Serial, or INT0.

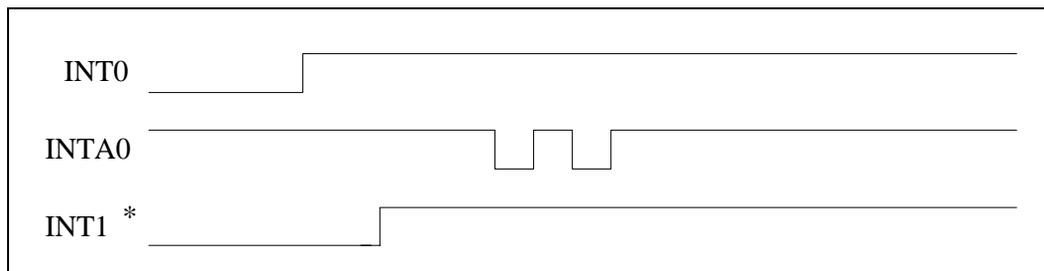
Figure 4. Correct INT0 Acknowledge Operation with a Simultaneous INT1

Correct operation acknowledges INT0 on INTA0#. Normally, this occurs even if there is a higher priority INT1 after INT0 but before the acknowledge (Figure 4).

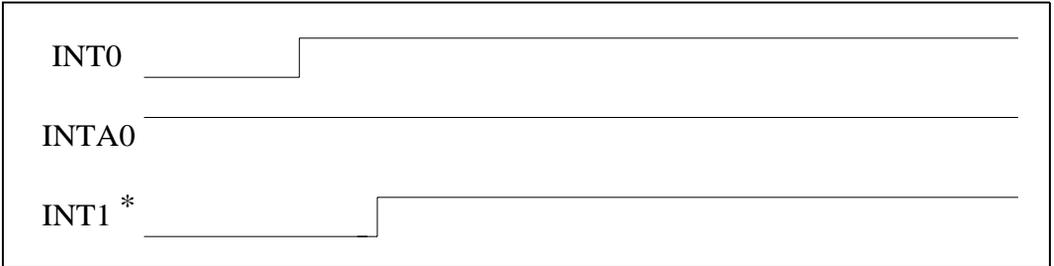
Figure 5. Incorrect INT0 Acknowledge Operation with a Simultaneous INT1

The errata occurs when INT1, which is higher priority than INT0, occurs between INT0 and its expected acknowledge. The processor completes internal interrupt acknowledge cycles as seen on the status lines but no acknowledge cycle is sent on the INTA0# output (Figure 5).

*Note: This problem occurs only if INT1 is higher priority than INT0.

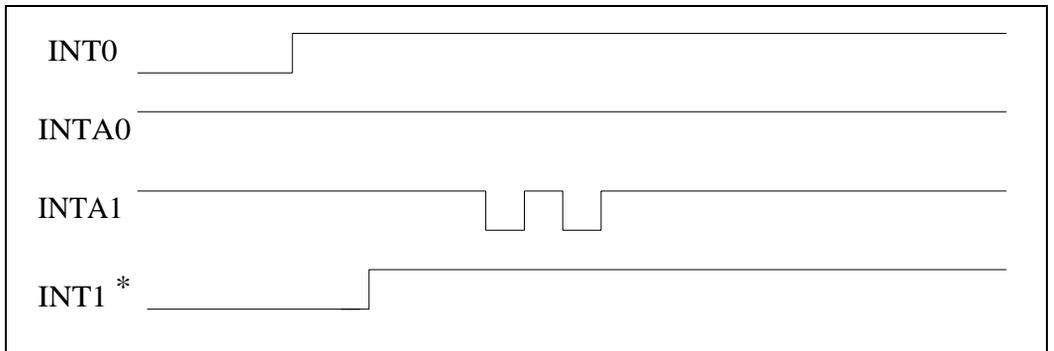
Figure 6. INT0 and INT1 Acknowledge Failure Due to the Higher Priority INT1

If INT0 and INT1 are configured in cascade mode and the higher priority INT1 occurs between INT0 and its expected acknowledge, then the acknowledge will appear on INTA1# instead of INTA0# (Figure 6).

*Note: This problem occurs only if INT1 is higher priority than INT0.
