**dsPIC30F6011/6012/6013/6014**

**dsPIC30F6011/6012/6013/6014 Family  
Silicon Errata and Data Sheet Clarification**

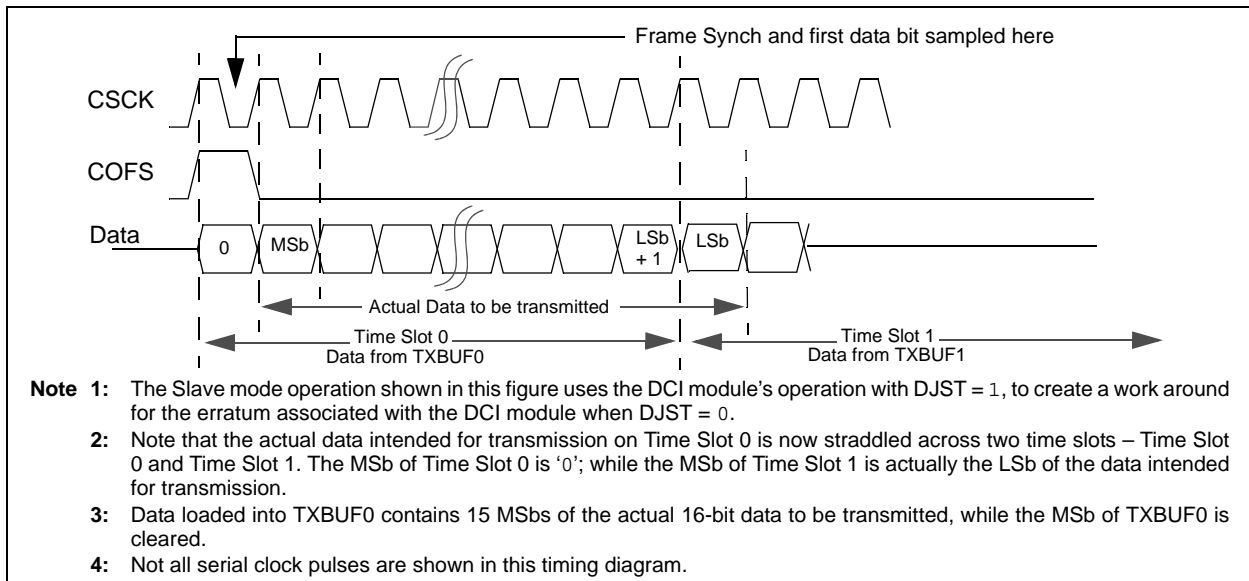
FIGURE 1: DCI SLAVE WORK AROUND

The Data Converter Interface (DCI) module does not function correctly in Slave mode when the following conditions are true:
