MICROCHIP PIC18F2410/2510/4410/4510

PIC18F2410/2510/4410/4510 Rev. A1 Silicon Errata

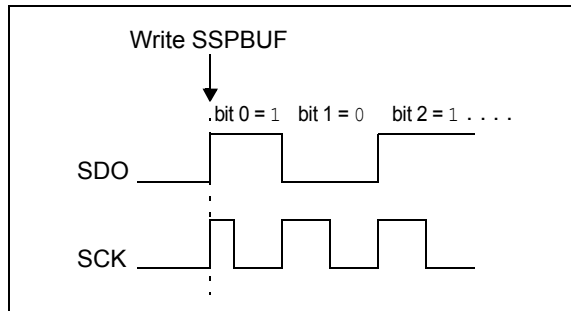
FIGURE 1: SCK PULSE VARIATION USING TIMER2/2

32. Module: MSSP (SPI Mode)

When the SPI is using Timer2/2 as the clock source, a shorter than expected SCK pulse may occur on the first bit of the transmitted/received data (Figure 1).

Work around

To avoid producing the short pulse, turn off Timer2 and clear the TMR2 register, load the SSPBUF with the data to transmit and then turn Timer2 back on. Refer to Example 5 for sample code.
