## PIC18CXX2 Rev. B Silicon/Data Sheet Errata

The PIC18CXX2 (Rev. B) parts you have received conform functionally to the Device Data Sheet (DS39026C), except for the anomalies described below.

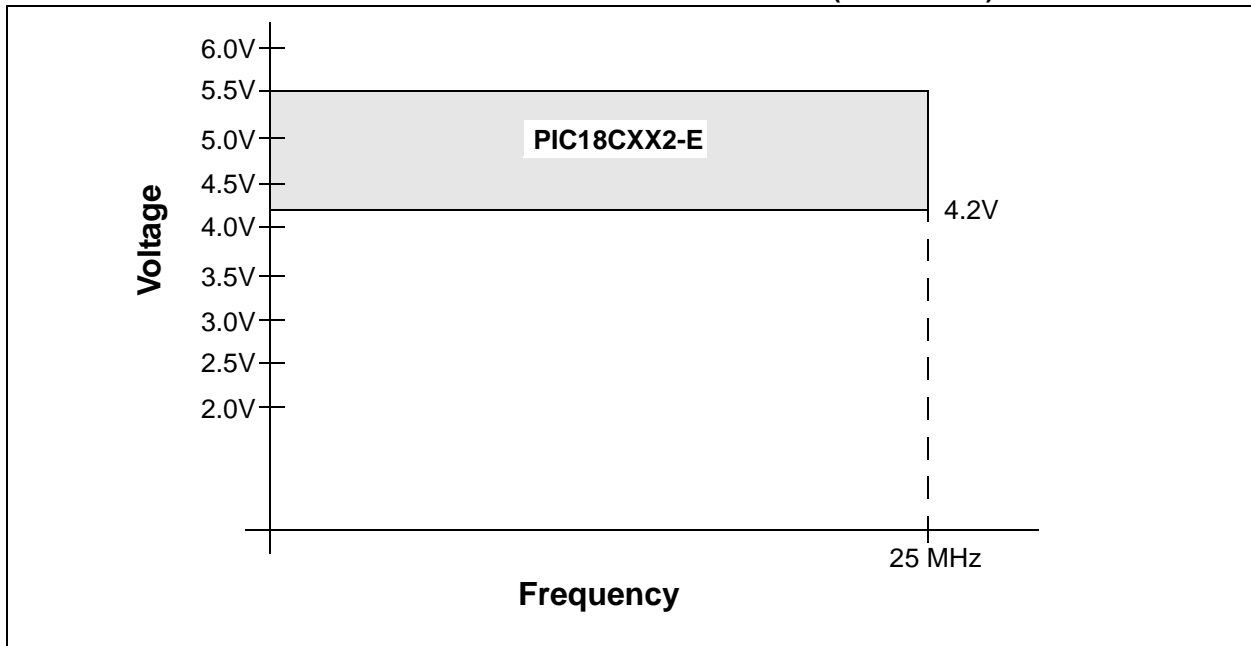
**FIGURE 21-3: PIC18CXX2 VOLTAGE-FREQUENCY GRAPH (EXTENDED)**

The operating frequency range for extended temperature devices has been changed.

The maximum external clock frequency (EC and ECIO modes) and oscillator frequency (HS mode) for extended temperature devices has been changed to 25 MHz. When the PLL is used

(HS+PLL mode), the maximum clock and oscillator frequency has been changed to 6.25 MHz. Other values of related parameters have changed accordingly.

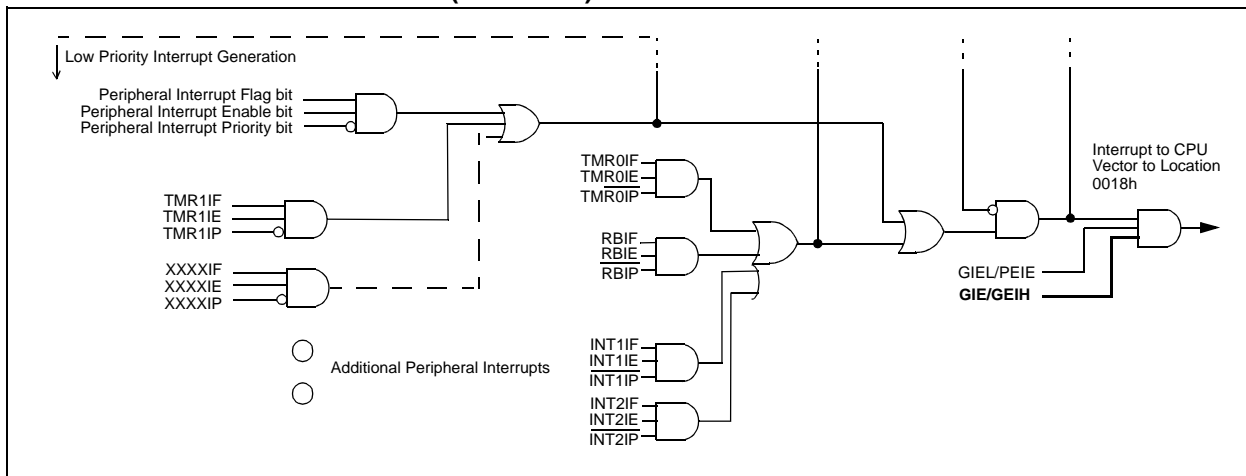
### FIGURE 1: INTERRUPT LOGIC (EXCERPT)

The operation of the GIE/GIEH bit (INTCON<7>) is clarified as follows: when the bit is cleared, all interrupts are disabled. This is regardless of the state of the IPEN bit (RCON<7>), the priority of the interrupt, or whether or not the interrupt is unmasked. This varies from the original description, in which clearing the bit when IPEN = '1' would only disable high priority interrupts.

Also, the interrupt logic funnel shown in Figure 7-1 of the Device Data Sheet is amended with the addition of a GIE/GIEH control line, as shown in Figure 1 (new material in **bold line**).
