dsPIC33CK256MP508 Family Silicon Errata and Data Sheet Clarification

The dsPIC33CK256MP508 family devices that you have received conform functionally to the current Device Data Sheet (DS70005349G), except for the anomalies described in this document.

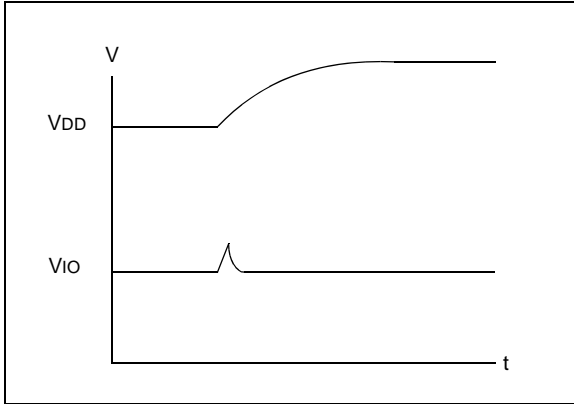
FIGURE 1-1: I/O RAMP

During a fast device power-up when the VDD ramp is less than 4 mS, the I/O pins may drive up to 100 μ A current for a duration of up to 10 μ S (Figure 1-1).

Example applications affected may include complementary power switches, where a transient current shoot-through might occur. High-voltage applications with complementary switches should power the high-voltage 200 μ Sec later than powering the dsPIC[®] device to avoid the current shoot-through. This behavior is specific to each device and not affected by aging.

1. Slow down the VDD ramp time (greater than 4 mS for VDD to ramp 0V to 3.3V).
2. Ensure the circuitry that is connected to the pins can endure this pulse.
