Technical Notes

TN_161

FT4222H Errata Technical Note

Version 1.7

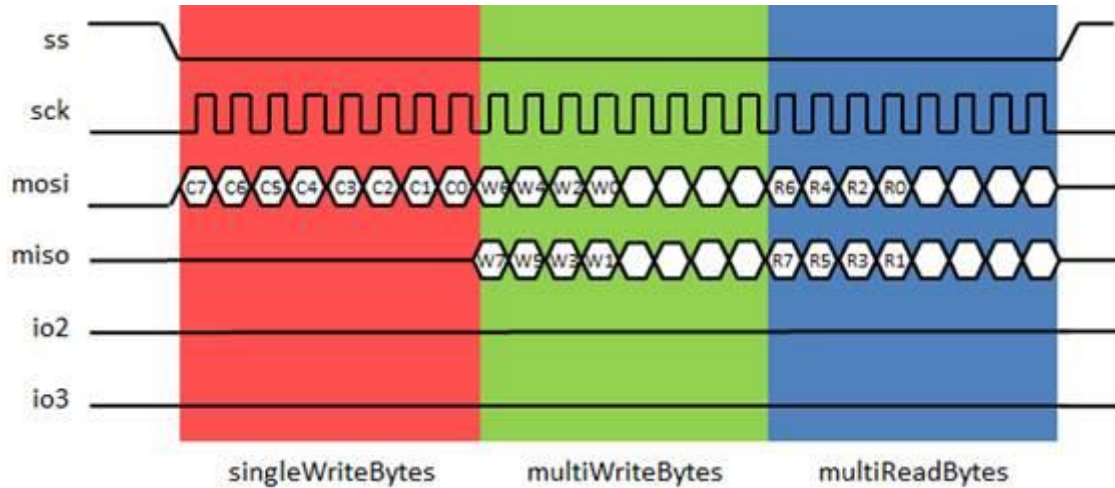
Figure 3.1 Quad SPI with Multi Write Phase

When accessing Toshiba flash with SPI Master Quad mode, FT4222H will hang without giving any responses.

FT4222H operates as master with supporting Dual or Quad SPI with three phases as illustrated in **Figure 3.1**.

As shown in **Figure 3.1**, 'C', 'W' and 'R', correspond to "Command Phase", "Write Phase" and "Read Phase", where there are information/data in all three phases that are to be exchanged.

In SPI Master Quad mode, the operation of single write with quad read was not supported. No workaround was provided, this feature is implemented with Revision D.

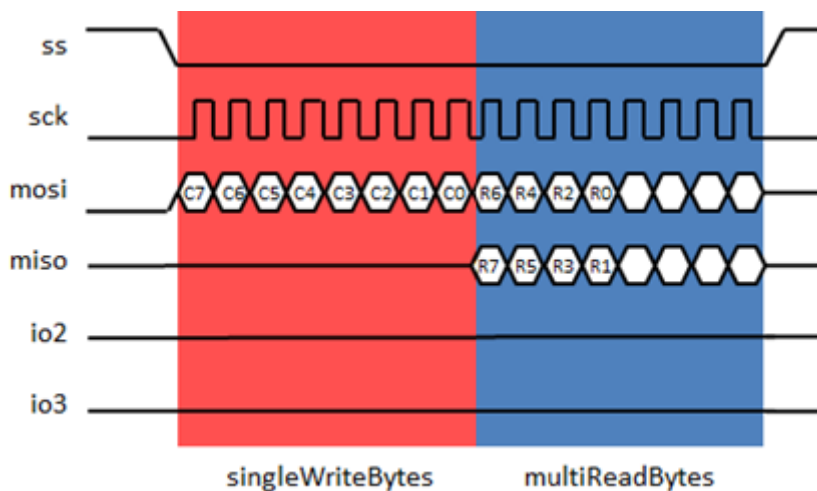
Figure 3.2 Quad SPI without Multi Write Phase

Some flash devices operate with single write and multi read protocol but without the multi write phase as illustrated in **Figure 3.2**:

Write Phase has no information/data to transfer. This combination of operating mode is not supported with Revision A, B, and C.

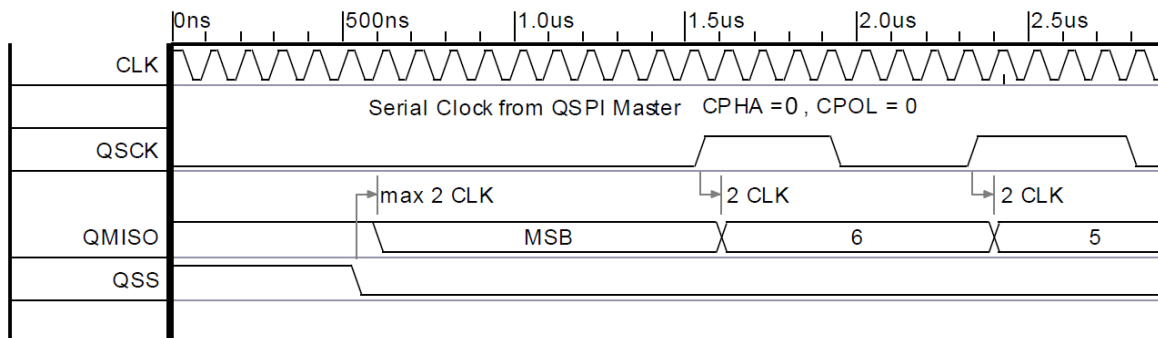
The issue happens on item 2.

As shown in the diagram below, FT4222 changes the IO polarity after 2 CLK (25ns) after leading phase happens. This issue may not cause problem when SPI Master is a hardware decode IP. However, if the SPI Master is a MCU base design with low sampling rate, the master might retrieve the wrong data.

Note: 2CLK = 25ns

Currently, there is no workaround for this issue. When leading phase happens, the SPI master needs to retrieve data as soon as possible. If the process cannot finish in 25ns, the data will be overwritten by the next data bit.

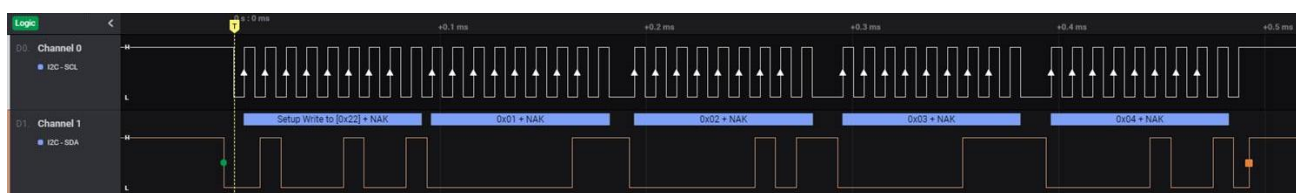
As shown in the diagram below, the I2C master of FT4222 executes the request from the host that writes four bytes 0x01, 0x02, 0x03, 0x04 to the I2C slave with address 0x22. Even though FT4222 gets NAK following the address byte, FT4222 still sends out all data. In theory, the data transmission should be terminated upon receiving an NAK.

N/A.
