# dsPIC33FJ06GS001/101A/102A/202A and dsPIC33FJ09GS302

## dsPIC33FJ06GS001/101A/102A/202A and dsPIC33FJ09GS302 Family Silicon Errata and Data Sheet Clarification

The dsPIC33FJ06GS001/101A/102A/202A and dsPIC33FJ09GS302 family devices that you have received conform functionally to the current Device Data Sheet (DS75018C), except for the anomalies described in this document.

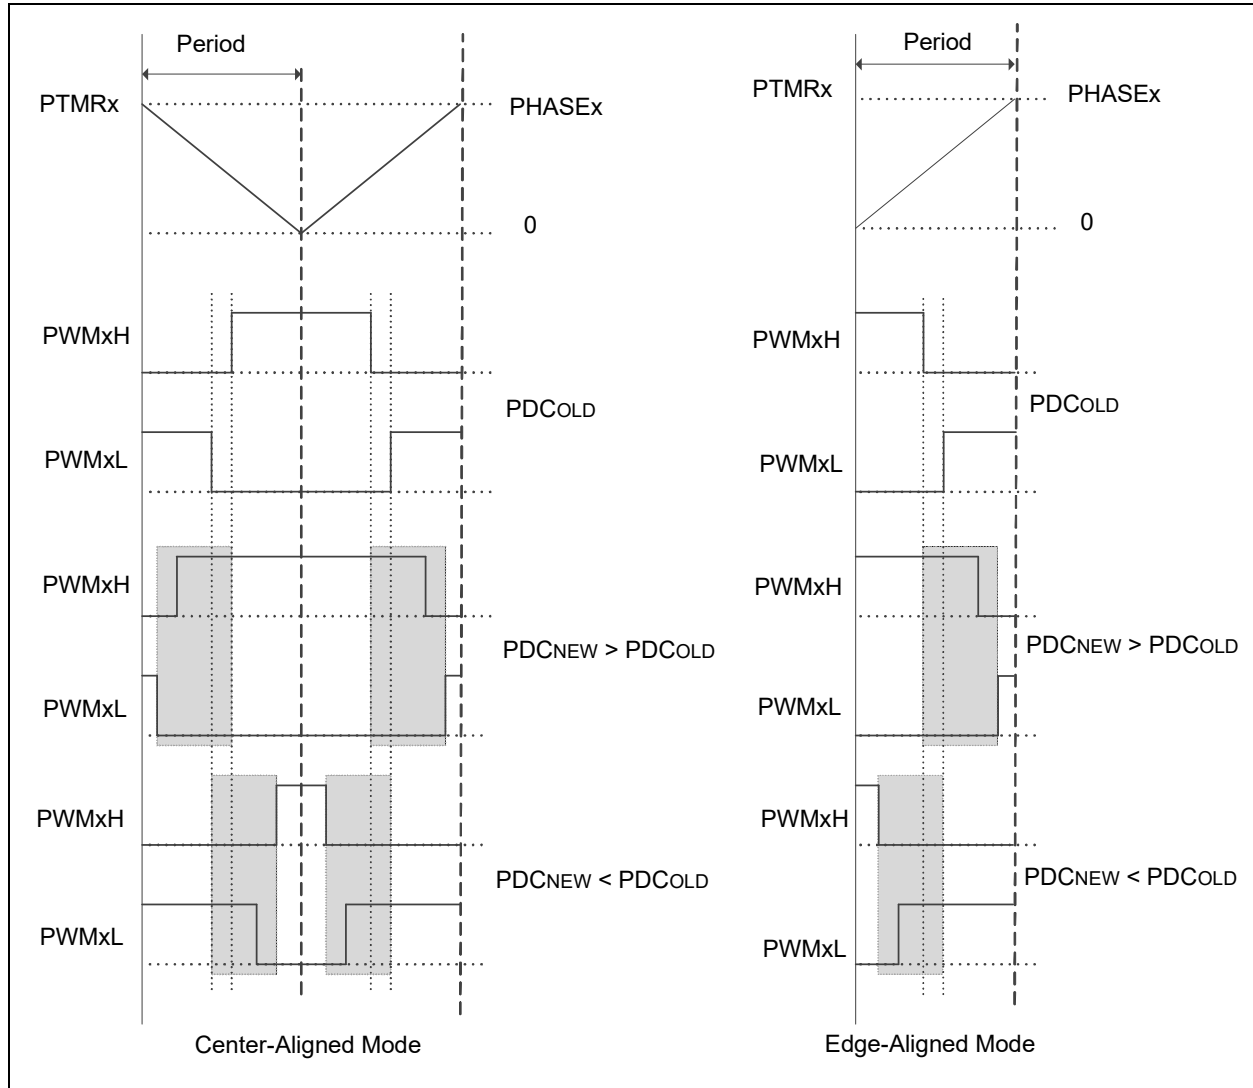
FIGURE 1: TIMING DIAGRAMS FOR CENTER-ALIGNED AND EDGE-ALIGNED MODES

The PWMx generator may not assert dead time on the edges of transitions. This has been observed when all of the following conditions are present:

- The PWMx generator is configured to operate in Complementary mode with the independent time base or master time base;
- Immediate update is enabled; and
- The value in the PDCx register is updated in such a manner that the PWMxH and PWMxL outputs make an immediate transition.

The current duty cycle, PDCOLD, newly calculated duty cycle, PDCNEW, and the point at which the write to the Duty Cycle register occurs within the PWMx time base, will determine if the PWMxH and PWMxL outputs make an immediate transition. PWMxH and PWMxL outputs make an immediate transition if the Duty Cycle register is written with a new value, PDCNEW, at a point of time when the PWMx time base is counting a value that is in between PDCNEW and PDCOLD. Additionally, writing to the Duty Cycle register close to the instant of time where dead time is being applied may result in reduced dead time, effective on the PWMxH and PWMxL transition edges.

In [Figure 1](#) (following page), if the duty cycle write occurred in the shaded box, then PWMxH and PWMxL will make an immediate transition without dead time.

None. However, in most applications the duty cycle update timing can be controlled using the TRIGx trigger or Special Event Trigger such that the above mentioned conditions are avoided altogether.

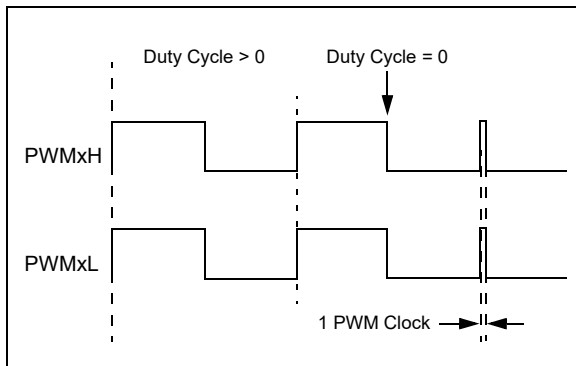
**FIGURE 2: ISSUE EXAMPLE FOR REDUNDANT OUTPUT MODE**

In Redundant Output mode ( $\text{IOCONx}[11:10] = 01$ ) and Push-Pull Output mode ( $\text{IOCONx}[11:10] = 10$ ) with the Immediate Update Enable bit ( $\text{PWMCONx}[0] = 0$ ) disabled, when the Duty Cycle register is updated from a non-zero value to zero, a glitch pulse of a width equal to one PWM clock will appear at the next PWM period boundary, as shown in Figure 2 (for the Redundant Output mode). The Duty Cycle register refers to the  $\text{PDCx}$  register if  $\text{PWMCONx}[8] = 0$  or the  $\text{MDC}$  register if  $\text{PWMCONx}[8] = 1$ .

If the application requires a zero duty cycle output, there are two possible work around methods:

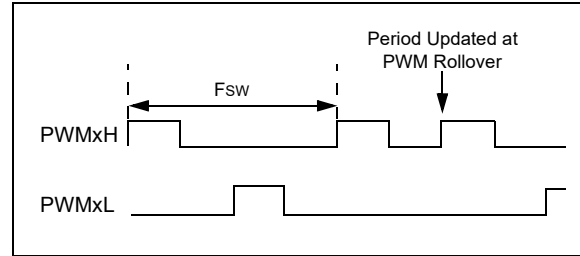
**FIGURE 3: ISSUE EXAMPLE IN PUSH-PULL MODE**

When the PWM module is configured for Push-Pull mode ( $\text{IOCONx}[11:10] = 10$ ) with the Enable Immediate Period Updates bit enabled ( $\text{PTCON}[10] = 1$ ), a write to the Period register that coincides with the period rollover event may cause the push-pull output logic to produce back-to-back pulses on the PWMx output pins (Figure 3).

Use either the PWMx Special Event Compare ( $\text{SEVTCMP}$ ) or PWMx Primary Trigger Compare Value ( $\text{TRIGx}$ ) to generate a PWM Interrupt Service Routine (ISR) near the start of the PWM cycle. This ISR will ensure that period writes do not occur near the PWM period rollover event.

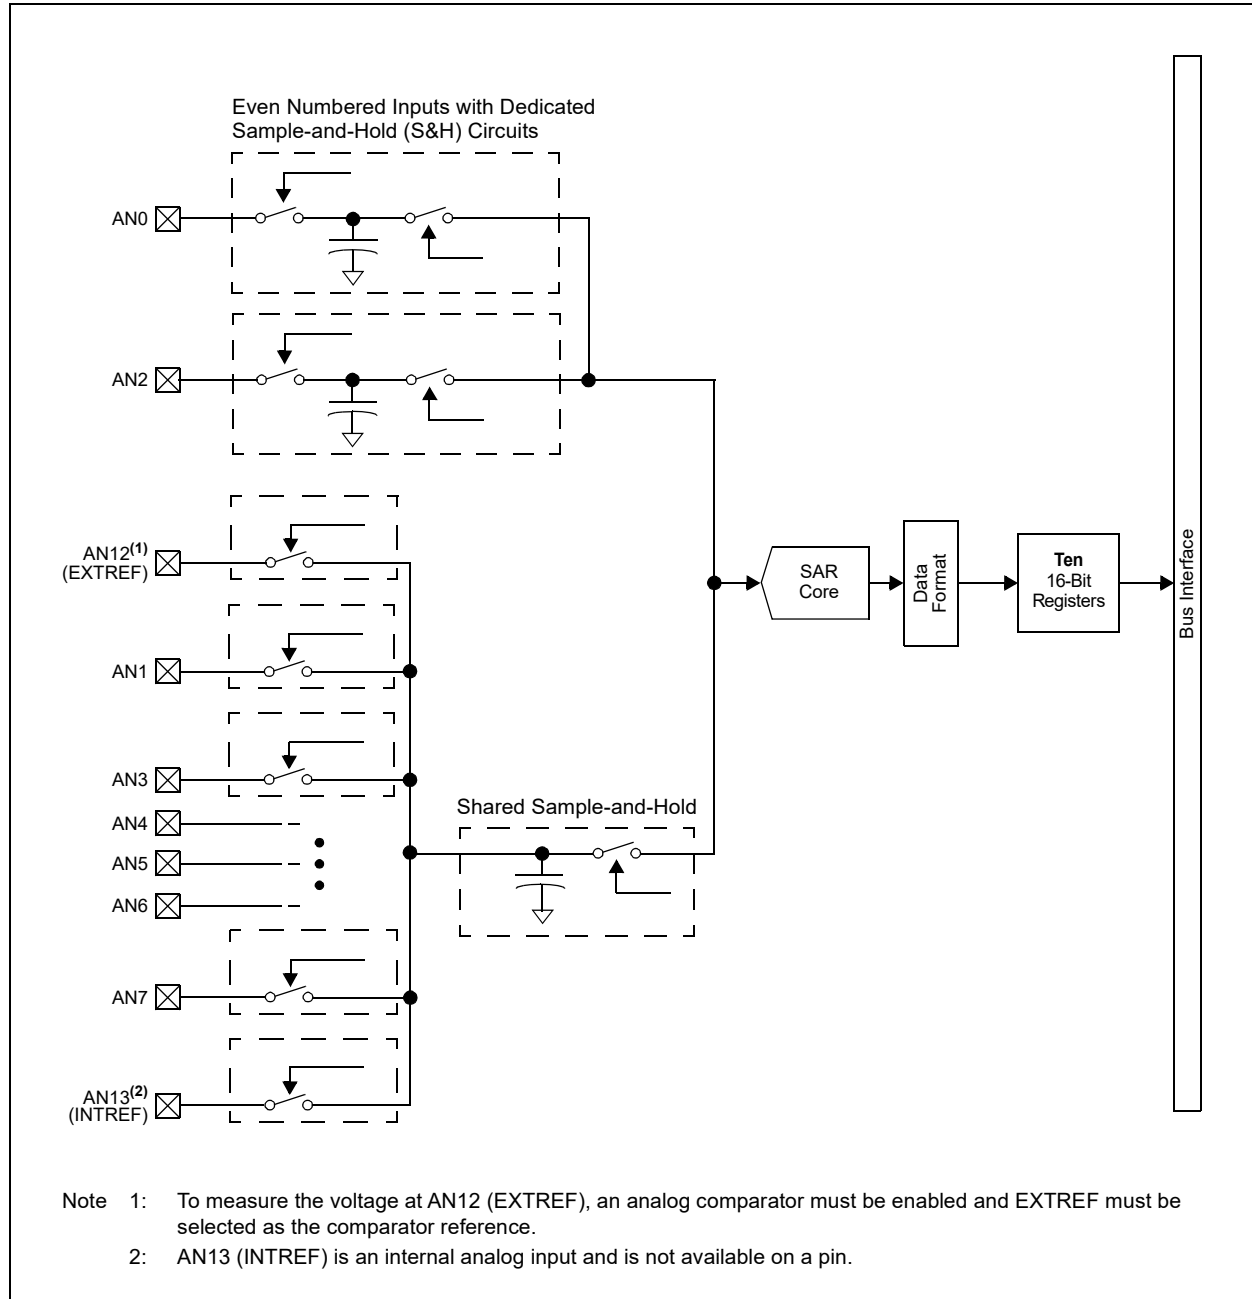
**FIGURE 19-5: ADC BLOCK DIAGRAM FOR THE dsPIC33FJ09GS302 DEVICE**

In [Figure 19-5](#), the number of output registers has been changed from eight to ten. The changes are shown in bold below:
