ENT-AN1238
Application Note
Timestamp Out-of-Sync (OOS) Summary
January 2019

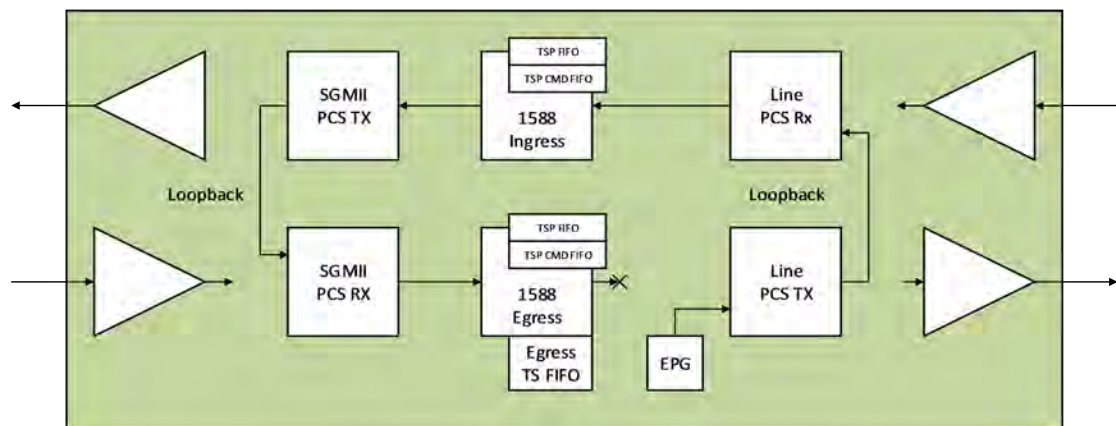
Figure 2 • VSC8574 Targeted Recovery Port

The following illustration shows a channel in the VSC8574 device. The initial steps of the software patch will isolate the targeted recovery port in the PHY by setting near-end and media loopbacks (so that traffic ends in the 1588 egress block) and by enabling MII isolate.

The following transactions occur within the routine in order to recover the OOS condition within the 1588 timestamping engine:

- EPG generates frames using test mode configuration.
- Frames are not transmitted on the MAC side (through the MII Isolate bit) or media side because the PHY datapath is isolated early in the routine.
- Ingress 1588 block is configured to insert 30-bit timestamps in PTP packet.
- Egress 1588 block is configured to extract ingress timestamps from the frames and save both 10-byte egress timestamps and 30-bit ingress timestamps into the egress TS FIFO.
- A TSP_FIFO recovery routine will execute on the 1588 engine (Eng 0 or Eng1) configured for PTP_ETH_IPv4 encapsulation.
- A TSP_CMD_FIFO recovery routine will execute on one PTP_OAM engine (Eng2A or 2B).

Once complete, the EPG is disabled and the 1588 engine configuration is restored to the original configuration programmed by the user PTP application and external frame traffic is re-enabled in the PHY datapath.
