**dsPIC33EPXXXGM3XX/6XX/7XX FAMILY**

## **dsPIC33EPXXXGM3XX/6XX/7XX Family Silicon Errata and Data Sheet Clarification**

The dsPIC33EPXXXGM3XX/6XX/7XX family devices that you have received conform functionally to the current Device Data Sheet (DS70000689D), except for the anomalies described in this document.

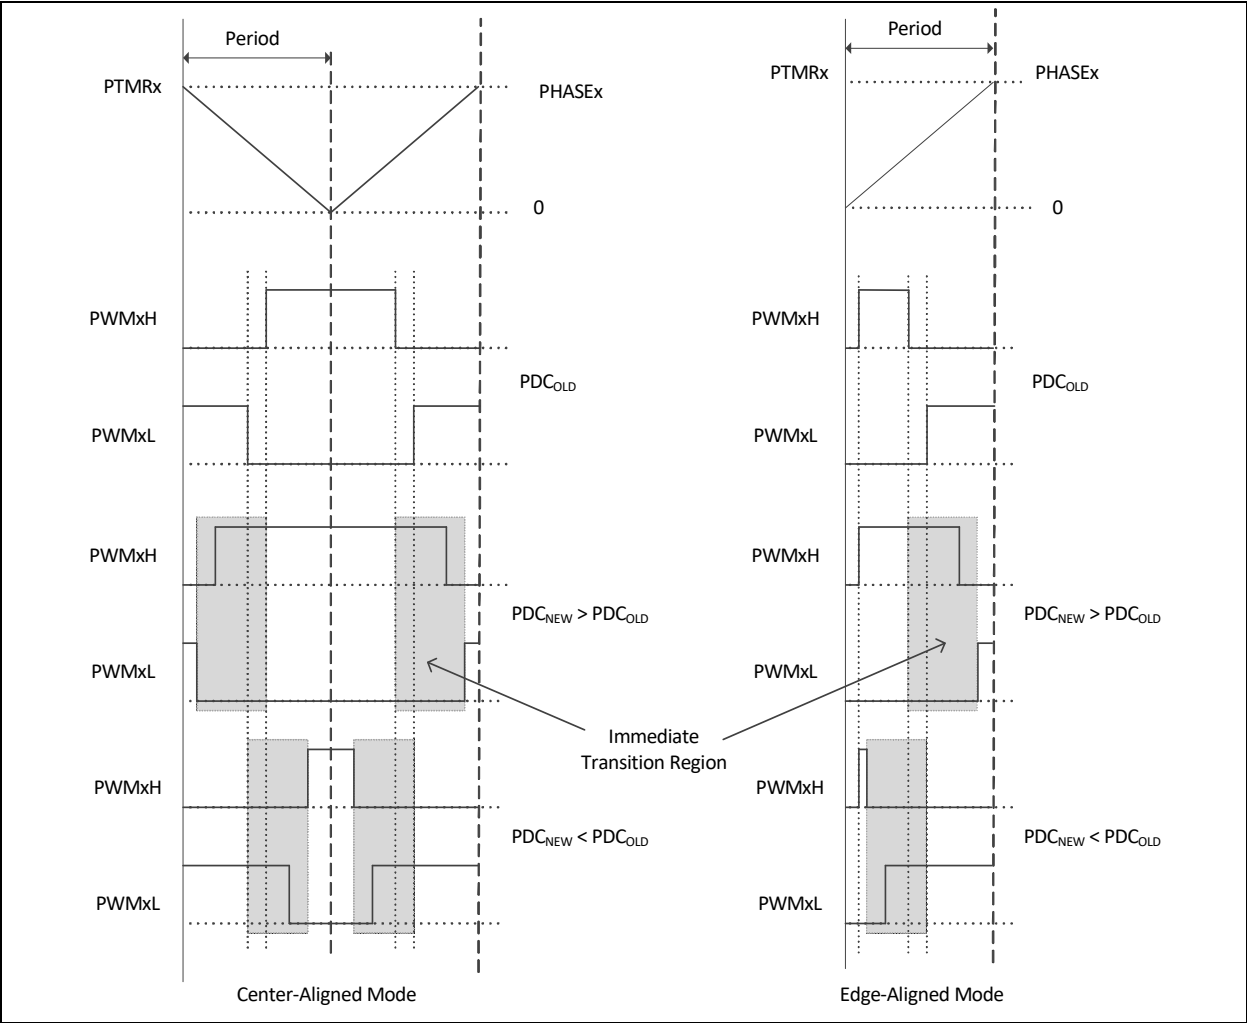
FIGURE 1: TIMING DIAGRAMS FOR CENTER-ALIGNED AND EDGE-ALIGNED MODES

The PWM generator may not assert dead time on the edges of transitions. This has been observed when all of the following conditions are present:

In Figure 1, if the duty cycle write occurred in the shaded box, then PWMxH and PWMxL will make an immediate transition without dead time.

None.

In most applications, the duty cycle update timing can be controlled using the TRIGx trigger, or Special Event Trigger, such that the above mentioned conditions are avoided altogether.

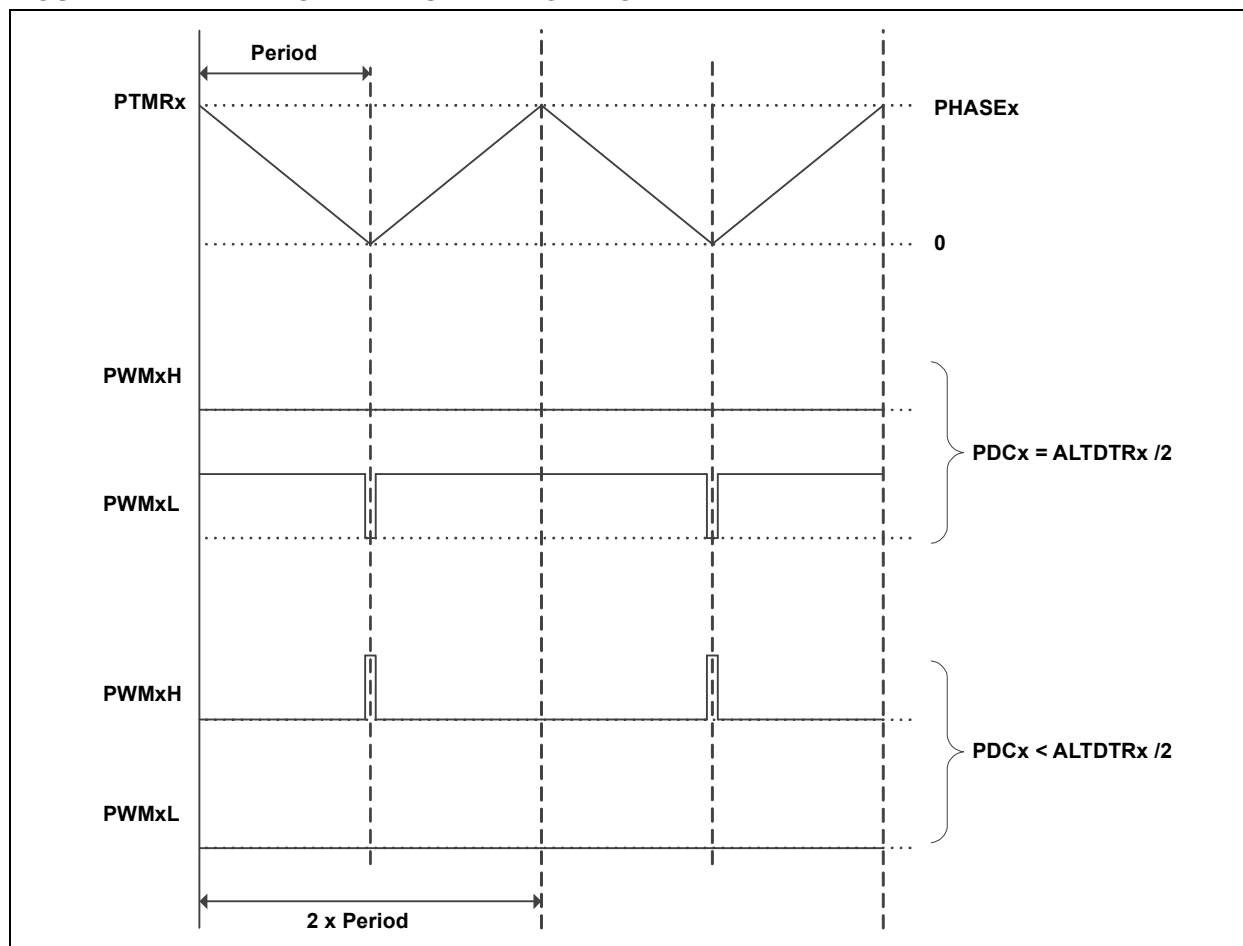
**FIGURE 2: PWM GENERATOR TIMING DIAGRAM**

In Center-Aligned Complementary mode with Independent Time Base, if the value in the PDCx register is less than one-half the value in the ALTDTRx register, the PWM generator will force the PWMxL to low, and on the PWMxH, generates pulses of a width less than twice the dead time, as shown in Figure 2.

Include a software routine to ensure that the duty cycle value written to the PDCx register is at least one-half of the value in ALTDTRx. Example 1 shows one method, with PDCtemp representing the variable which has the value to be written to the PDCx register. Alternatively, for duty cycle values less than half the desired dead-time value, zero out the ALTDTRx register or dynamically reduce the value in the ALTDTRx register, such that ALTDTRx is always equal to  $2 * PDCx$ , as shown in Example 2.

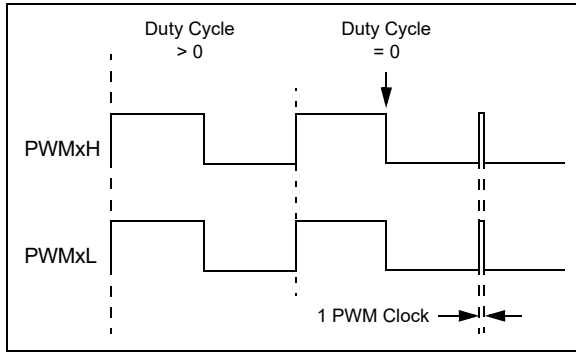
**FIGURE 3:**

In certain output modes, the PWMx module produces a pulse glitch of one PWM clock in width (Figure 3). This has been observed only when all of the following are true:

The pulse glitch has been observed to occur at the beginning of the following PWM boundary period.

If the application requires a duty cycle of zero, two possible work arounds are available.

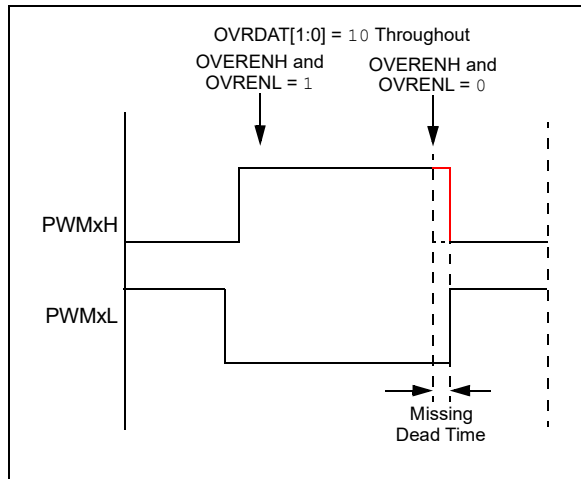
**FIGURE 4:**

This has been observed in both Center-Aligned and Edge-Aligned modes.

None.

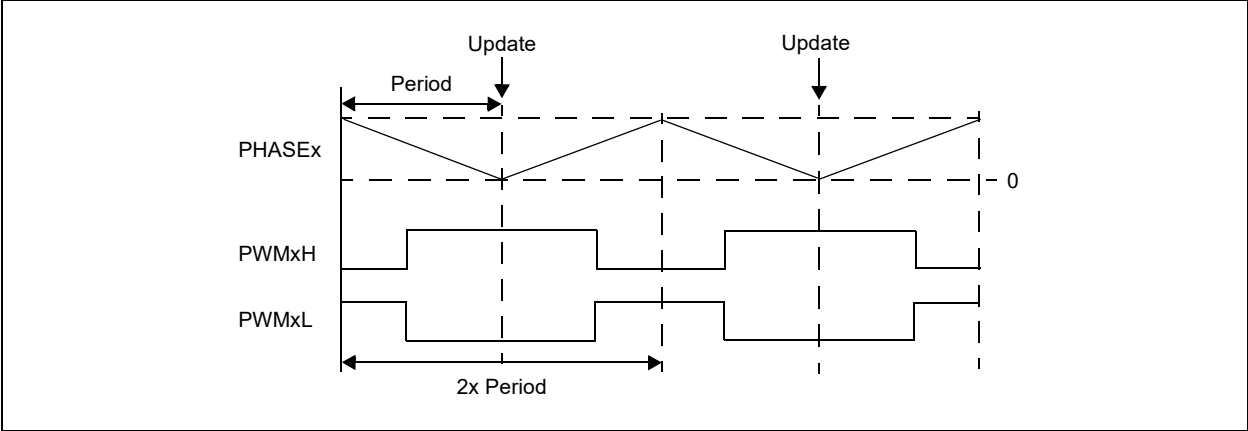
FIGURE 5:

In Center-Aligned Complementary mode with Independent Time Base, updates to the PHASEx register take effect in the middle of a Center-Aligned PWM cycle, as shown in Figure 5. This occurs only when the Immediate Update feature is disabled (IUE = 0). If Immediate Update is enabled (IUE = 1), the PHASEx register updates will take effect immediately.

None.

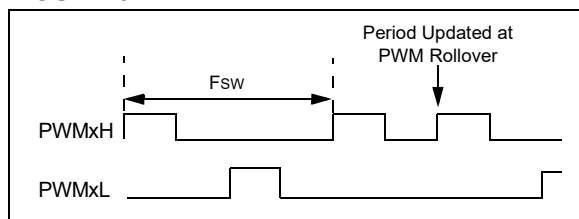
**FIGURE 6:**

When the PWM module is configured for Push-Pull mode (IOCONx[11:10] = 10) with the Enable Immediate Period Update bit enabled (PTCON[10] = 1), a write to the Period register that coincides with the period rollover event may cause the push-pull output logic to produce back-to-back pulses on the PWMx pins (Figure 6).

Ensure that the update to the PWM Period register occurs away from the PWM rollover event by setting the EIPU bit (PTCON[10] = 1). Use either the PWM Special Event Trigger (SEVTCMP) or the PWM Primary Trigger (TRIGx) to generate a PWM Interrupt Service Routine (ISR) near the start of the PWM cycle. This ISR will ensure that period writes do not occur near the PWM period rollover event.

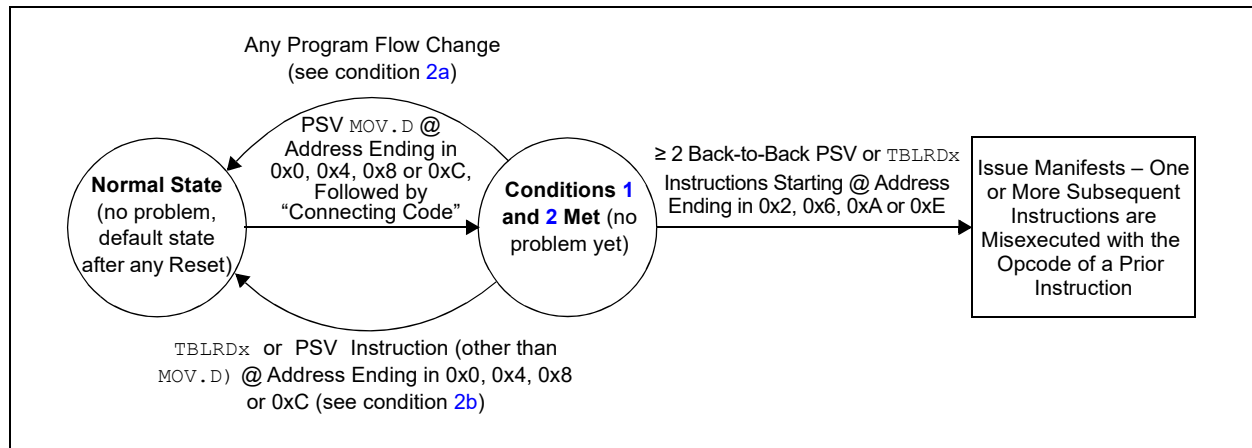
**FIGURE 7: SIMPLIFIED BEHAVIOR**

When two or more data Flash read instructions (via Program Space Visibility (PSV) read or table read) are executed back-to-back, one or more subsequent instructions can be misexecuted when all of the conditions in [Table 6](#) occur.

[Figure 7](#) provides an example of the effective behavior.

1. All instances of PSV `MOV.D` can be replaced with two PSV `MOV` instructions instead. Non-PSV `MOV.D` instructions acting on RAM/SFRs do not need to be modified; or
2. If not already present, a program flow change instruction (such as `BRA $+2`) can be inserted above back-to-back data Flash read sequences; or
3. Back-to-back data Flash read instruction sequences can be broken up by inserting a non-Flash read instruction (such as a `NOP`), in between the Flash read instructions; or
4. The alignment of the code can be shifted to avoid the required opcode location addresses.
