PIC16(L)F15325/45

PIC16(L)F15325/45 Family Silicon Errata and Data Sheet Clarification

The PIC16(L)F15325/45 family devices that you have received conform functionally to the current Device Data Sheet (DS40001865**D**), except for the anomalies described in this document.

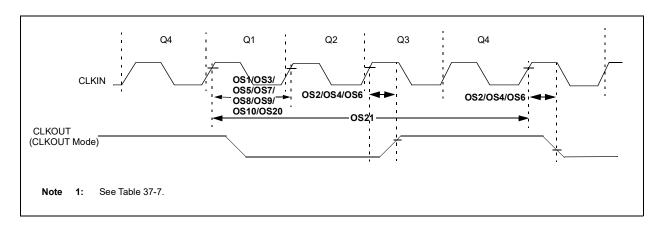
2.1 Figure 37-5: Clock Timing

Figure 37-5 incorrectly shows the location of parameters OS1, OS2, OS3, OS4, OS5, OS6, OS7, OS8, OS9, OS10, OS20 and OS21. The correct location for the above-mentioned parameters is depicted in the following figure.

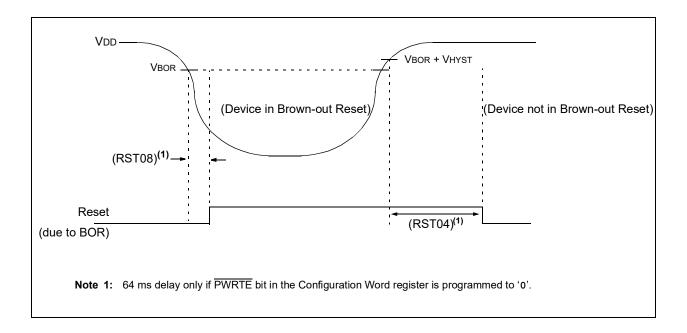
2.2 Figure 37-9: Brown-Out Reset Timing and Characteristics

Note 1 in Figure 37-9 is incorrect. The correct note along with the figure is depicted below.
