## Introduction

The following table lists the device specific errata and the affected SmartFusion2 devices. See [IGLOO® 2 FPGA and SmartFusion® 2 SoC FPGA Datasheet](#) for the die revision part marking specification.

## 1. Errata Descriptions and Solutions

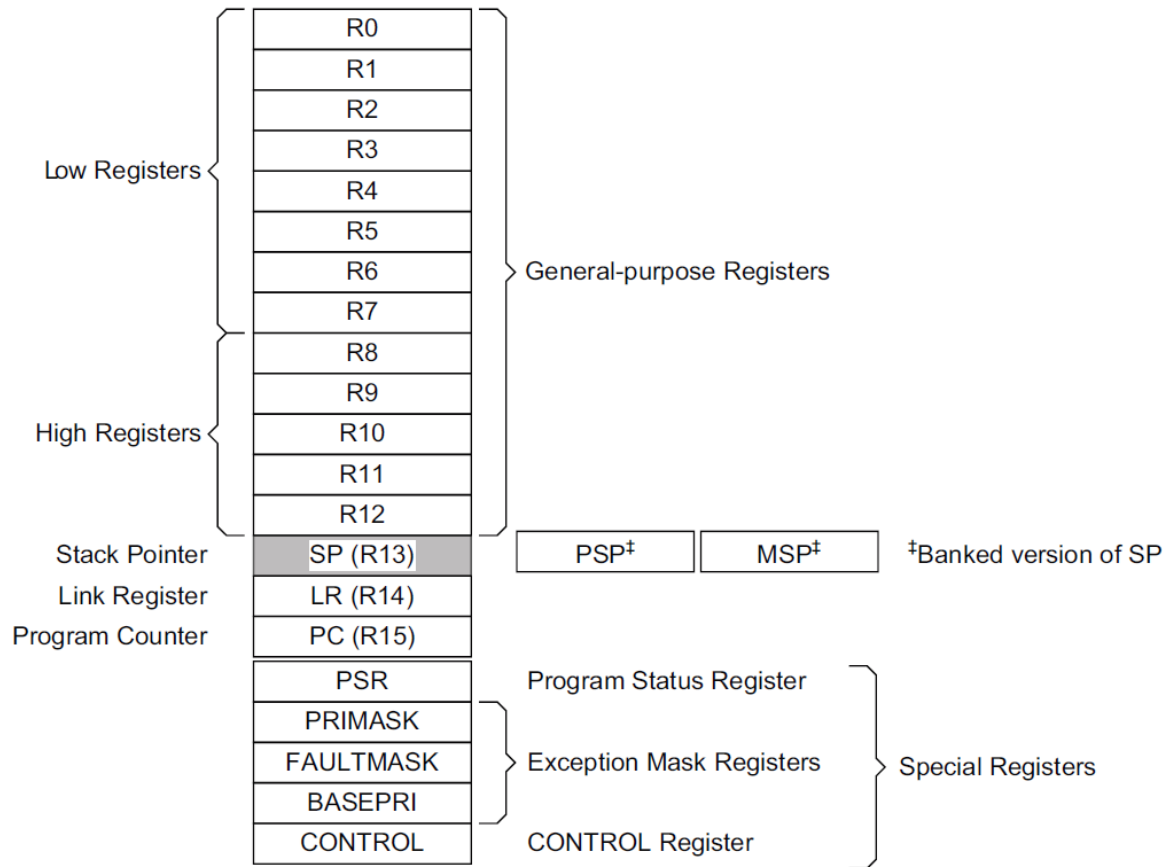
**Figure 1-1. Cortex-M3 Core Register Set**

Cortex-M3 internal general-purpose registers (for example R6) gets corrupted when two nested D-Bus (must be a non-64-bit-aligned access) and I-Bus cache miss cycles occur in cache controller fetching from eNVM followed immediately by a D-Bus read without cache miss.

A D-Bus read takes the precedence over an I-Bus but the data loaded into the Cortex-M3 internal register (for example, R6) is erroneously the I-Bus data which causes the corruption and consequently the application fails in an unpredictable manner.

1. Add one the following compiling options depending on the toolchain used. This option prevents a D-Bus read to happen after I-Bus read. The following is a list of most common compilers used.
  - Keil, `--no_integer_literal_pools` or similar options
  - IAR, `--no_literal_pool`
  - GCC-ARM, `-mpure-code`
2. Recompile the code and update the executable code on the boot medium.
