PIC18F06/16Q41 Silicon Errata and Data Sheet Clarifications

The PIC18F06/16Q41 devices you have received conform functionally to the current device data sheet (DS40002214G), except for the anomalies described in this document.

The silicon issues discussed in the following pages are for silicon revisions with the Device and Revision IDs listed in the table below.

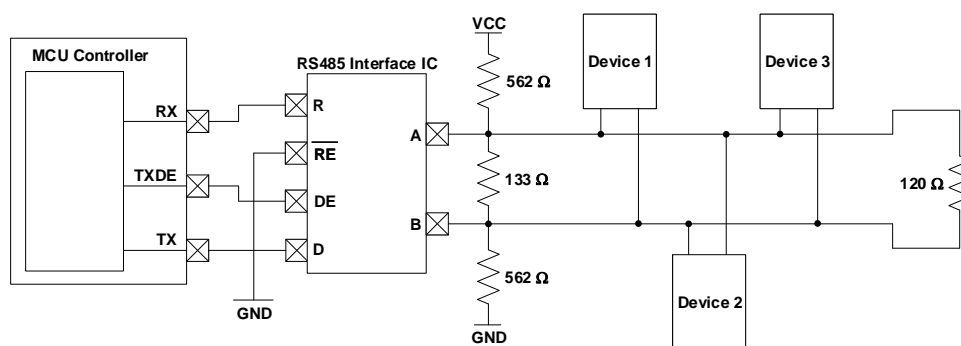
1.5.1 UART TXDE Signal May Go Low Before the STOP Bit Has Been Entirely Transmitted

The UART Transmit Drive Enable (TXDE) signal could potentially transition into a low state before the UART STOP bit has been entirely transmitted due to the effects of parasitic capacitance on the TX line. In some applications, this could result in communication being prematurely terminated due to the TXDE signal going low before the STOP bit has had enough time to settle.

To ensure that the STOP bit settles into its final logic state before the TXDE signal transitions low, a biasing circuit can be implemented. A biasing circuit allows the TX line to either be driven high or low, rather than being left in a floating tri-state mode where prolonged rise or fall times could lead to communication being disrupted. This bias circuit should only be implemented on one end of the serial bus, and a termination resistor should be used on the other end. The figure below shows an example of a bias circuit that can be used to achieve this.

Please note that the resistor values used in this circuit are recommendations and that the actual resistor values required may vary based on the application.
