ATtiny87/167 Automotive

Automotive Silicon Errata and Data Sheet Clarifications

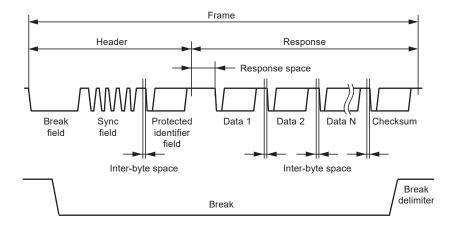
Figure 2-1. The Break Field

In SLAVE MODE, a BREAK field detection error can occur under the following conditions.

The problem occurs if two conditions occur simultaneously:

- 1. The DOMINANT part of the BREAK is (N+0.5)*Tbit long with N=13, 14,15, ...
- The RECESSIVE part of the BREAK (BREAK DELIMITER) is equal to 1*Tbit. (See the note below).

The BREAK_high is not detected, and the 2nd bit of the SYNC field is interpreted as the BREAK DELIMITER. The error is detected as a framing error on the first bits of the PID or subsequent Data or a Checksum error.

There is no error if BREAK_high is greater than 1 x Tbit + 18%.

None
