**ENT-AN1281**  
**Application Note**  
**VSC8504/VSC8552/VSC8572/VSC8574 Transition Design**  
**Guide**

September 2018

This document highlights considerations for transitioning from revision D to revision E of the VSC8504/VSC8552/VSC8572/VSC8574 devices.

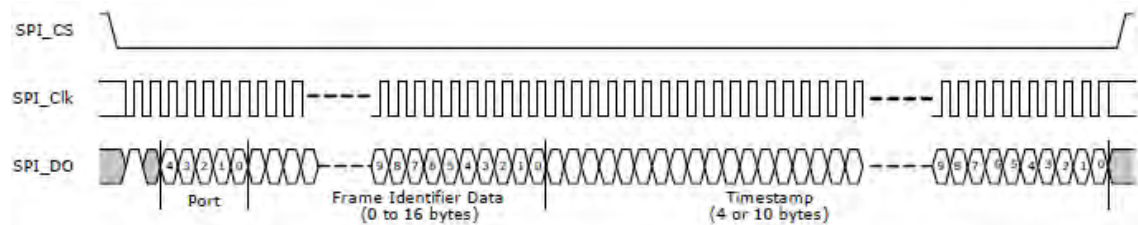
**Figure 1 • VSC8572-02/VSC8574-02 SPI TS/Signal Output**

**Note:** The silicon defaults to generating output bits on the falling edge of the SPI clock, so a SPI receiver implementation will latch the bits at its input pin on the rising edge of the SPI clock.

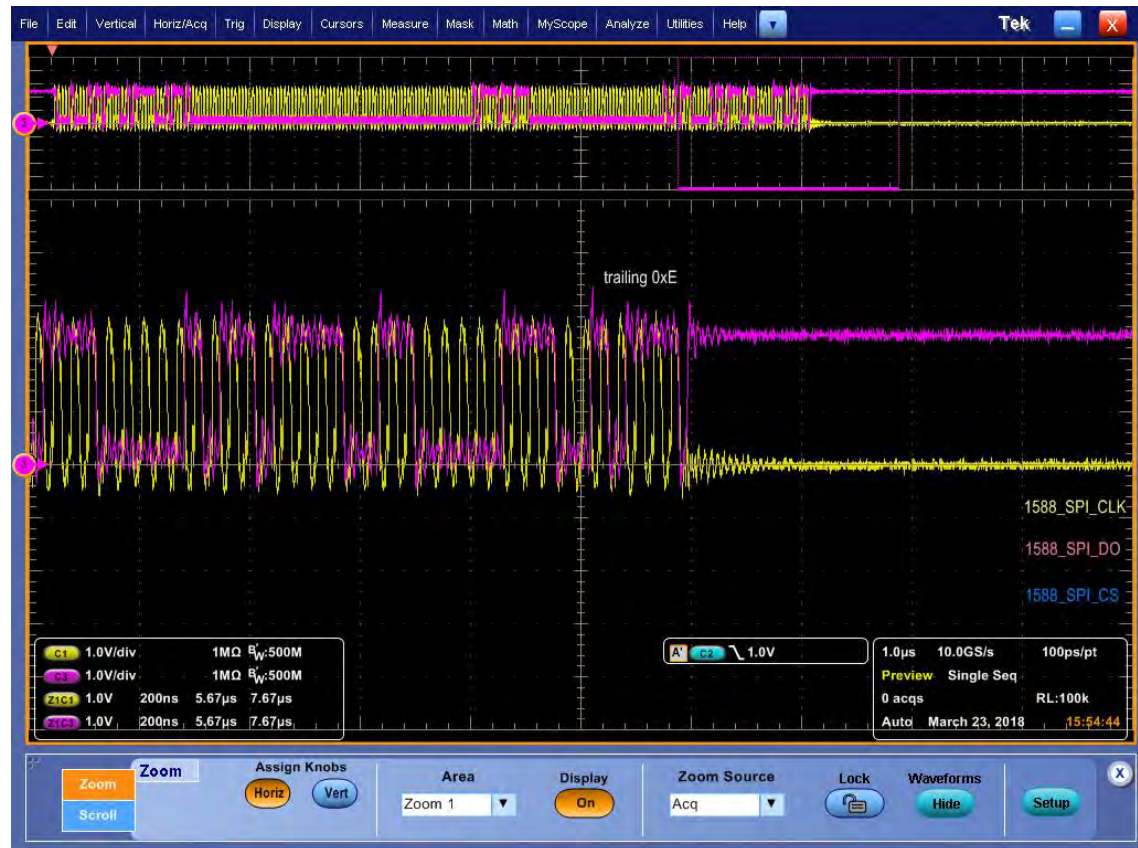
Figure 2 • SPI Timestamp Error

As a consequence of the SPI clock cycle termination failure, the final bit of a faulty serial timestamp transaction will not be latched at the receiver. The failure phenomenon can be inferred from the following oscilloscope capture.

The timestamp transaction shown utilizes a PTP Delay\_Req message with a known T3 timestamp ending in nibble 0xE (serial output order is MSB→LSB). The scope capture shows the final three rising edges of 1588\_SPI\_CLK (yellow) are all 1s, while the terminating 1588\_SPI\_DO (magenta) transition from 1→0 lacks a corresponding rising edge of 1588\_SPI\_CLK. Instead, the transaction terminates prematurely, which results in the 1588\_SPI\_DO (magenta) returning to value 1.

Depending on the SPI receiver implementation, the timestamp may be merged with bits in the subsequent T3 timestamp or it might never be latched at the receiver. The failure effects can vary due to unpredictable behavior at the SPI receiver, but the PTP Slave will generally not be able to lock with the PTP Master as a result of corrupted Delay\_Req timestamps.

API-4.67.04 forcibly configures the 1588 serial timestamp output interface to have a SI\_CLK\_HI\_CYCS of 0x3 and SI\_CLK\_LO\_CYCS of 0x1. In other words, a 31.25 MHz SPI clock with 24 ns high time and 8 ns low time. Other 1588 devices are unaffected.

As indicated previously, the pushed T3 timestamp has nanosecond units. Because these PHYs timestamp with a minimum 4 ns resolution, the least-significant bit of the pushed timestamp is not meaningful for PTP slave timing accuracy. In other words, the least-significant bit of the T3 timestamp can be unconditionally set to a 0 inside the FPGA receiver logic without degrading system accuracy. This way, the SPI receiver could ignore the last bit of every pushed timestamp, whether or not the least significant bit is made available by the serial timestamp interface of the PHY.
