## Introduction

The ATxmega128A1U/64A1U devices you have received conform functionally to the current device data sheet ([www.microchip.com/DS40002058](http://www.microchip.com/DS40002058)), except for the anomalies described in this document. The errata described in this document will likely be addressed in future revisions of the ATxmega128A1U/64A1U devices.

# 1. Silicon Issue Summary

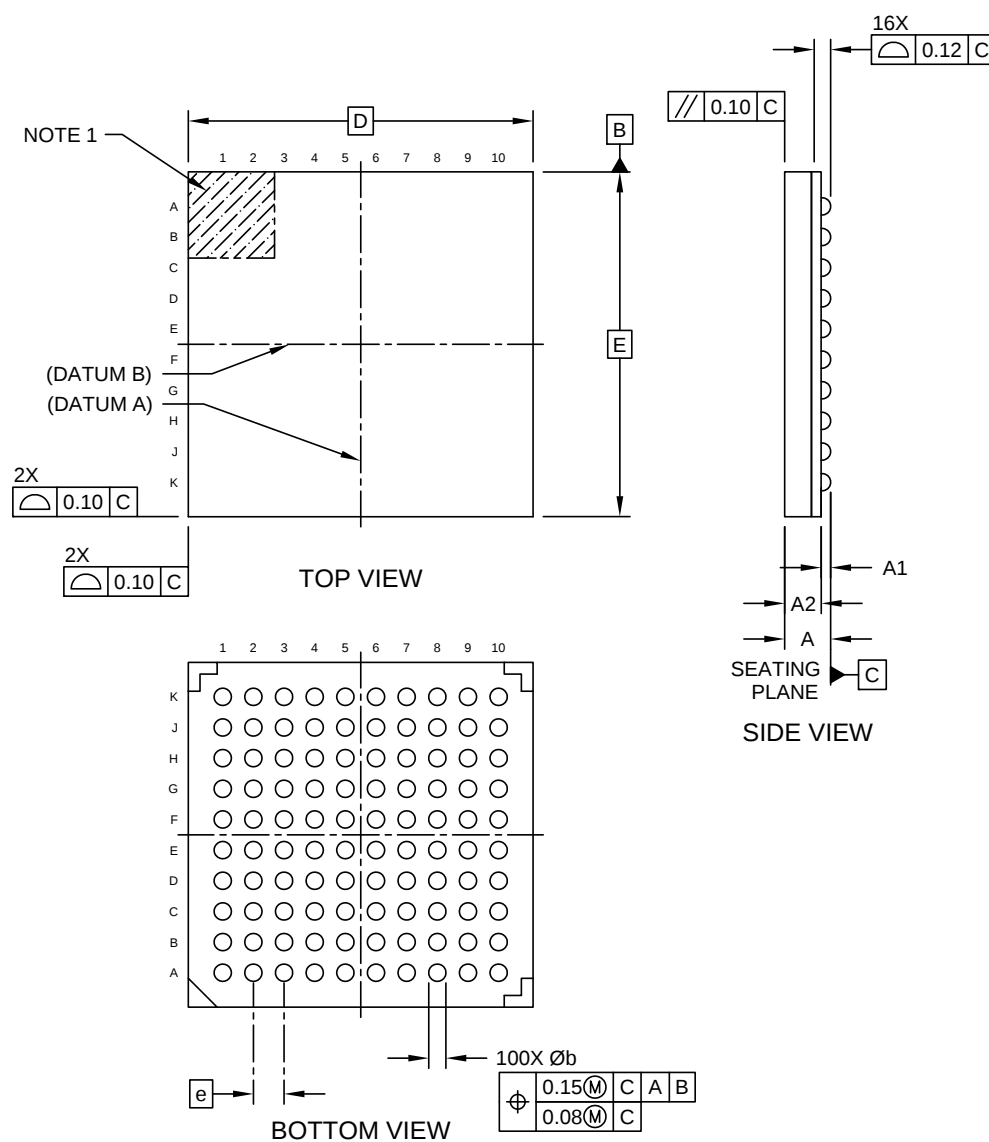
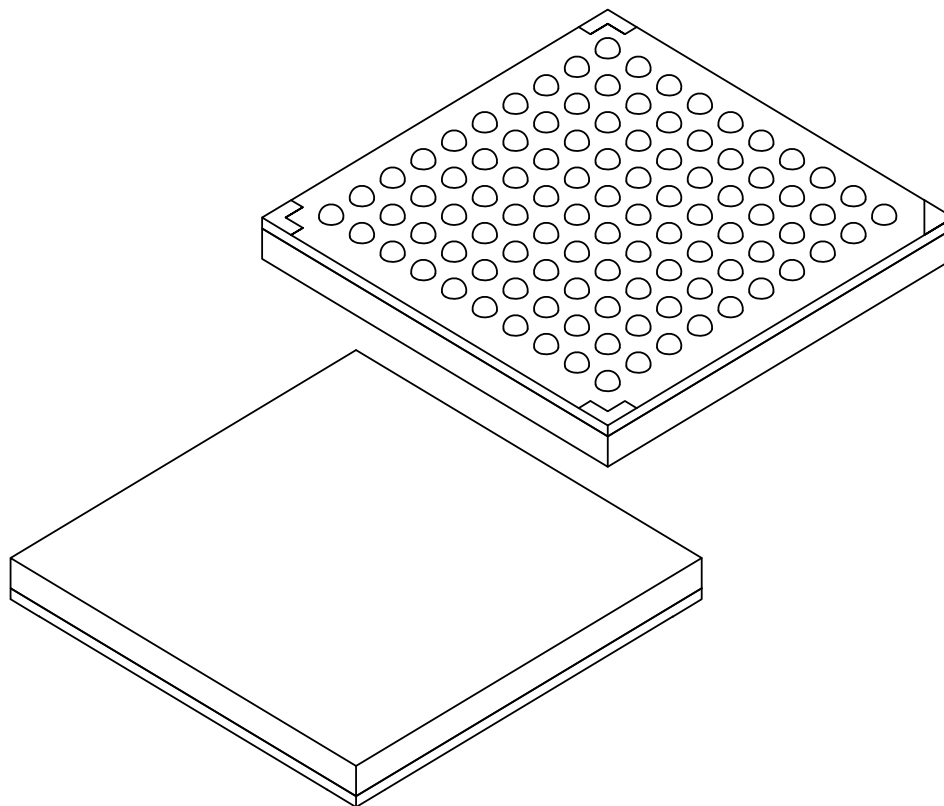
Microchip Technology Drawing C04-21135 Rev A Sheet 1 of 2

A clarification has been made to section **100C1**, providing the correct package outline drawing.
