**VSC8584**  
**Application Note**  
**VSC8584 Family Revision A/B 1588 Timestamp Out-of-Sync (OOS) Summary**

August 2017

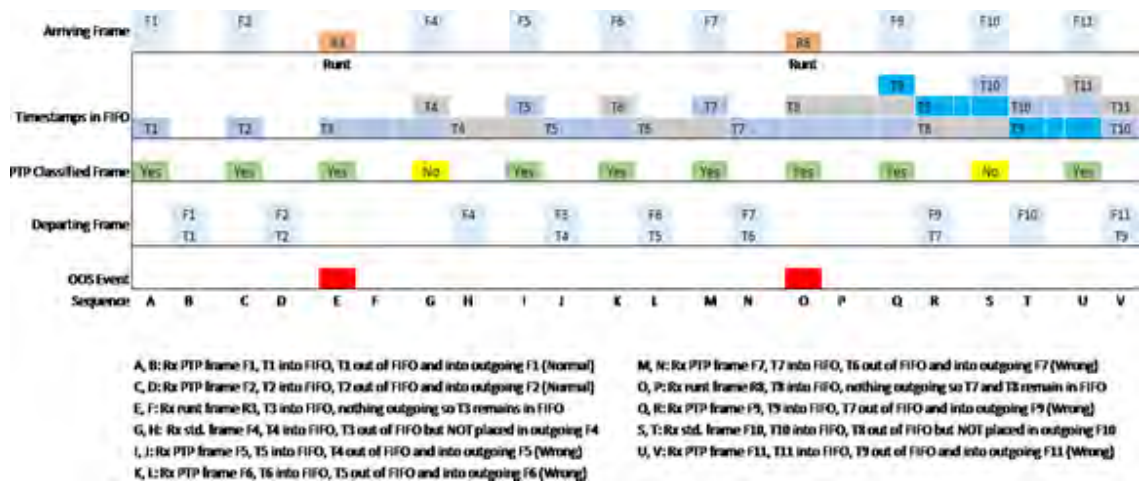
Figure 1 • Timestamp Sequence

Every time a start of frame is detected at the interface, a timestamp is generated and pushed into the TSP\_FIFO, which will hold this entry until a pop operation is issued to pull the FIFO's next entry before the frame is written with this timestamp upon its departure from the 1588 processor. However, if for some reason every frame received does not have a corresponding pop operation, the FIFO will accumulate an extra timestamp, causing subsequent packets to be loaded with the incorrect timestamp.

The following illustration shows the sequence of events relating to timestamps. It demonstrates two OOS conditions as a result of short or runt frames that fail to induce a corresponding TSP\_FIFO pop operation and the events that follow.
