# LAN8741A/LAN8741Ai

## LAN8741A/LAN8741Ai Silicon Errata and Data Sheet Clarification

This document describes known anomalies for functional revision A and B of the LAN8741A/LAN8741Ai device. The functional revision can be determined by its top marking as indicated in [Figure 1](#) and [Figure 2](#).

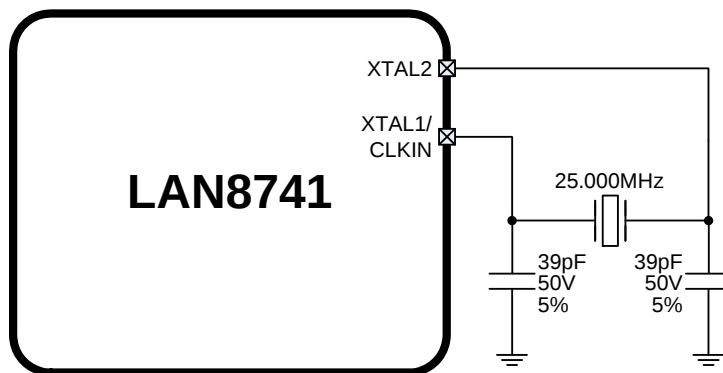
**FIGURE 3: EXAMPLE EXTERNAL CRYSTAL CIRCUIT**

In EEE mode, the device may drop link when using a Broadcom BCM53125 link partner at cable lengths less than 20 meters.

When using a Broadcom BCM53125 link partner in EEE mode, the device may drop link when using cable lengths less than 20 meters. The BCM53125 has exhibited a sensitivity to minute deviations in its link partner's transmit clock frequency during 100Mb EEE operation. This issue is exacerbated at short cable lengths. This anomaly does not impact 10Mb or non-EEE operation.

1. Utilize an Ethernet cable length of greater than 20m.
2. Increase the load capacitors on the LAN8741A/LAN8741Ai external crystal circuit to 39pF and exercise best practices for board layout. Refer to [FIGURE 3](#): for an example external crystal circuit.

3. Use a single-ended 25MHz clock source that meets the LAN8741A/LAN8741Ai specification requirements in lieu of a crystal.
