## dsPIC33EVXXXGM00X/10X Family Silicon Errata and Data Sheet Clarification

The dsPIC33EVXXXGM00X/10X family devices that you have received conform functionally to the current Device Data Sheet (DS70005144H), except for the anomalies described in this document.

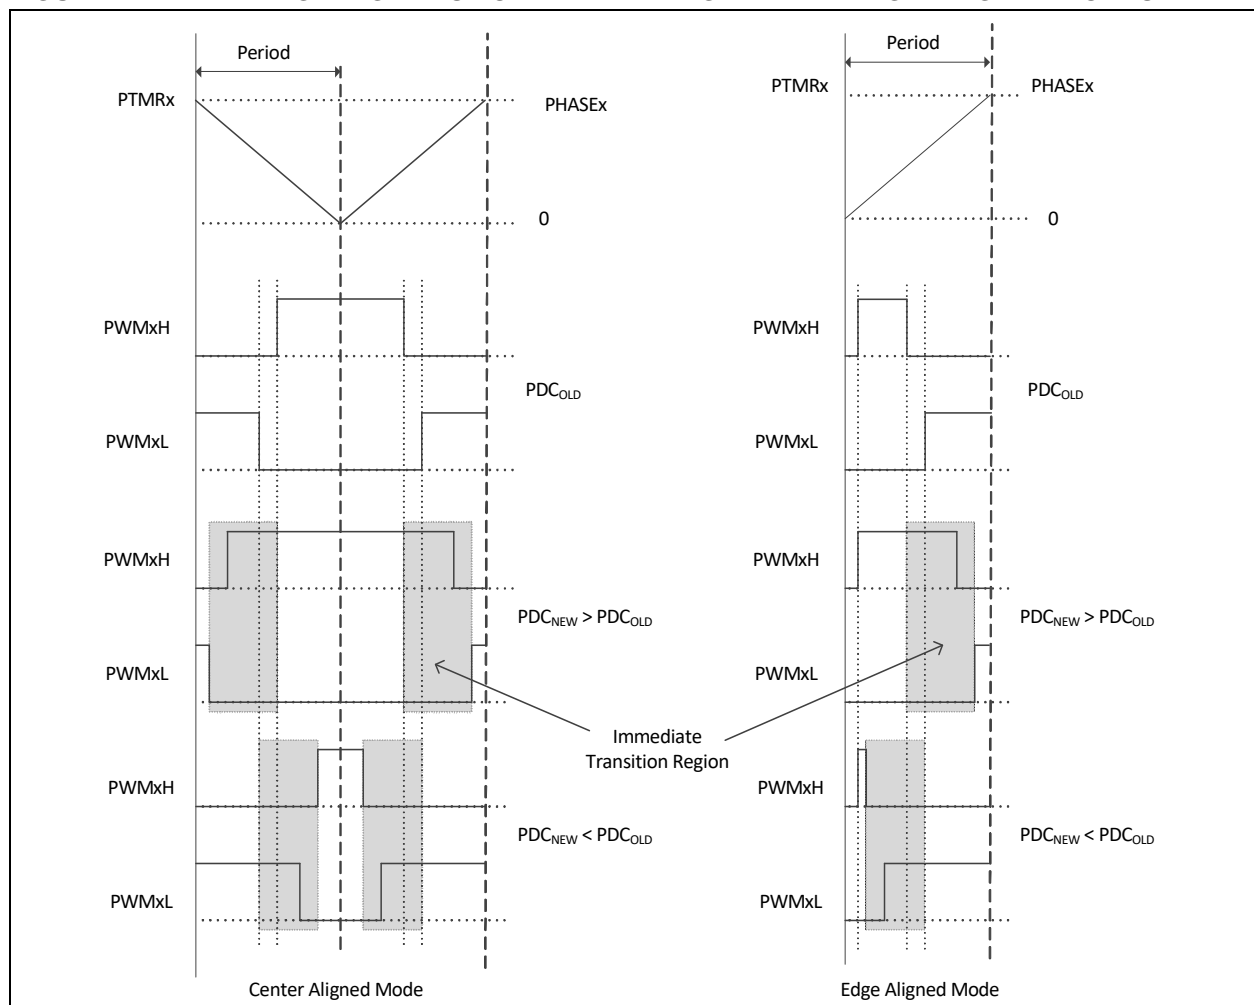
**FIGURE 2: TIMING DIAGRAMS FOR CENTER-ALIGNED AND EDGE-ALIGNED MODES**

The PWM generator may not assert dead time on the edges of transitions. This has been observed when all of the following conditions are present:

In [Figure 2](#), if the duty cycle write occurred in the shaded box, then PWMxH and PWMxL will make an immediate transition without dead time.

None.

However, in most applications, the duty cycle update timing can be controlled using the TRIGx trigger or Special Event Trigger, such that the above mentioned conditions are avoided altogether.

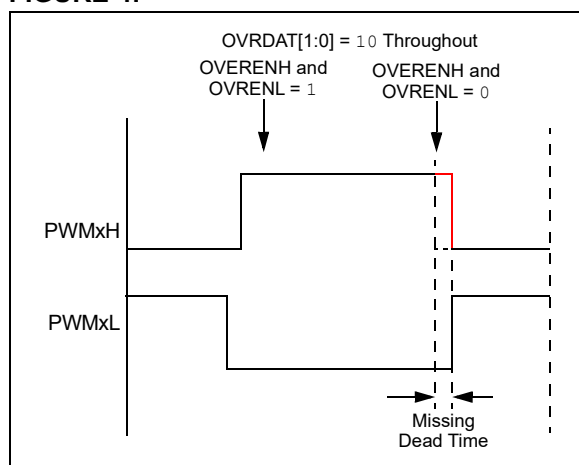
FIGURE 4:

- Output override synchronization is configured to occur on the CPU clock boundary (IOCONx[0] = 0);
- Both PWMxH and PWMxL overrides are enabled prior to the event (OVRENH and OVRENL are both '1'), and
- Both overrides are disabled (OVRENH and OVRENL are both '0') at the instant the dead time should be asserted (Figure 4). This has been observed in both Center-Aligned and Edge-Aligned modes.

None.

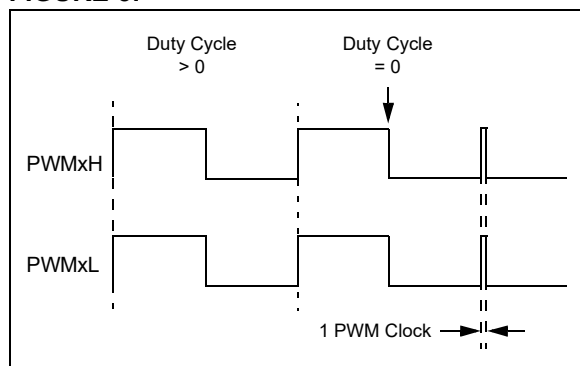
FIGURE 5:

In the Redundant Output mode (IOCONx[11:10] = 10) and Push-Pull Output mode (IOCONx[11:10] = 01) with Immediate Update disabled (PWMCONx[0] = 0), when the Duty Cycle register is updated from a non-zero value to zero, a glitch pulse of a width equal to one PWM clock will appear at the next PWM period boundary, as shown in Figure 5, for the Redundant Output mode. Here, the Duty Cycle register refers to the PDCx register if PWMCONx[8] = 0 or the MDC register if PWMCONx[8] = 1.

If the application requires a zero duty cycle output, there are two possible work around methods:

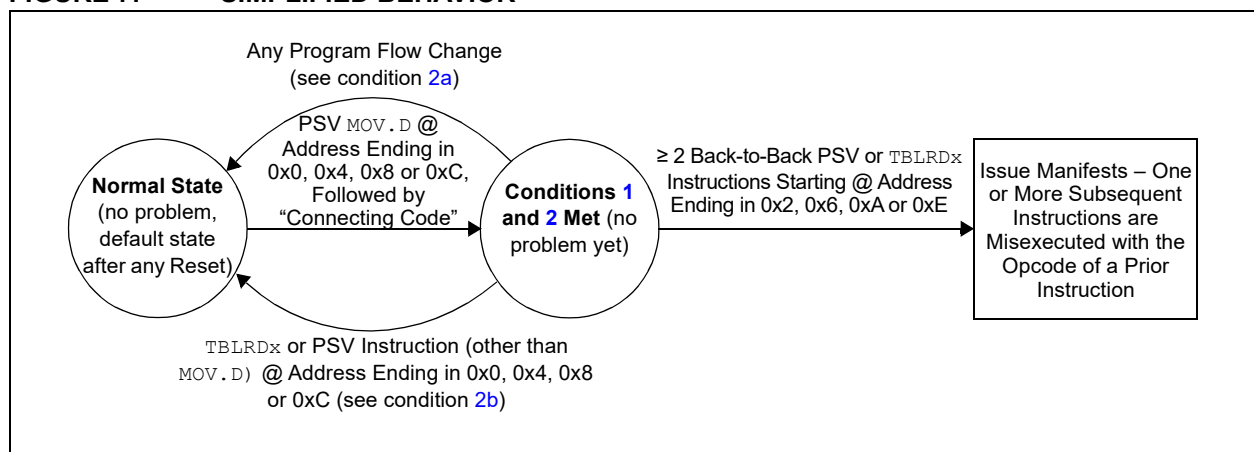
**FIGURE 7: SIMPLIFIED BEHAVIOR**

When two or more data Flash read instructions (via Program Space Visibility (PSV) read or table read) are executed back-to-back, one or more subsequent instructions can be misexecuted when all of the conditions in [Table 6](#) occur.

| 3. | ≥ 2 back-to-back PSV or <code>TBLRDx</code> instructions are executed (following the code of condition 2), where the first of the back-to-back instructions is located at an address ending in 0x2, 0x6, 0xA or 0xE. |

1. All instances of PSV MOV.D can be replaced with two PSV MOV instructions instead. Non-PSV MOV.D instructions acting on RAM/SFRs do not need to be modified; or
2. If not already present, a program flow change instruction (such as BRA \$+2) can be inserted above back-to-back data Flash read sequences; or
3. Back-to-back data Flash read instruction sequences can be broken up by inserting a non-Flash read instruction (such as a NOP), in between the Flash read instructions; or
4. The alignment of the code can be shifted to avoid the required opcode location addresses.
