## PIC16(L)F15324/44 Family Silicon Errata and Data Sheet Clarification

The PIC16(L)F15324/44 family devices that you have received conform functionally to the current Device Data Sheet (DS40001889C), except for the anomalies described in this document.

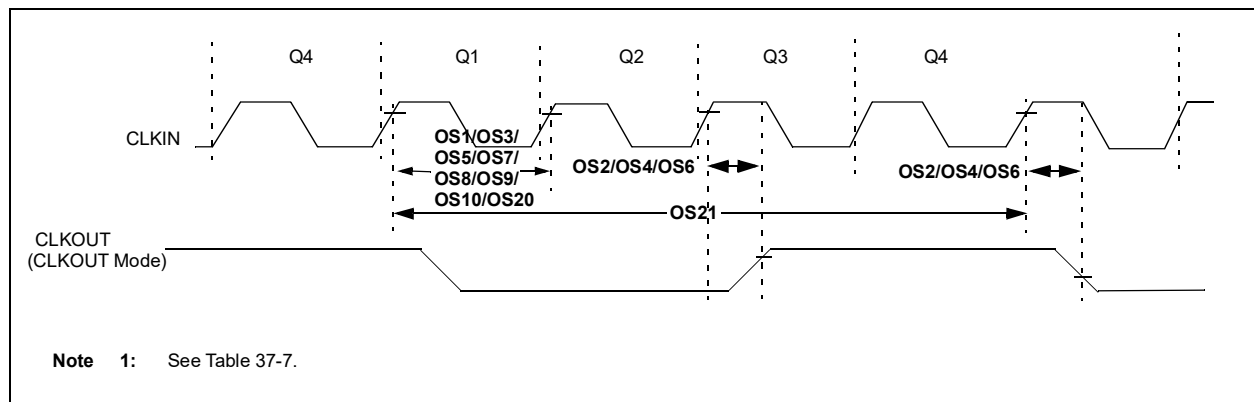
#### 2.1 Figure 37-5: Clock Timing

Figure 37-5 incorrectly shows the location of parameters OS1, OS2, OS3, OS4, OS5, OS6, OS7, OS8, OS9, OS10, OS20 and OS21. The correct location for the above-mentioned parameters is depicted in the following figure.

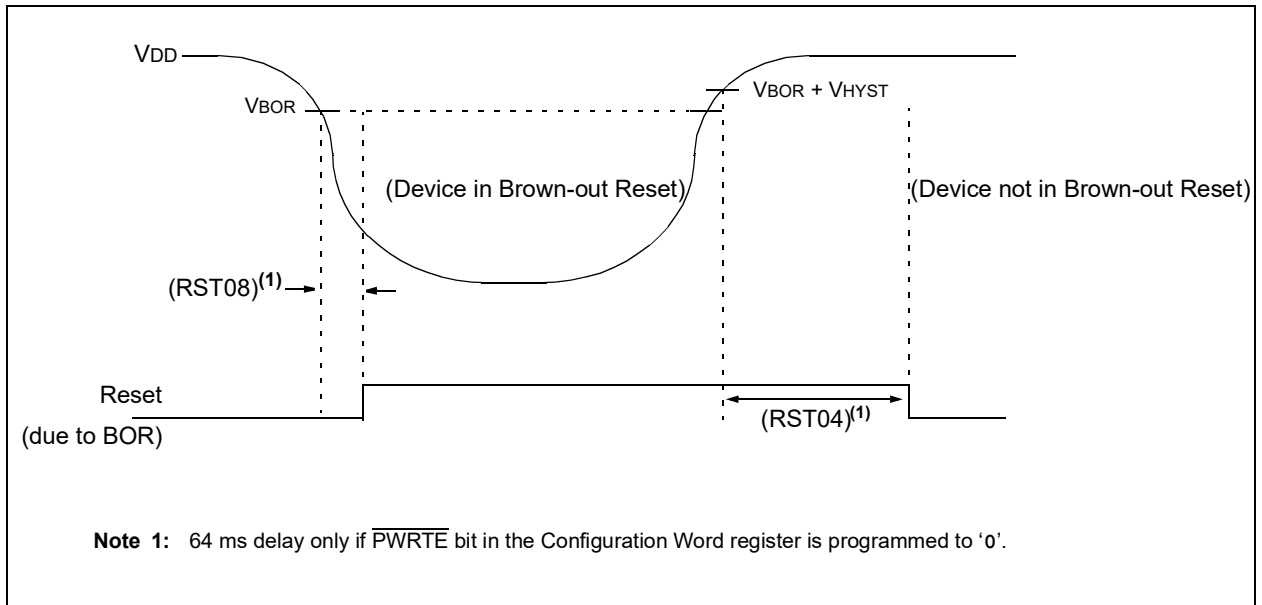
#### 2.2 Figure 37-9: Brown-Out Reset Timing and Characteristics

Note 1 in Figure 37-9 is incorrect. The correct note along with the figure is depicted below.
