## KSZ9031RNX Silicon Errata & Data Sheet Clarification

This document describes known silicon errata for the Microchip KSZ9031RNX device, which include the following variants:

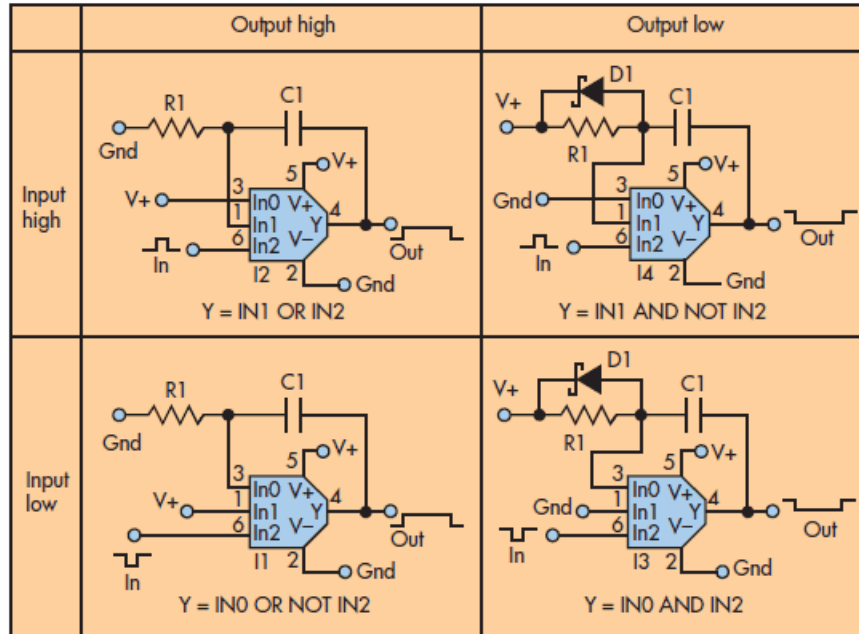
**FIGURE 2: LED CONFIGURATION**

In Tri-color Dual-LED mode, the LED[2:1] pin outputs toggle high pulses for transmit/receive activity indication. The high pulse width incorrectly tracks the activity data rate. At low data rate (e.g., one frame per second), the LED pin drives high (OFF) with a narrow high pulse width of about 640ns.

Typically, the LED toggle rate should be <10Hz (100ms clock period or 50ms high pulse width) to be visible to the human eye. A 640ns pulse is not visible.

If Tri-color Dual-LED mode must be used, use a pulse stretching circuit to detect high narrow pulse widths down to 500ns and stretch them to the visible width (e.g., >50ms). The following Electronic Design web link article has a sample pulse stretching circuit:

Use the Input high / Output high configuration, as shown in Figure 2 from the Electronic Design link. The output high stretch time is set by the time constant ( $R1 * C1$ ).

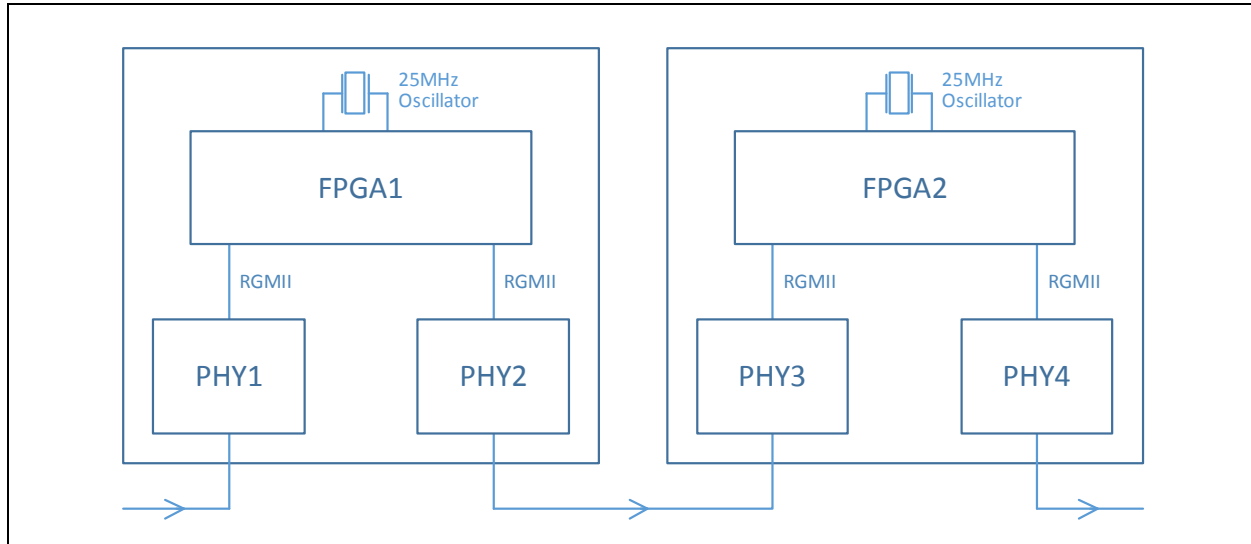
**FIGURE 3: DAISY CHAIN CONFIGURATION**

In a daisy chain configuration (PHY1 through PHY4 in [Figure 3](#)), 1000BASE-T receive traffic stoppage can occur at one of the device-to-device links in the chain.

The 1000BASE-T receive traffic stoppage at the local device (PHY3) is triggered by a single GTX\_CLK clock pulse assertion of the TX\_EN signal from the MAC (FPGA1) to the link partner device (PHY2). This scenario can occur after FPGA programming when the FPGA1 MAC transmit pins change to outputs. During the pins transition, if the TX\_EN signal is not driven by the FPGA1 and then floats high (gets asserted) for a single clock period at the PHY2 input, a GTX\_CLK output transition from low to high triggers the error condition.

Delay GTX\_CLK output from FPGA after programming to allow the TX\_EN output to be driven low first. Alternatively, add an 1 kohm pull-down at the TX\_EN input of the device.

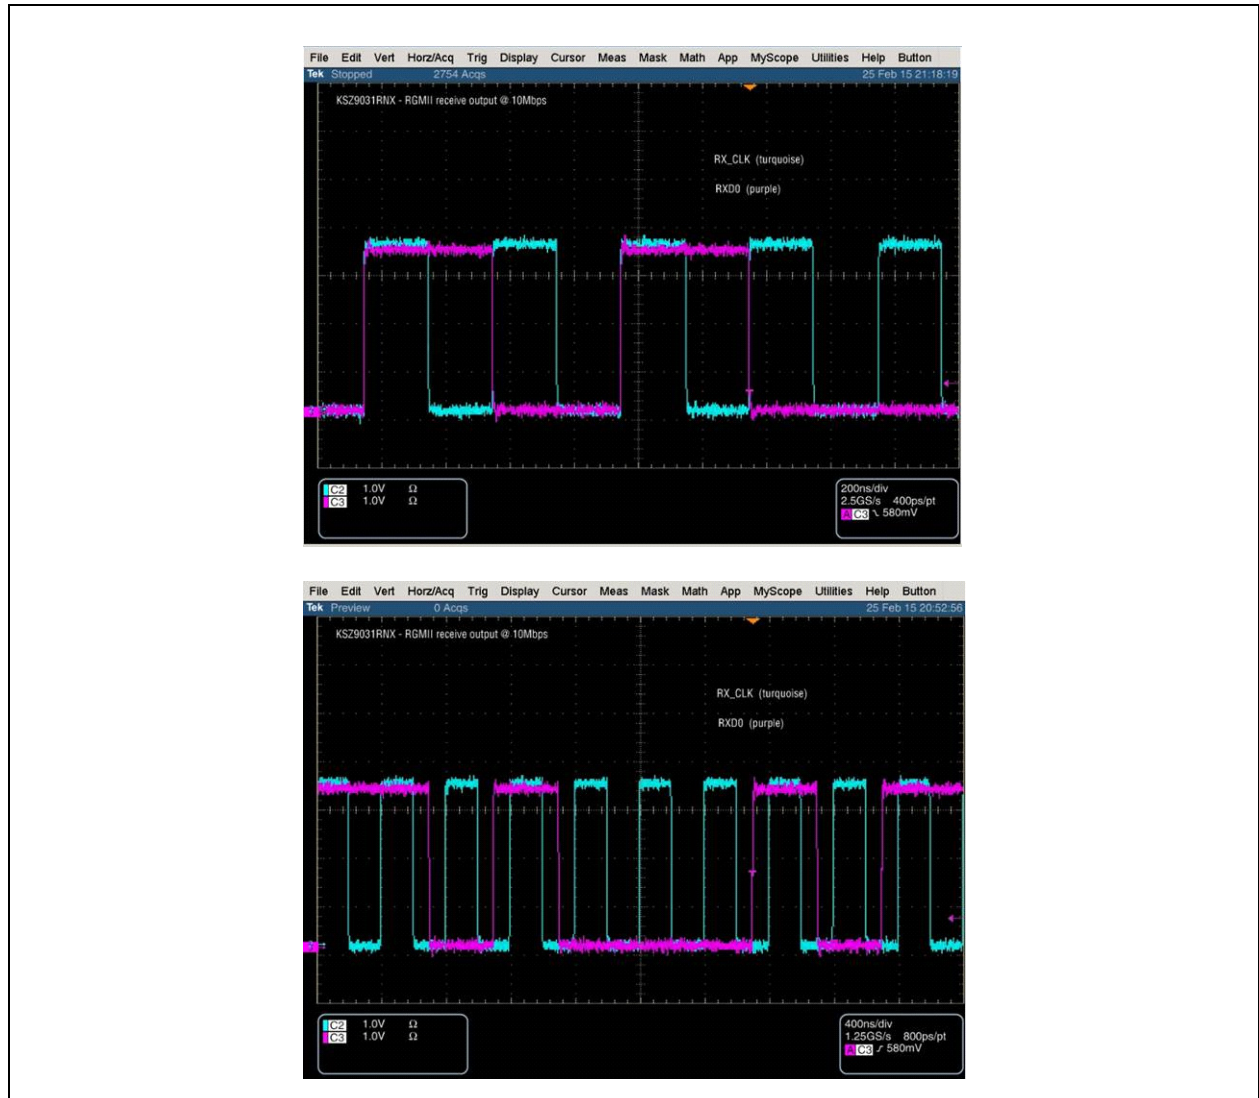
**FIGURE 4: RXD0 SCOPE CAPTURES**

In RGMII 10Mbps mode only, the device can power-up/reset to one of two possible clock phases. With respect to the RX\_DV and RXD[3:0] output high/low transitions, one phase transition is in sync with the RX\_CLK clock rising edge, and the other phase transition is 100ns before the RX\_CLK clock rising edge.

Figure 4 details scope captures of RXD0 aligned and not aligned (100ns before) with respect to the RX\_CLK clock rising edge. RX\_DV and RXD[3:1] have similar timings.

None. This anomaly is unlikely to cause timing problem with MACs. MAC chips have setup/hold times that are typically <10ns. There is plenty of timing margin to allow for the device's 100ns clock phase shift in a 400ns clock period.
