# PIC18F27/47/57Q43 Silicon Errata and Data Sheet Clarifications

The PIC18F27/47/57Q43 devices you have received conform functionally to the current device data sheet (DS40002147G), except for the anomalies described in this document.

The silicon issues discussed in the following pages are for silicon revisions with the Device and Revision IDs listed in the table below.

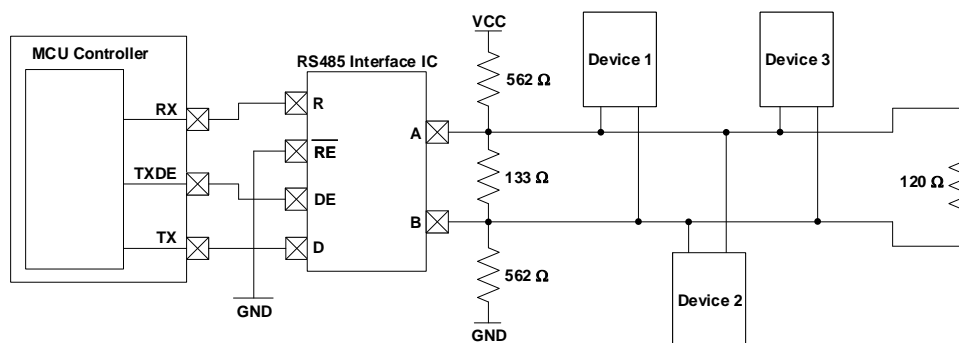
**1.7.1 UART TXDE Signal May Go Low before the STOP Bit Has Been Entirely Transmitted**

The UART Transmit Drive Enable (TXDE) signal could potentially transition into a low state before the UART STOP bit has been entirely transmitted due to the effects of parasitic capacitance on the TX line. In some applications, this could result in communication being prematurely terminated due to the TXDE bit going low before the STOP bit has had enough time to settle.

To ensure that the STOP bit settles into its final logic state before the TXDE signal transitions low, a biasing circuit can be implemented. A biasing circuit allows the TX line to either be driven high or low, rather than being left in a floating tri-state mode where prolonged rise or fall times could lead to communication being disrupted. This bias circuit should only be implemented on one end of the serial bus, and a termination resistor should be used on the other end. The figure below shows an example of a bias circuit that can be used to achieve this.

Please note that the resistor values used in this circuit are recommendations and that the actual resistor values required may vary based on the application.
