PIC18F27/47/57Q84 Silicon Errata and Data Sheet Clarifications

The PIC18F27/47/57Q84 devices that you have received conform functionally to the current device data sheet (DS40002213F), except for the anomalies described in this document.

The silicon issues discussed in the following pages are for silicon revisions with the Device and Revision IDs listed in the table below.

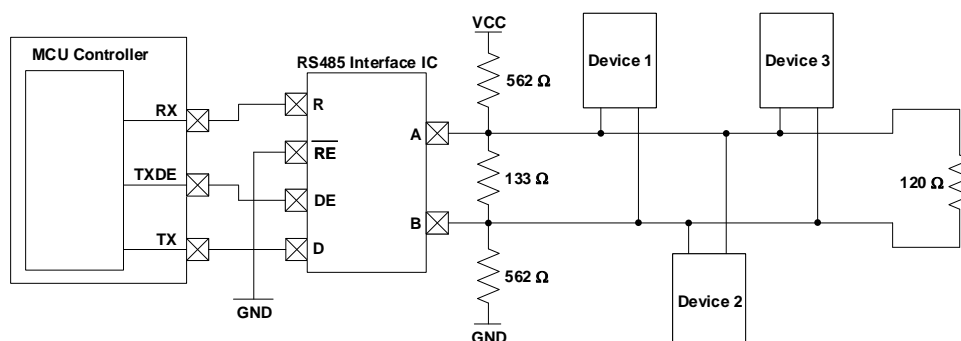
1.6.1 UART TXDE Signal May Go Low before the STOP Bit Has Been Entirely Transmitted

The UART Transmit Drive Enable (TXDE) signal could potentially transition into a low state before the UART STOP bit has been entirely transmitted due to the effects of parasitic capacitance on the TX line. In some applications, this could result in communication being prematurely terminated due to the TXDE bit going low before the STOP bit has had enough time to settle.

To ensure that the STOP bit settles into its final logic state before the TXDE signal transitions low, a biasing circuit can be implemented. A biasing circuit allows the TX line to either be driven high or low, rather than being left in a floating tri-state mode where prolonged rise or fall times could lead to communication being disrupted. This bias circuit should only be implemented on one end of the serial bus, and a termination resistor should be used on the other end. The figure below shows an example of a bias circuit that can be used to achieve this.

Please note that the resistor values used in this circuit are recommendations and that the actual resistor values required may vary based on the application.
