# dsPIC33FJ06GS101/X02 and dsPIC33FJ16GSX02/X04

## dsPIC33FJ06GS101/X02 and dsPIC33FJ16GSX02/X04 Family Silicon Errata and Data Sheet Clarification

The dsPIC33FJ06GS101/X02 and dsPIC33FJ16GSX02/X04 family devices that you have received conform functionally to the current Device Data Sheet (DS70000318G), except for the anomalies described in this document.

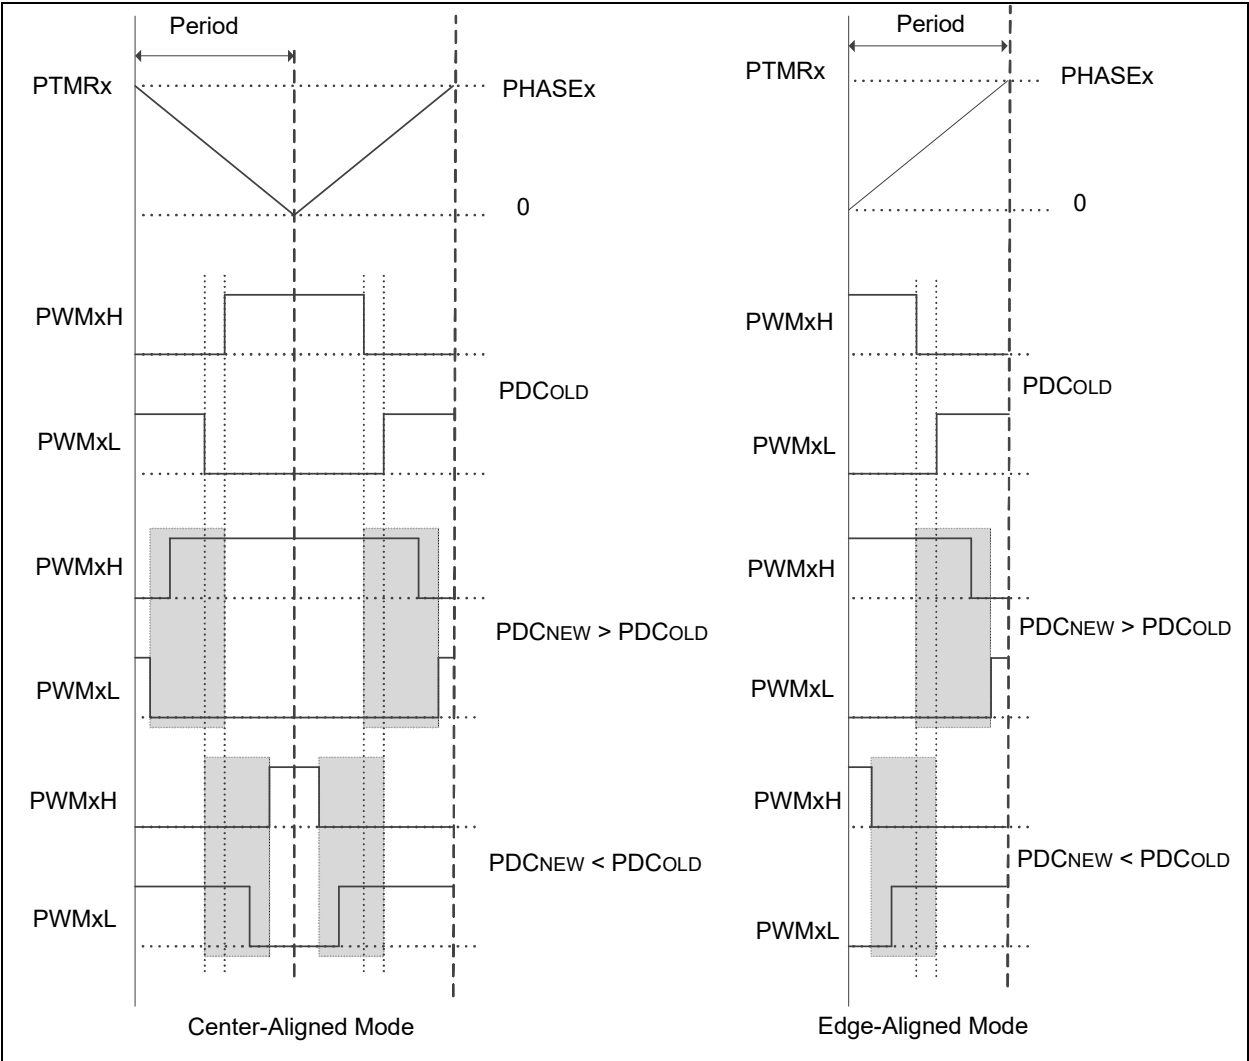
FIGURE 1: TIMING DIAGRAMS FOR CENTER-ALIGNED AND EDGE-ALIGNED MODES

The PWMx generator may not assert dead time on the edges of transitions. This has been observed when all of the following conditions are present:

None. However, in most applications, the duty cycle update timing can be controlled using the TRIGx trigger or Special Event Trigger, such that the above mentioned conditions are avoided altogether.

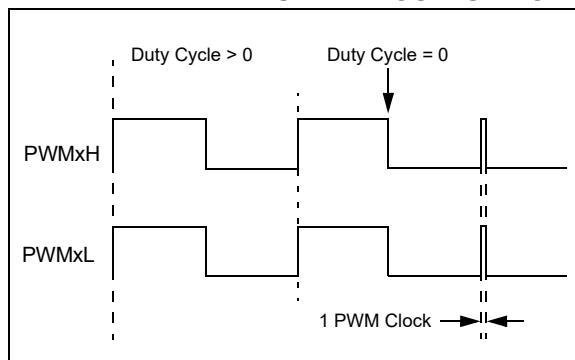
**FIGURE 2: ISSUE EXAMPLE FOR REDUNDANT OUTPUT MODE**

In Redundant Output mode (IOCONx[11:10] = 01) and Push-Pull Output mode (IOCONx[11:10] = 10), with the Immediate Update disabled (PWMCONx[0] = 0), when the Duty Cycle register is updated from a non-zero value to zero, a glitch pulse of a width equal to one PWM clock will appear at the next PWM period boundary, as shown in Figure 2 (for the Redundant Output mode). The Duty Cycle register refers to the PDCx register if PWMCONx[8] = 0 or the MDCx register if PWMCONx[8] = 1.

If the application requires a zero duty cycle output, there are two possible work around methods:

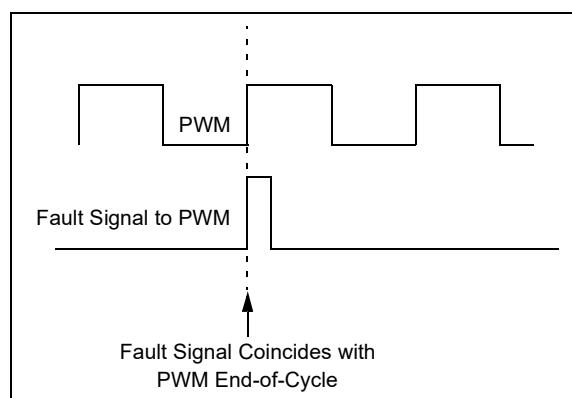
When the PWM module is operated in Complementary, Redundant, Push-Pull or True Independent Output modes and the PWM Fault/Current-Limit Fault are configured to provide a Fault event to the PWM, under certain conditions where the Fault event active edge happens to coincide with the PWM End-of-Cycle (EOC) event, the PWM fails to recognize the Fault event.

Configure the PWM module to include Leading-Edge Blanking bits, LEB[6:0] (LEBCONx [9:3]), with a count always greater than eight, with the appropriate PWMxH/PWMxL Leading-Edge Blanking triggers.
