PIC32MX1XX/2XX/5XX 64/100-pin Family

Silicon Errata and Data Sheet Clarification

The PIC32MX1XX/2XX/5XX 64/100-pin family of devices that you have received conform functionally to the current Device Data Sheet (DS60001290F), except for the anomalies described in this document.

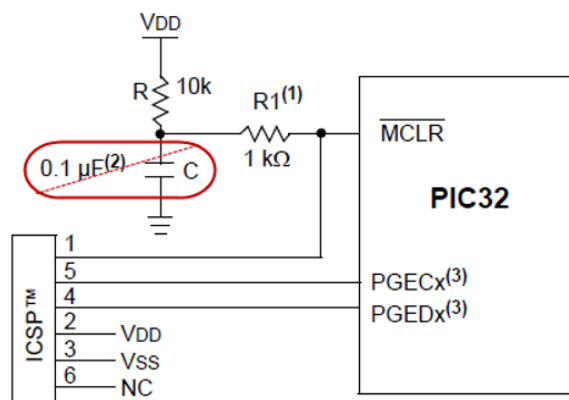
Work around 1:

17. Module: I/O Port - Initial Pin State

On power-up depending on the VDD ramp rate, the I/O pins can be in an active random output driving state if MCLR is active until a BOR event.

If, not using an external reset supervisor IC or equivalent, remove the MCLR capacitor as shown below, and retain the MCLR Pull-up resistor.

Work around 2:

If using an external reset supervisor IC or equivalent, increase the value of the VCAP capacitor to $\geq 47 \mu\text{F}$ ceramic or solid tantalum capacitor with an ESR $\leq 1 \text{ ohm}$.
