PIC18F25/45/55Q43 Silicon Errata and Data Sheet Clarifications

The PIC18F25/45/55Q43 devices you have received conform functionally to the current device data sheet (DS40002170F), except for the anomalies described in this document.

The silicon issues discussed in the following pages are for silicon revisions with the Device and Revision IDs listed in the table below.

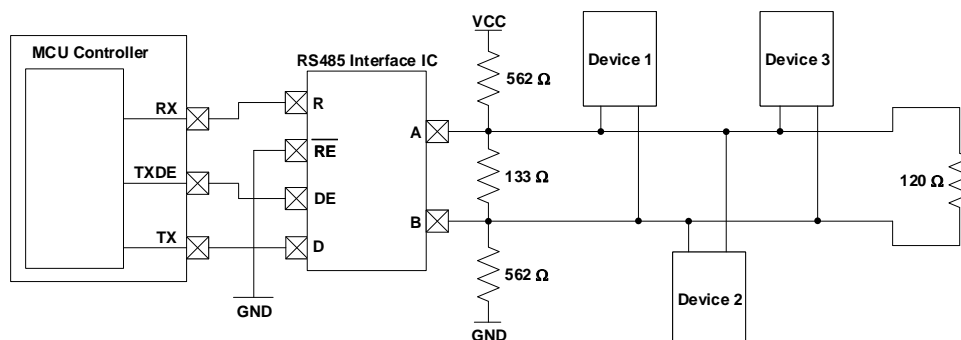
1.7.1 UART TXDE Signal May Go Low before the STOP Bit Has Been Entirely Transmitted

The UART Transmit Drive Enable (TXDE) signal could potentially transition into a low state before the UART STOP bit has been entirely transmitted due to the effects of parasitic capacitance on the TX line. In some applications, this could result in communication being prematurely terminated due to the TXDE bit going low before the STOP bit has had enough time to settle.

To ensure that the STOP bit settles into its final logic state before the TXDE signal transitions low, a biasing circuit can be implemented. A biasing circuit allows the TX line to either be driven high or low, rather than being left in a floating tri-state mode where prolonged rise or fall times could lead to communication being disrupted. This bias circuit should only be implemented on one end of the serial bus, and a termination resistor should be used on the other end. The figure below shows an example of a bias circuit that can be used to achieve this.

Please note that the resistor values used in this circuit are recommendations and that the actual resistor values required may vary based on the application.
