## dsPIC33CH128MP508 Family Silicon Errata and Data Sheet Clarification

The dsPIC33CH128MP508 family devices that you have received conform functionally to the current device data sheet (DS70005319E), except for the anomalies described in this document.

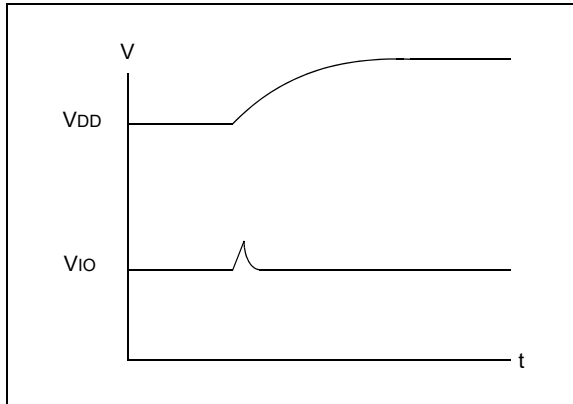
**FIGURE 1: I/O RAMP**

During a fast device power-up, when the VDD ramp is less than 4 mS, the I/O pins may drive up to 100  $\mu$ A current for a duration of up to 10  $\mu$ S (Figure 1).

Example applications affected may include complementary power switches, where a transient current shoot-through might occur.

1. Slow down the VDD ramp time (greater than 4 mS for VDD to ramp 0V to 3.3V).
2. Ensure the circuitry that is connected to the pins can endure this pulse.

High-voltage applications with complementary switches should power the high-voltage 200  $\mu$ Sec later than powering the dsPIC<sup>®</sup> device to avoid the current shoot-through. This behavior is specific to each device and not affected by aging.
