PIC18F26/46/56Q84 Silicon Errata and Data Sheet Clarifications

The PIC18F26/46/56Q84 devices that you have received conform functionally to the current device data sheet (DS40002259D), except for the anomalies described in this document.

The silicon issues discussed in the following pages are for silicon revisions with the Device and Revision IDs listed in the table below.

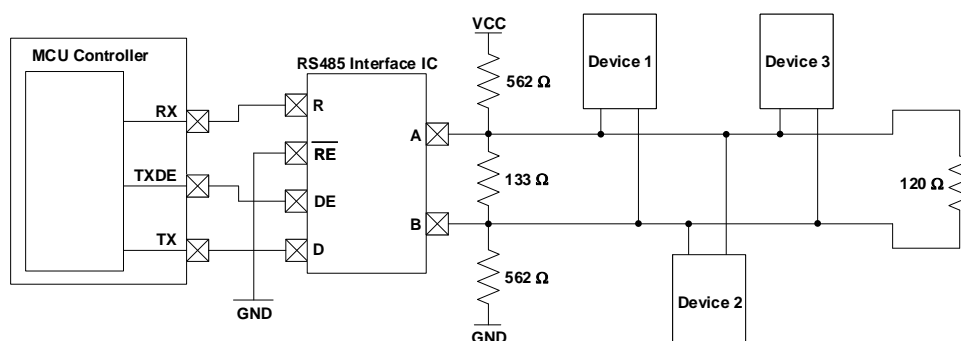
1.6.1 UART TXDE Signal May Go Low before the STOP Bit Has Been Entirely Transmitted

The UART Transmit Drive Enable (TXDE) signal could potentially transition into a low state before the UART STOP bit has been entirely transmitted due to the effects of parasitic capacitance on the TX line. In some applications, this could result in communication being prematurely terminated due to the TXDE bit going low before the STOP bit has had enough time to settle.

To ensure that the STOP bit settles into its final logic state before the TXDE signal transitions low, a biasing circuit can be implemented. A biasing circuit allows the TX line to either be driven high or low, rather than being left in a floating tri-state mode where prolonged rise or fall times could lead to communication being disrupted. This bias circuit should only be implemented on one end of the serial bus, and a termination resistor should be used on the other end. The figure below shows an example of a bias circuit that can be used to achieve this.

Please note that the resistor values used in this circuit are recommendations and that the actual resistor values required may vary based on the application.
