# PIC16(L)F1938/1939 Silicon Errata and Data Sheet Clarifications

## PIC16(L)F1938/1939

The PIC16(L)F1938/1939 devices that you have received conform functionally to the current device data sheet (DS40001574D), except for the anomalies described in this document.

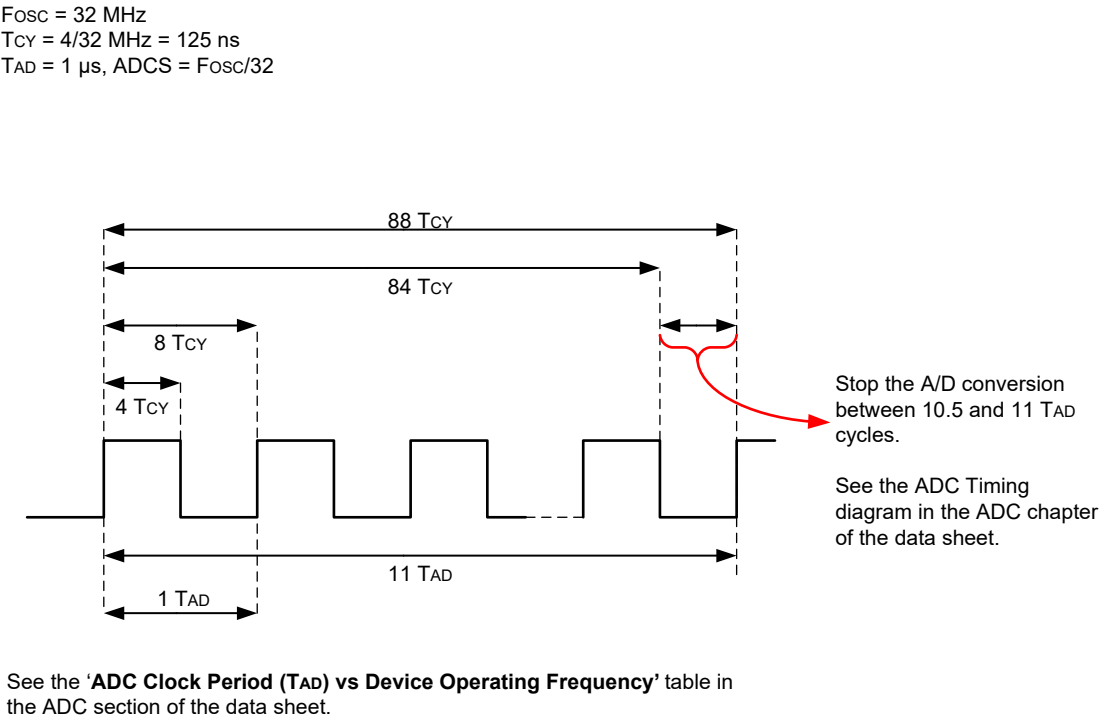
Figure 1-1. Instruction Cycle Delay Calculation Example

An ADC conversion may not complete under these conditions:

1. When  $F_{OSC}$  is greater than 8 MHz and it is the clock source used for the ADC converter.
2. The ADC is operating from its dedicated ADCRC oscillator and the device is not in Sleep mode (at any  $F_{OSC}$  frequency). When this occurs, the ADC Interrupt Flag (ADIF) does not get set, the GO/DONE bit does not get cleared, and the conversion result does not get loaded into the ADRESH and ADRESL result registers.

In [Figure 1-1](#), 88 instruction cycles will be required to complete the full conversion. Each  $T_{AD}$  cycle consists of 8  $T_{CY}$  periods. A fixed delay is provided to stop the A/D conversion after 86 instruction cycles and terminate the conversion at the correct time.

**Note:** The exact delay time will depend on the  $T_{AD}$  divisor (ADCS) selection. The  $T_{CY}$  counts shown in [Figure 1-1](#) apply to this example only. Refer to [Table 1-1](#) for examples of the required delay counts for other configurations.

This method is provided if the application cannot use Sleep mode and requires continuous operation at frequencies above 8 MHz. This method requires early termination of an ADC conversion. Provide a fixed time delay in software to stop the ADC conversion manually, after all 10 bits are converted, but before the conversion would complete automatically. The conversion is stopped by clearing the GO/DONE bit in software, and must be cleared during the last  $\frac{1}{2} T_{AD}$  cycle, before the conversion would have completed automatically.
