## USB332x Family Silicon Errata and Data Sheet Clarification

This document describes known anomalies for all functional revisions of the USB332x device.

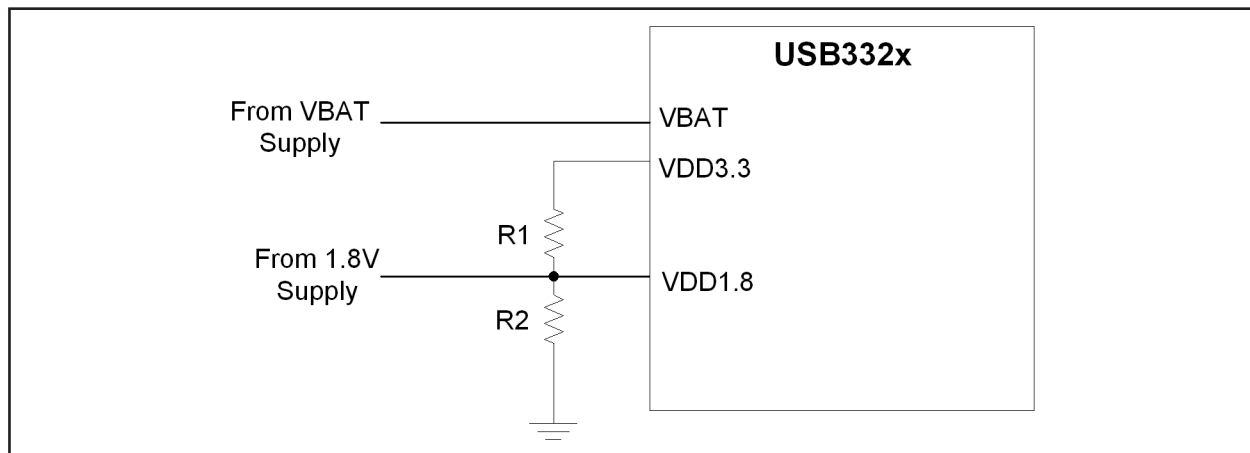
**FIGURE 1: RESISTOR DIVIDER CIRCUIT**

The VBAT (VDD3.3) pin may draw up to 1.3mA of current from the VBAT source when all of the following conditions apply:

In this mode the VBAT (VDD3.3) pin should draw  $\leq 25 \mu\text{A}$ .

Removing supply voltage from both VBAT and VDD1.8 produces a leakage current of 0  $\mu$ A. If the customer elects to leave VBAT on while VDD1.8V is off, the USB332x may exhibit increased current draw (>25  $\mu$ A) from the VBAT (VDD3.3) supply when in Suspend Mode. USB functionality is not affected

- Leave the VDD1.8 supply ON whenever voltage is applied to VBAT. Standby current will be  $\leq 25 \mu$ A.
- Supply voltage on VBAT from a PMIC and switch it off whenever VDD1.8 is switched off. Standby current will be 0  $\mu$ A.
- Add a LDO regulator with enable between VBAT and the battery which can be switched off whenever VDD1.8 is switched off. Standby current will be 0  $\mu$ A.
- Add a resistor divider between VDD3.3 and VDD1.8 supplies, as shown in [Figure 1](#):

R1 = 210 k $\Omega$  1%

R2 = 309 k $\Omega$  1%

**Note:** If there are other devices attached to the 1.8V on the customer platform, those device impedances need to be taken into account.

Standby current will be  $\leq 30 \mu$ A.
