## dsPIC33EPXXXGS70X/80X Family Silicon Errata and Data Sheet Clarification

The dsPIC33EPXXXGS70X/80X family devices that you have received conform functionally to the current Device Data Sheet (DS70005258C), except for the anomalies described in this document.

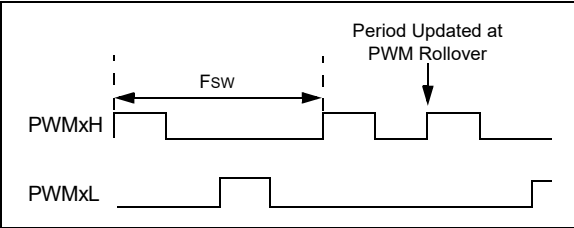
FIGURE 1:

When the PWM module is configured for Push-Pull mode (IOCONx[11:10] = 0b10) with the Enable Immediate Period Update bit enabled (PTCON [10] = 1), a write to the Period register that coincides with the period rollover event may cause the push-pull output logic to produce back-to-back pulses on the PWMx pins (see Figure 1).

Ensure that the update to the PWM Period register occurs away from the PWM rollover event by setting the EIPU bit (PTCON[10] = 1). Use either the PWM Special Event Trigger (SEVTCMP) or the PWM Primary Trigger (TRIGx) to generate a PWM Interrupt Service Routine (ISR) near the start of the PWM cycle. This ISR will ensure that period writes do not occur near the PWM period rollover event.

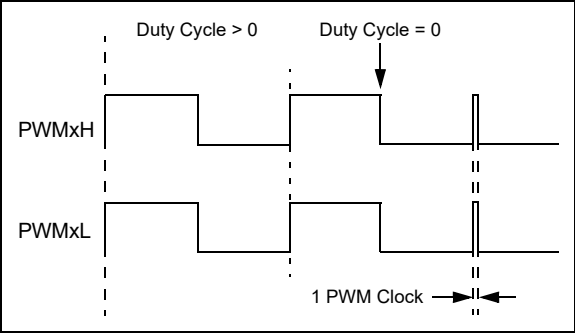
FIGURE 2: EXAMPLE FOR REDUNDANT OUTPUT MODE

In the Redundant Output mode (IOCONx[11:10] = 0b01) and Push-Pull Output mode (IOCONx[11:10] = 0b10), with the Immediate Update Enable bit disabled (PWMCONx[0] = 0), when the Duty Cycle register is updated from a non-zero value to zero, a glitch pulse of a width equal to 1 PWM clock will appear at the next PWM period boundary, as shown in Figure 2 (for the Redundant Output mode). The Duty Cycle register refers to the PDCx register if PWMCONx[8] = 0 or the MDC register if PWMCONx[8] = 1.

If the application requires a zero duty cycle output, there are two possible work around methods:

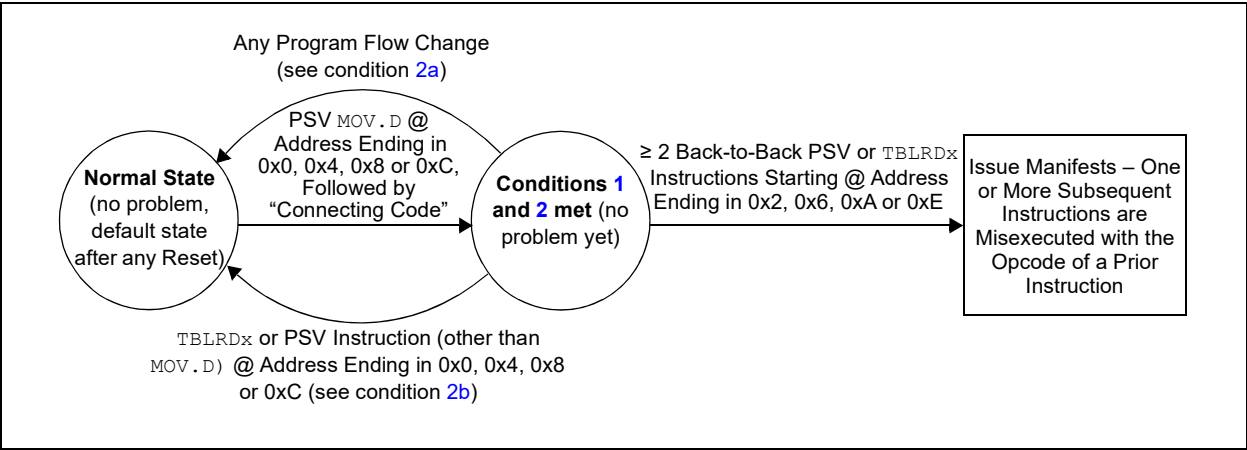
FIGURE 3: SIMPLIFIED BEHAVIOR

When two or more data Flash read instructions (via Program Space Visibility (PSV) read or Table Read) are executed back-to-back, one or more subsequent instructions can be misexecuted when all of the conditions in Table 4 occur.

| 3. | ≥ 2 back-to-back PSV or TBLRDx instructions are executed (following the code of condition 2), where the first of the back-to-back instructions is located at an address ending in 0x2, 0x6, 0xA or 0xE. |

Figure 3 provides an example of the effective behavior.

The issue can be avoided by ensuring any one or more of the requirements are not met. For example:

1. All instances of PSV MOV.D can be replaced with two PSV MOV instructions instead. Non-PSV MOV.D instructions acting on RAM/SFRs do not need to be modified; or
2. If not already present, a program flow change instruction (such as BRA \$+2) can be inserted above back-to-back data Flash read sequences; or
3. Back-to-back data Flash read instruction sequences can be broken up by inserting a non-Flash read instruction (such as a NOP), in between the Flash read instructions; or
4. The alignment of the code can be shifted to avoid the required opcode location addresses.

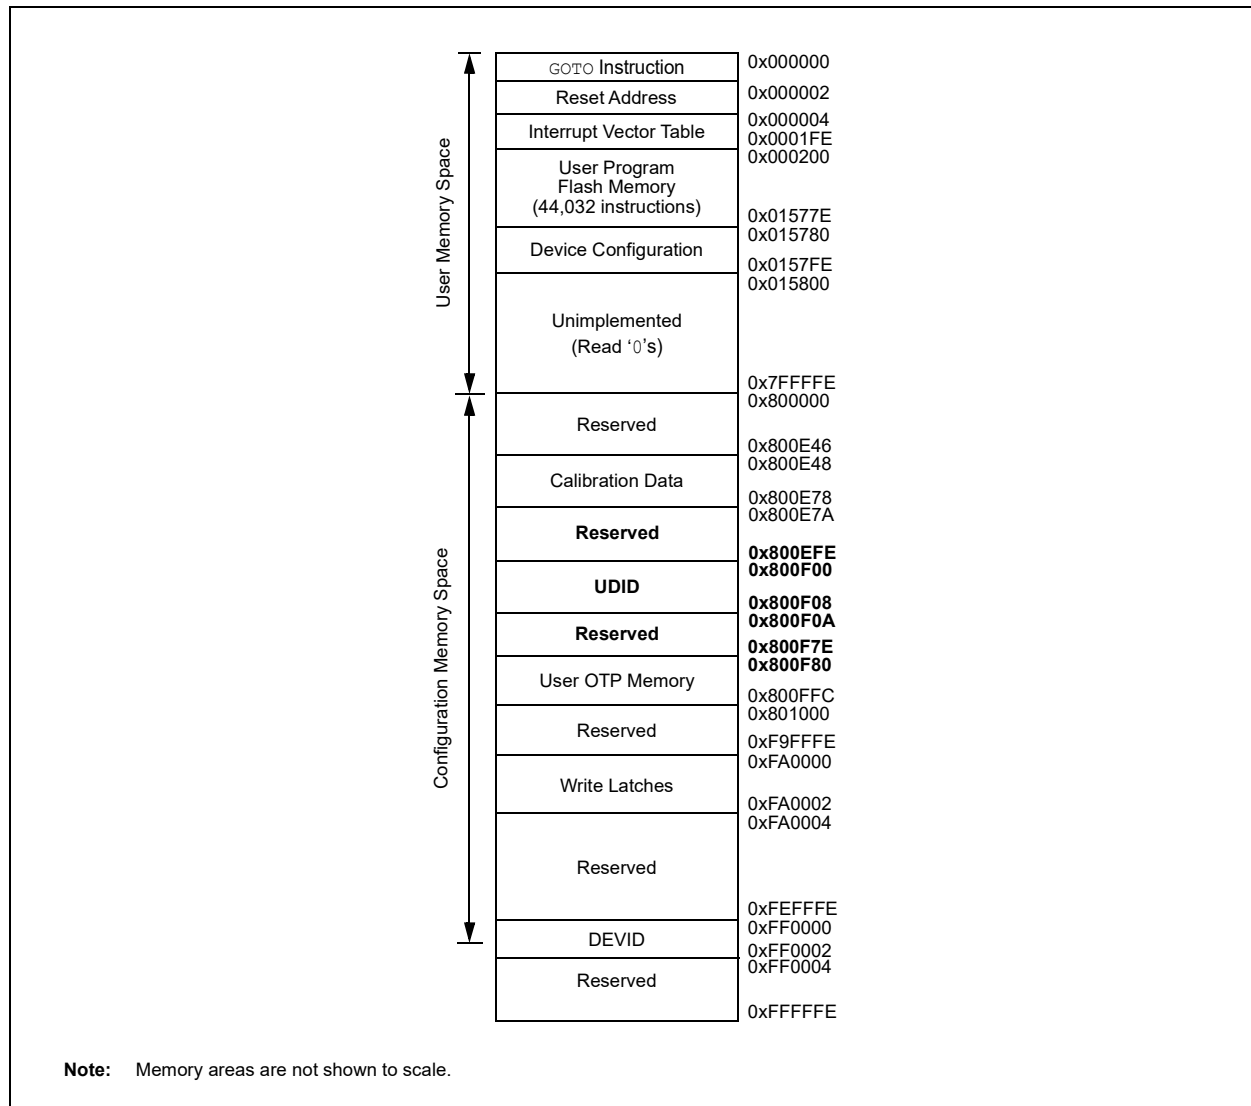
**FIGURE 4-2: PROGRAM MEMORY MAP FOR dsPIC33EP128GS70X/80X DEVICES**

In [Figure 4-2](#), the following changes have been made as shown in **bold**:
