### **LAN7800**

## LAN7800 Silicon Errata and Data Sheet Clarification

This document describes known silicon errata for functional revisions B0 and B1 of the LAN7800. The silicon revision can be determined by the device's top marking as indicated in Figure 1. A summary of LAN7800 silicon errata is provided in Table 1.

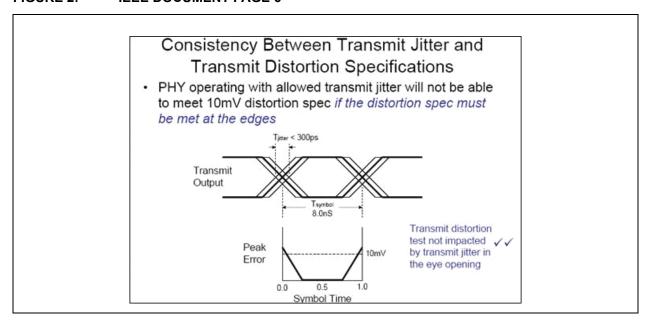
### FIGURE 2: IEEE DOCUMENT PAGE 6

The device's 1000BASE-T Transmitter Distortion is in the 15-30mV range, versus the <10mV indicated in the IEEE specification.

IEEE testing calls for <10mV peak transmitter distortion for at least 60% of the UI within the eye opening. However, this measurement might not be valid, as the transmit distortion test is sensitive to transmit jitter. Refer to the explanation below, taken from the aforementioned IEEE document.

• On page 6, a contradiction between Transmit Jitter and Transmit Distortion requirements:

It is recommended to change the requirement to use at least 30%, instead of at least 60%, of the UI within the eye opening for the <10mV peak transmitter distortion.
