## dsPIC33EPXXGS202 Family Silicon Errata and Data Sheet Clarification

The dsPIC33EPXXGS202 family devices that you have received conform functionally to the current Device Data Sheet (DS70005208E), except for the anomalies described in this document.

**Note:** This document summarizes all silicon errata issues from all revisions of silicon, previous as well as current. Only the issues indicated in the last column of [Table 2](#) apply to the current silicon revision (B0).

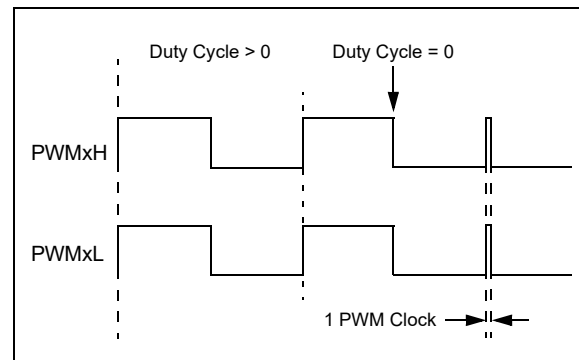
**FIGURE 1: EXAMPLE FOR REDUNDANT OUTPUT MODE**

In the Redundant Output mode (`IOCONx[11:10] = 0b01`) and Push-Pull Output mode (`IOCONx[11:10] = 0b10`), with the Immediate Update Enable bit disabled (`PWMCONx[0] = 0`), when the Duty Cycle register is updated from a non-zero value to zero, a glitch pulse of a width equal to one PWM clock will appear at the next PWM period boundary, as shown in Figure 1 (for the Redundant Output mode). The Duty Cycle register refers to the `PDCx` register if `PWMCONx[8] = 0` or the `MDC` register if `PWMCONx[8] = 1`.

If the application requires a zero duty cycle output, there are two possible work around methods:

1. Use the PWM override feature to override the PWM output to a low state instead of writing to the Duty Cycle register. In order to switch back to a non-zero duty cycle output, turn off the PWM override. The override-on and override-off events must be timed close to the PWM period boundary if the `IOCONx` register has been configured with `IOCONx[0] = 0` (i.e., output overrides through the `OVDDAT[1:0]` bits occur on the next CPU clock boundary).
2. Enable the Immediate Update Enable bit (`PWMCONx[0] = 1`) while configuring the PWMx module (i.e., before enabling the PWMx module, `PTCON[15] = 1`). With the Immediate Update enabled, writes to the Duty Cycle register can have an immediate effect on the PWM output. Therefore, the duty cycle write operations must be timed close to the PWM period boundary in order to avoid distortions in the PWM output.

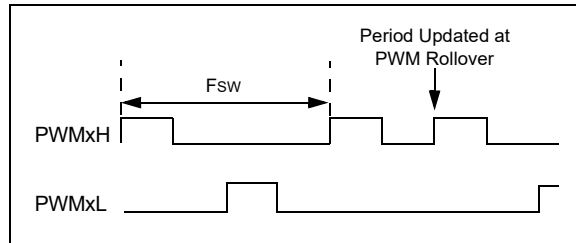
FIGURE 2:

When the PWM module is configured for Push-Pull mode (IOCONx[11:10] = 0b10) with the Enable Immediate Period Update bit enabled (PTCON[10] = 1), a write to the Period register that coincides with the period rollover event may cause the push-pull output logic to produce back-to-back pulses on the PWMx pins (Figure 2).

If the EIPU bit is set (PTCON[10] = 1), ensure that the update to the PWM Period register occurs away from the PWM rollover event. Use either the PWM Special Event Trigger (SEVTCMP) or the PWM Primary Trigger (TRIGx) to generate a PWM Interrupt Service Routine (ISR) near the start of the PWM cycle. The PWM Period register could be updated inside this ISR so that the period writes do not occur near the PWM period rollover event.

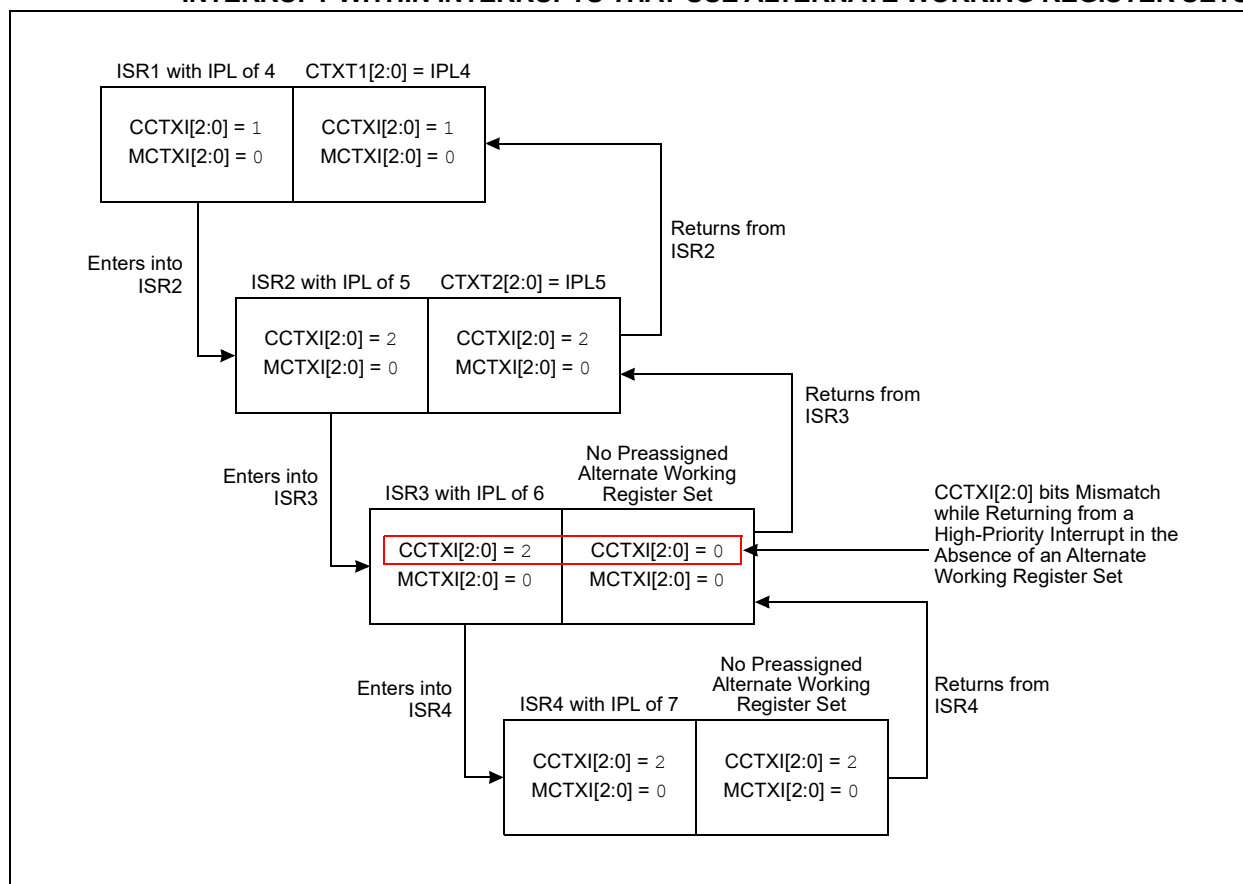
**FIGURE 3: MISMATCH OF WORKING REGISTER SET WHEN NESTING MORE THAN ONE INTERRUPT WITHIN INTERRUPTS THAT USE ALTERNATE WORKING REGISTER SETS**

Issue and work around are illustrated in [Figure 3](#) and [Figure 4](#), respectively. The figures show the status bits, `CCTXI[2:0]` and `MCTXI[2:0]`, after entering into an ISR from a lower priority ISR (left pane), and after returning to the same ISR from a higher priority ISR (right pane).

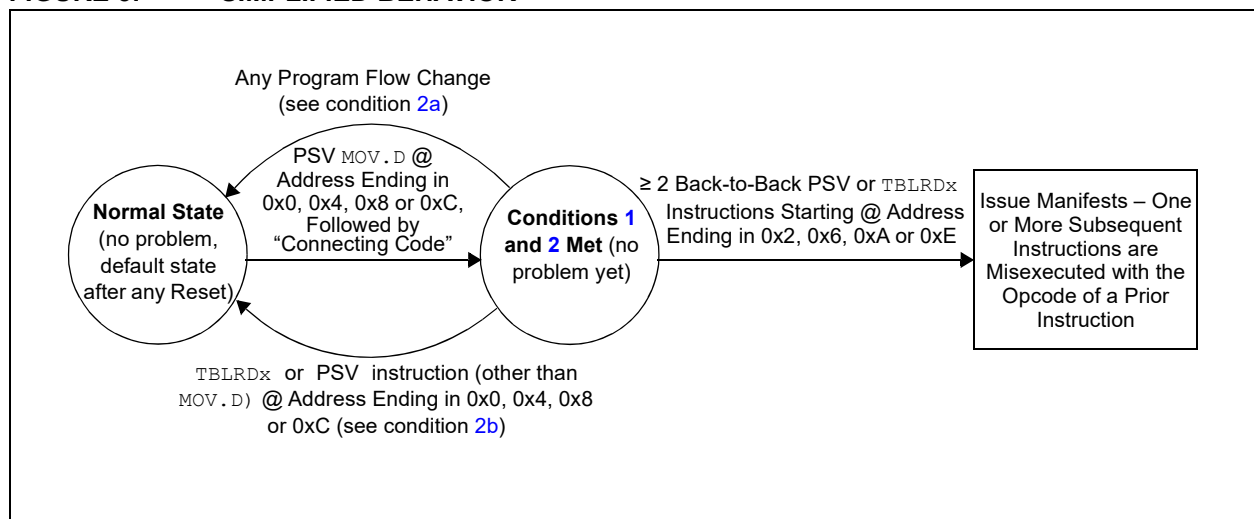
**FIGURE 5: SIMPLIFIED BEHAVIOR**

When two or more data Flash read instructions (via Program Space Visibility (PSV) read or table read) are executed back-to-back, one or more subsequent instructions can be misexecuted when all of the conditions in [Table 4](#) occur.

[Figure 5](#) provides an example of the effective behavior.

1. All instances of PSV MOV.D can be replaced with two PSV MOV instructions instead. Non-PSV MOV.D instructions acting on RAM/SFRs do not need to be modified; or
2. If not already present, a program flow change instruction (such as BRA \$+2) can be inserted above back-to-back data Flash read sequences; or
3. Back-to-back data Flash read instruction sequences can be broken up by inserting a non-Flash read instruction (such as a NOP), in between the Flash read instructions; or
4. The alignment of the code can be shifted to avoid the required opcode location addresses.

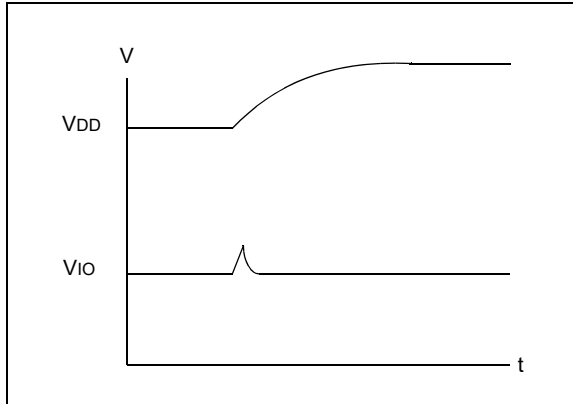
**FIGURE 6: I/O RAMP**

During device power-up, the I/O pins may drive up to 100  $\mu$ A current for a duration of up to 300  $\mu$ S. (Figure 6).

Ensure the circuitry that is connected to the pins can endure this pulse.
