## PIC32MK General Purpose and Motor Control (GP/MC) Silicon Errata and Data Sheet Clarification

The PIC32MK General Purpose and Motor Control (GP/MC) family of devices that you have received conform functionally to the current Device Data Sheet (DS60001402G), except for the anomalies described in this document.

**Note:** This document summarizes all silicon errata issues from all revisions of silicon, previous and current. Only the issues indicated in the last column of [Table 2](#) apply to the current silicon revision (**A2**).

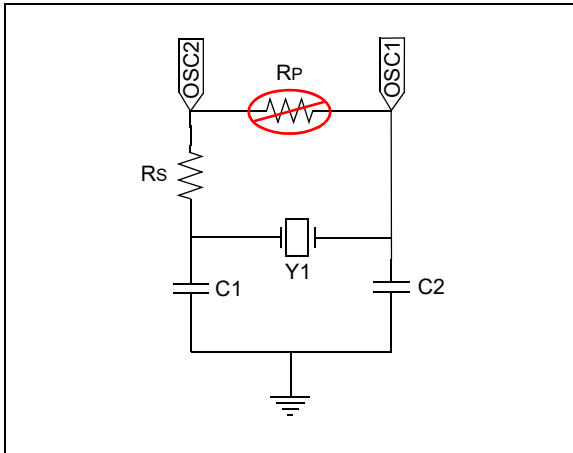
**FIGURE 1: POSC CRYSTAL CIRCUIT**

The POSC supports only specific crystal operation, as provided in [Table 1](#).

The Primary Oscillator (POSC) has been characterized to operate at 8 MHz and 12 MHz when the circuit shown in [Figure 1](#) is implemented and the operating conditions provided in [Table 1](#) are met.

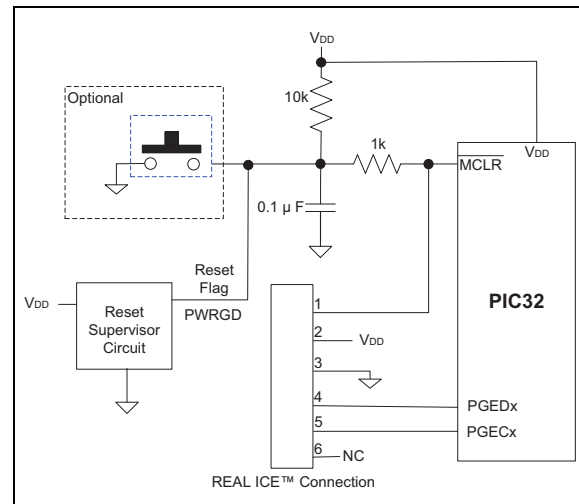
**FIGURE 2: RESET SUPERVISOR CIRCUIT**

On a BOR event,  $V_{POR} < V_{DD} < V_{BOR}$ , a Reset is not generated when the BOR threshold is reached. System clocks will stop with all I/O pins functions frozen in their present state until either  $V_{DD}$  falls to  $V_{POR}$  or  $V_{DD}$  returns to above  $V_{BOR}$ . The user must assess if this  $V_{DD}$  brown-out condition and the resulting frozen I/O pin state has an adverse effect on their application (UART, PWM, I/O, OC, etc.).

If the application can sustain frozen I/O states for ~2.1 ms (UART, CAN, I/O, etc.), the application must enable the Deep Sleep Watchdog Timer and Clock Fail Monitor, based on the details provided in Table 3 and Table 4. If implemented correctly, after ~2.1 ms, a valid internal reset state is entered and the I/O pins are set to the device default Reset state.
