AVR128DA Silicon Errata and Data Sheet Clarification

AVR128DA28/32/48/64(S)

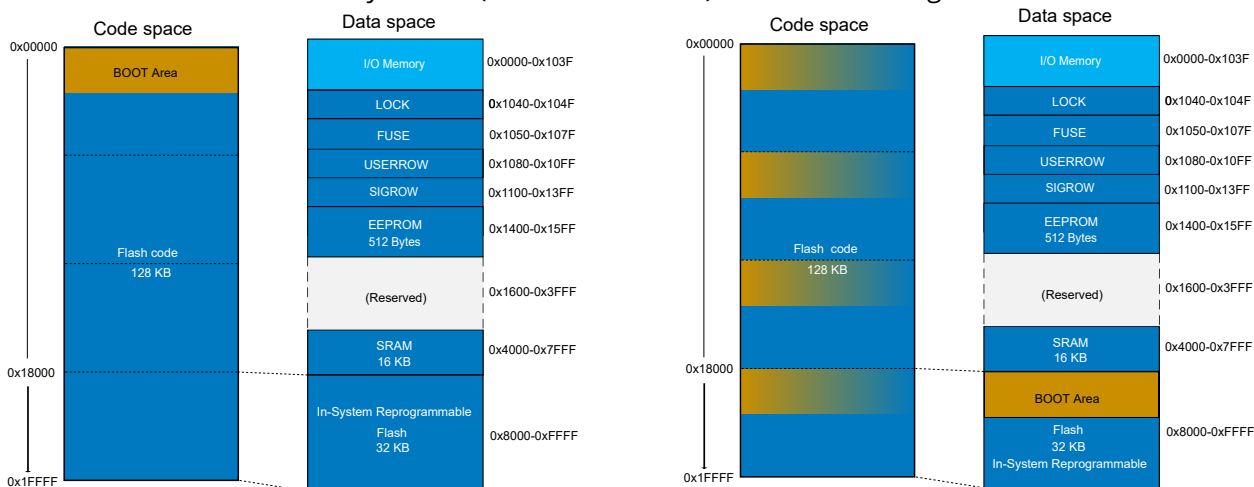
2.7.1 Flash Mapping Into Data Space not Working Properly

The inter-section Flash protection mechanism does not take into account the FLMAP bit field when checking if the address is in BOOT, APPCODE or APPDATA areas. It uses for comparison only the address offset between Flash start address in data space (0x8000) and the accessed address. This will cause the mirroring of the BOOT area in each Flash section selected by FLMAP (in blocks of 32 KB). Refer to the image below.

For read operations, the FLMAP bits work as documented when the Boot Read Protect (BOOTRP) bit is not enabled. For write operations, the inter-section Flash protection works properly only when FLMAP is set to '0x00'.

Use only store program memory (SPM) instructions to write and load program memory (LPM) instructions to read Flash memory.
