## KSZ9896C Silicon Errata and Data Sheet Clarification

This document describes known silicon errata for functional revisions A1 of the KSZ9896C. The silicon errata discussed in this document are for silicon revisions as listed in [Table 1](#). The silicon revision can be determined by the device's top marking. A summary of KSZ9896C silicon errata is provided in [Table 2](#).

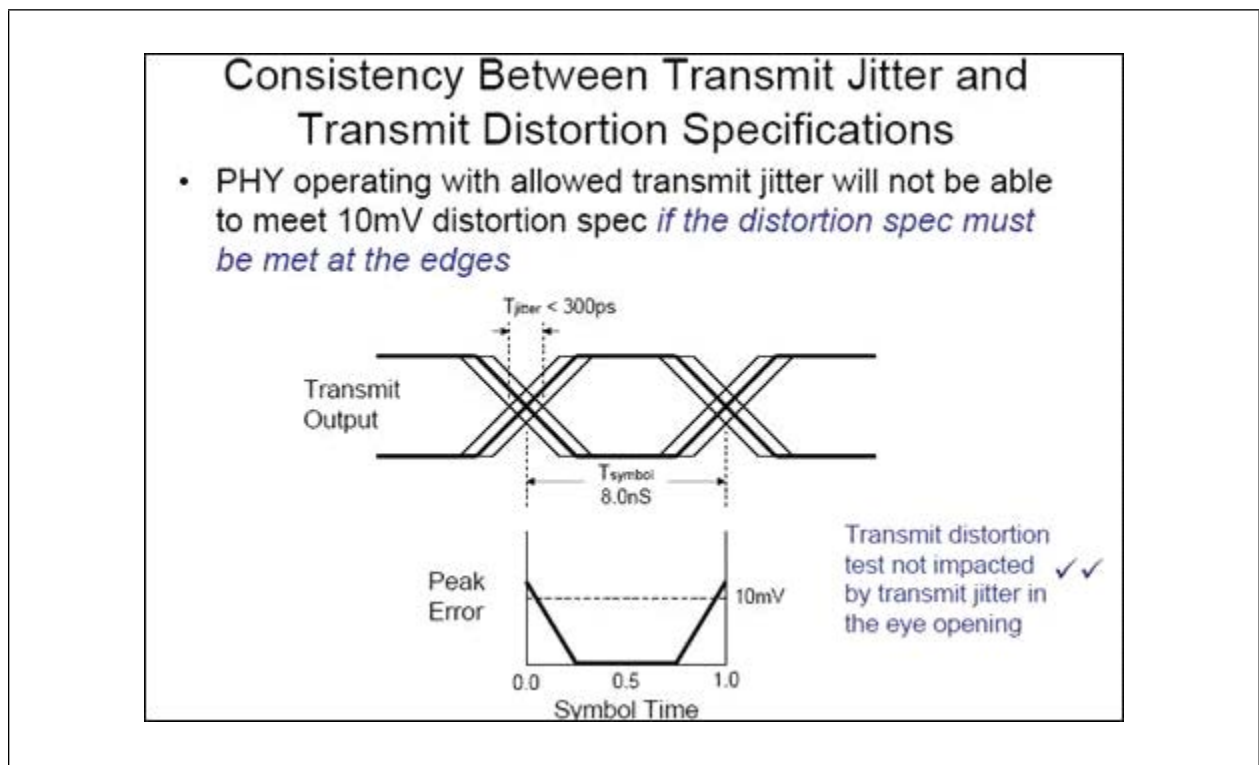
**FIGURE 1: IEEE DOCUMENT PAGE 6**

The device's 1000BASE-T Transmitter Distortion is approximately 40mV, versus the <10mV indicated in the IEEE specification.

IEEE testing calls for <10mV peak transmitter distortion for at least 60% of the UI within the eye opening. However, this measurement might not be valid, as the transmit distortion test is sensitive to transmit jitter. Refer to the explanation below, taken from the aforementioned IEEE document.

- On page 6, a contradiction between Transmit Jitter and Transmit Distortion requirements:
