## USB2517/17i Family Silicon Errata

The USB2517/17i family devices that you have received conform functionally to the current Device Data Sheet (Revision 2.8), except for the anomalies described in this document.

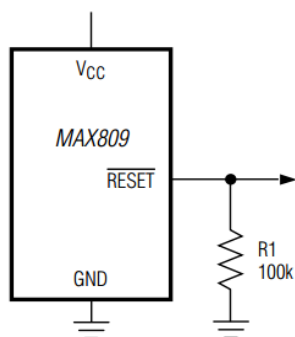
The internal POR does not generate reset when power drops below the threshold. For a supply that has non-monotonous ramp reset may be lost.

Device might not enumerate.

Use external power on reset circuit (for example, reset circuit with MAX809S(V2.9V) voltage supervisor).
