PIC18F04/05/14/15Q41 Silicon Errata and Data Sheet Clarifications

PIC18F04/05/14/15Q41

The PIC18F04/05/14/15Q41 devices that you have received conform functionally to the current device data sheet (DS40002242F), except for the anomalies described in this document.

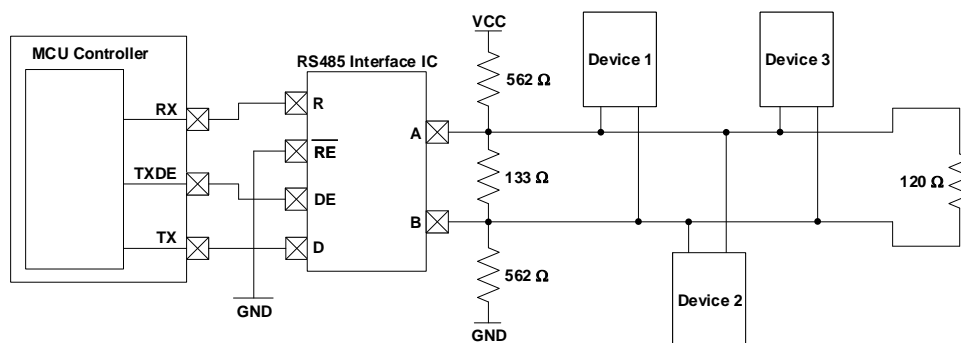
1.6.1 UART TXDE Signal May Go Low Before the STOP Bit Has Been Entirely Transmitted

The UART Transmit Drive Enable (TXDE) signal could potentially transition into a low state before the UART STOP bit has been entirely transmitted due to the effects of parasitic capacitance on the TX line. In some applications, this could result in communication being prematurely terminated due to the TXDE signal going low before the STOP bit has had enough time to settle.

To ensure that the STOP bit settles into its final logic state before the TXDE signal transitions low, a biasing circuit can be implemented. A biasing circuit allows the TX line to either be driven high or low, rather than being left in a floating tri-state mode where prolonged rise or fall times could lead to communication being disrupted. This bias circuit should only be implemented on one end of the serial bus, and a termination resistor should be used on the other end. The figure below shows an example of a bias circuit that can be used to achieve this.

Please note that the resistor values used in this circuit are recommendations and that the actual resistor values required may vary based on the application.
