ENT-AN1243
Application Note
VSC8254, VSC8257, and VSC8258 1588 Timestamp Out-of-Sync (OOS) Summary

August 2017

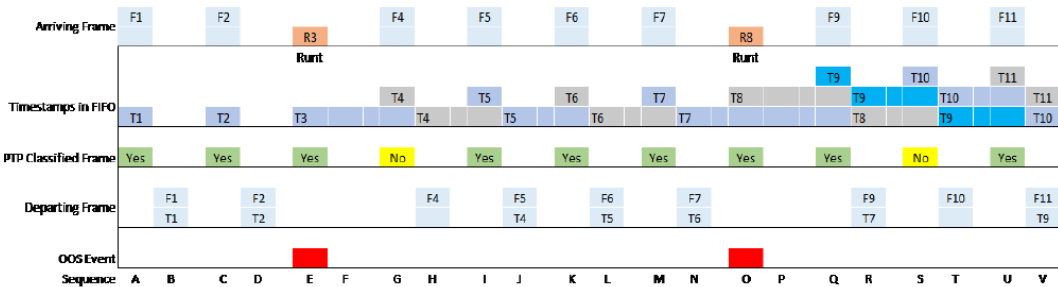
Figure 2 • Timestamp Sequence

It is possible that link events such as fiber breaks, fiber pulls, link flaps, or certain traffic interruptions may meet the defined criteria and cause the TSP_FIFO go out-of-sync. Frames following an OOS condition will be timestamped with the time from past frames. This continues for every classified frame thereafter, until the OOS condition is cleared.

The following illustration shows the sequence of events relating to timestamps. It demonstrates two OOS conditions as a result of short or runt frames meeting the inducing criteria and the events following it.

A, B: Rx PTP frame F1, T1 into FIFO, T1 out of FIFO and into outgoing F1 (Normal)
 C, D: Rx PTP frame F2, T2 into FIFO, T2 out of FIFO and into outgoing F2 (Normal)
 E, F: Rx runt frame R3, T3 into FIFO, nothing outgoing so T3 remains in FIFO
 G, H: Rx std. frame F4, T4 into FIFO, T3 out of FIFO but NOT placed in outgoing F4
 I, J: Rx PTP frame F5, T5 into FIFO, T4 out of FIFO and into outgoing F5 (Wrong)
 K, L: Rx PTP frame F6, T6 into FIFO, T5 out of FIFO and into outgoing F6 (Wrong)
 M, N: Rx PTP frame F7, T7 into FIFO, T6 out of FIFO and into outgoing F7 (Wrong)
 O, P: Rx runt frame R3, T8 into FIFO, nothing outgoing so T7 and T8 remain in FIFO
 Q, R: Rx PTP frame F9, T9 into FIFO, T7 out of FIFO and into outgoing F9 (Wrong)
 S, T: Rx std. frame F10, T10 into FIFO, T8 out of FIFO but NOT placed in outgoing F10
 U, V: Rx PTP frame F11, T11 into FIFO, T9 out of FIFO and into outgoing F11 (Wrong)
