## KSZ9563R Silicon Errata and Data Sheet Clarification

This document describes known silicon errata for the Microchip KSZ9563R. The silicon errata discussed in this document are for silicon revisions as listed in [Table 1](#). The silicon revision can be determined by the device's top marking. A summary of KSZ9563R silicon errata is provided in [Table 2](#).

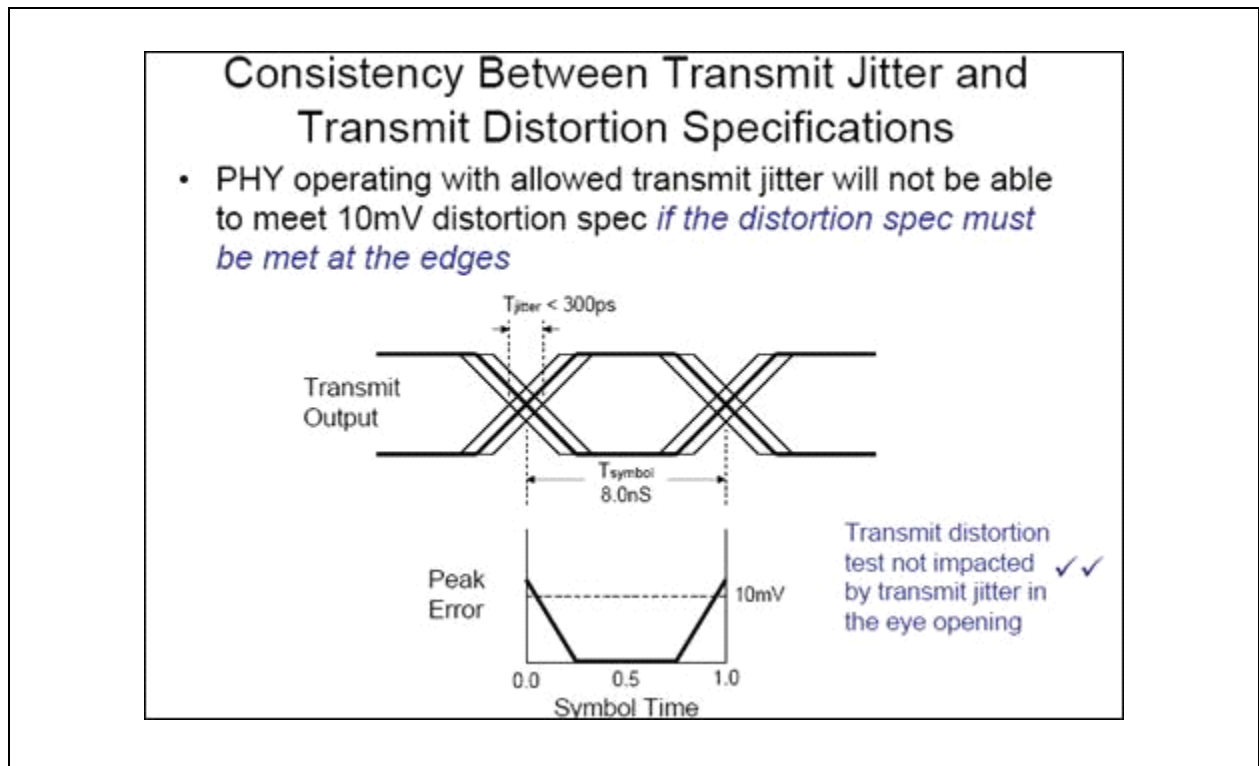
**FIGURE 2: IEEE DOCUMENT PAGE 6**

The device's 1000BASE-T Transmitter Distortion is approximately 40mV, versus the <10mV indicated in the IEEE specification.

IEEE testing calls for <10mV peak transmitter distortion for at least 60% of the UI within the eye opening. However, this measurement might not be valid, as the transmit distortion test is sensitive to transmit jitter. Refer to the explanation below, taken from the aforementioned IEEE document.

- On page 6, a contradiction between Transmit Jitter and Transmit Distortion requirements:
