## PIC16C74B Rev. A Silicon Errata Sheet

The PIC16C74B (Rev. A) parts you have received conform functionally to the Device Data Sheet (DS30605A), except for the anomalies described below.

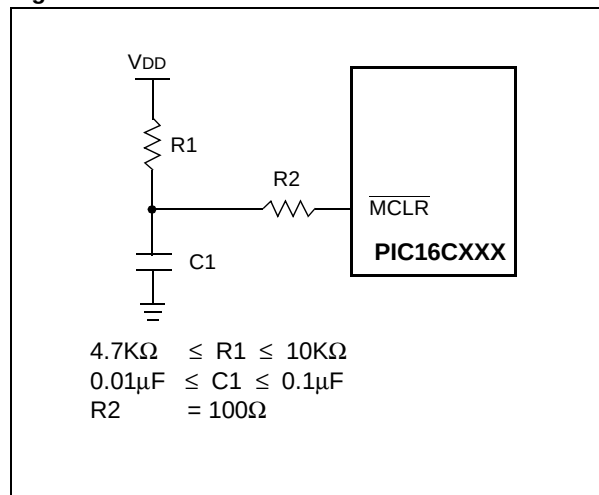
**Figure 1:**  $\overline{\text{MCLR}}$  External Circuit

### 1. Module: RESET

The minimum specification for the  $\overline{\text{MCLR}}$  must be met in order to RESET the PIC16CXXX. If a  $\overline{\text{MCLR}}$  pulse occurs that is less than the minimum specification (parameter #30), improper device operation can occur.

If the minimum specification cannot be met, then an external circuit must be used to insure that any pulse width less than the specification will be filtered before it reaches the  $\overline{\text{MCLR}}$  pin.

A possible circuit is shown in Figure 1. Proper design validation needs to be done to ensure desired operation over the applications operating conditions.

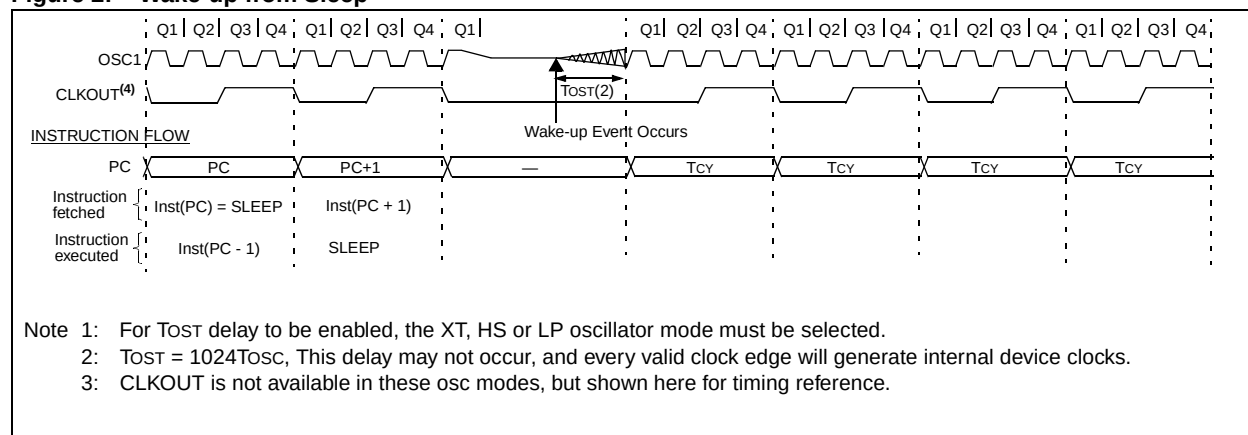
**Figure 2: Wake-up from Sleep**

The Oscillator Start-up Timer ( $T_{OST}$ ) delay may not occur when the device wakes-up from sleep.

Figure 2 shows the start-up of the crystal after the event that causes the device to wake up from sleep mode (as specified in device data sheet). The start-up time ( $T_{OST}$ ) may not occur.

The events that wake-up the device from sleep are:

- An interrupt
- A WDT overflow (wake-up)
- A Brown-out Reset
- A  $\overline{MCLR}$  reset

After the SLEEP instruction, do a software delay of 256  $T_{CY}$  (same as 1024  $T_{OSC}$ ). At the Reset and Interrupt vector addresses, test to see if the device woke from sleep (the  $\overline{TO}$  and  $\overline{PD}$  bits), and if the device did wake from sleep, ensure that the total cycle delay is 256  $T_{CY}$ .

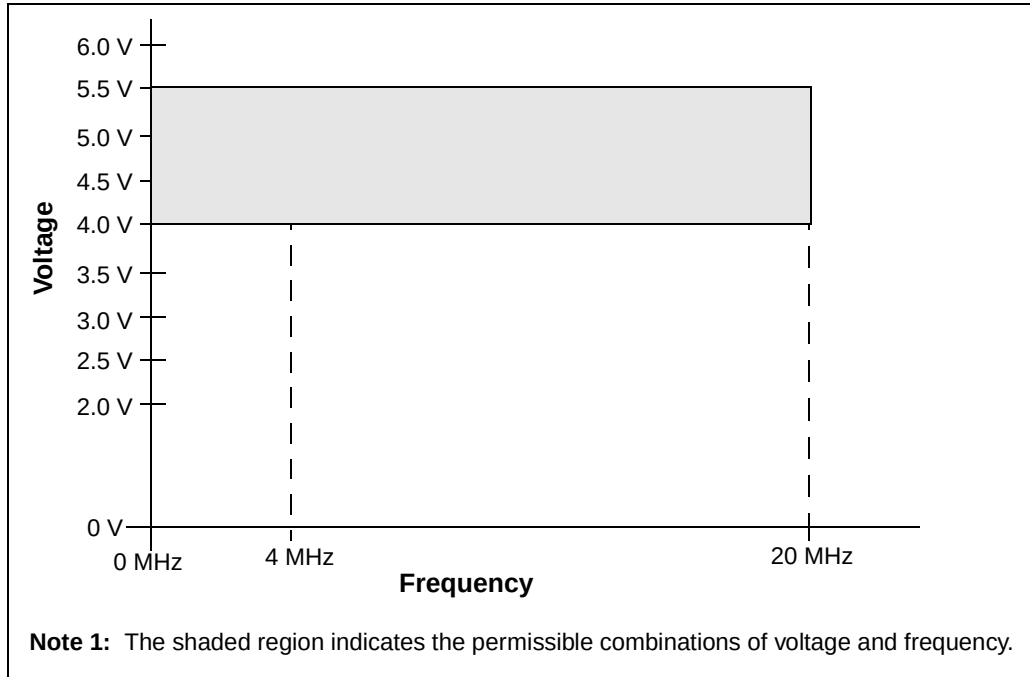
**Figure 3: PIC16CXXX Voltage-Frequency Graph**

1. Figure 3 and Figure 4 are additions to the data sheet to show the area of operation. These figures replace the Cross Reference of Device Specs for Oscillator Modes Table in the Electrical Specification section.

Figure 3 shows the voltage vs. frequency operation for the PIC16CXXX devices. Devices marked with a "-04" operate up to 4 MHz, while devices marked with a "-20" operate up to 20 MHz. The entire shaded region is the valid operating region.

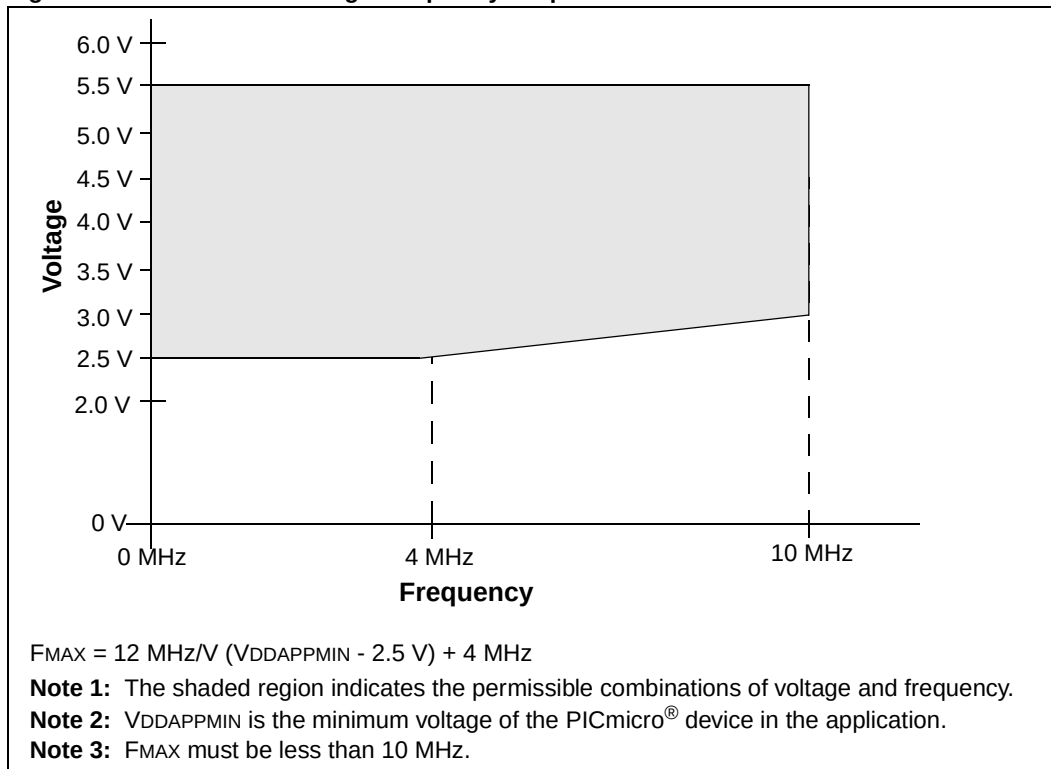
**Figure 4: PIC16LCXXX Voltage-Frequency Graph**

Figure 4 shows the voltage vs. frequency operation for the PIC16LCXXX devices. The devices marked with a "-04" operate up to 4 MHz at the minimum supplied voltage. The devices also operate at a higher frequency (10 MHz) and at a higher voltage (3V). The entire shaded region is the valid operating region.
