## Silicon Errata and Data Sheet Clarification

This document describes known silicon errata for functional revisions A and B of the LAN7500/LAN7500i device. The functional revision can be determined by its top marking as indicated in [Figure 1](#). A summary of the silicon errata issues is provided in [Table 1](#).

# LAN7500/LAN7500i

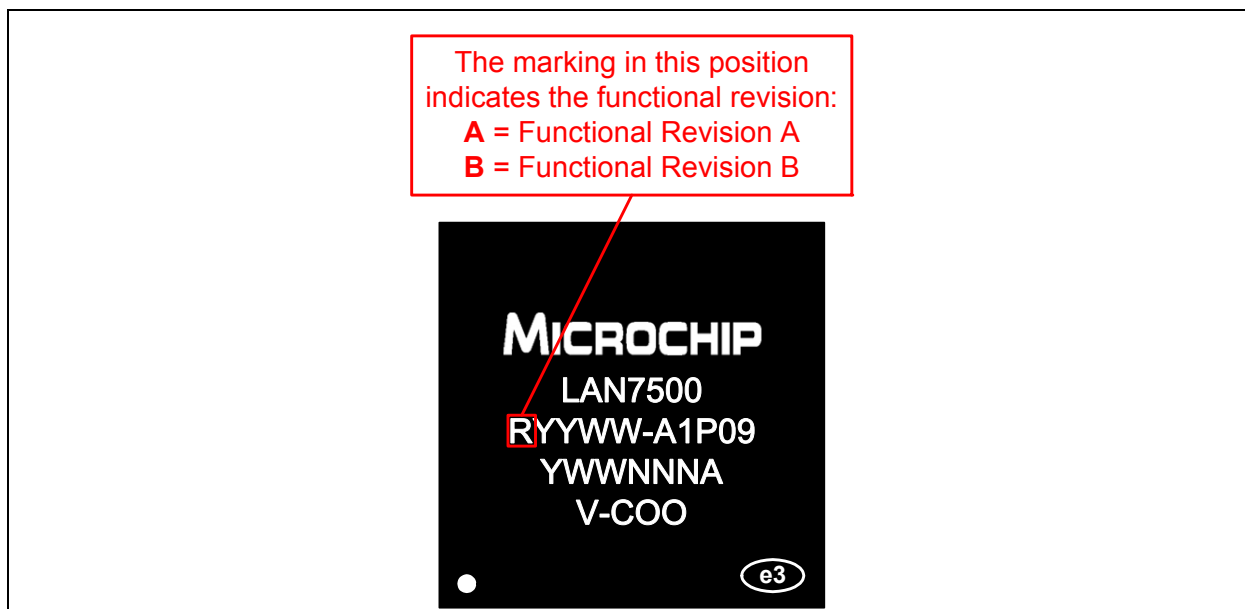
**FIGURE 1: TOP MARKING FUNCTIONAL REVISION INDICATION**

**Note:** [Figure 1](#) details the top markings of an example part. Other than the highlighted revision marking, other top marking values may differ (manufacturer date, lot codes, industrial temperature part, etc.).
