## PIC16(L)F1782/1783 Family Silicon Errata and Data Sheet Clarification

The PIC16(L)F1782/1783 family devices that you have received conform functionally to the current Device Data Sheet (DS400001579E), except for the anomalies described in this document.

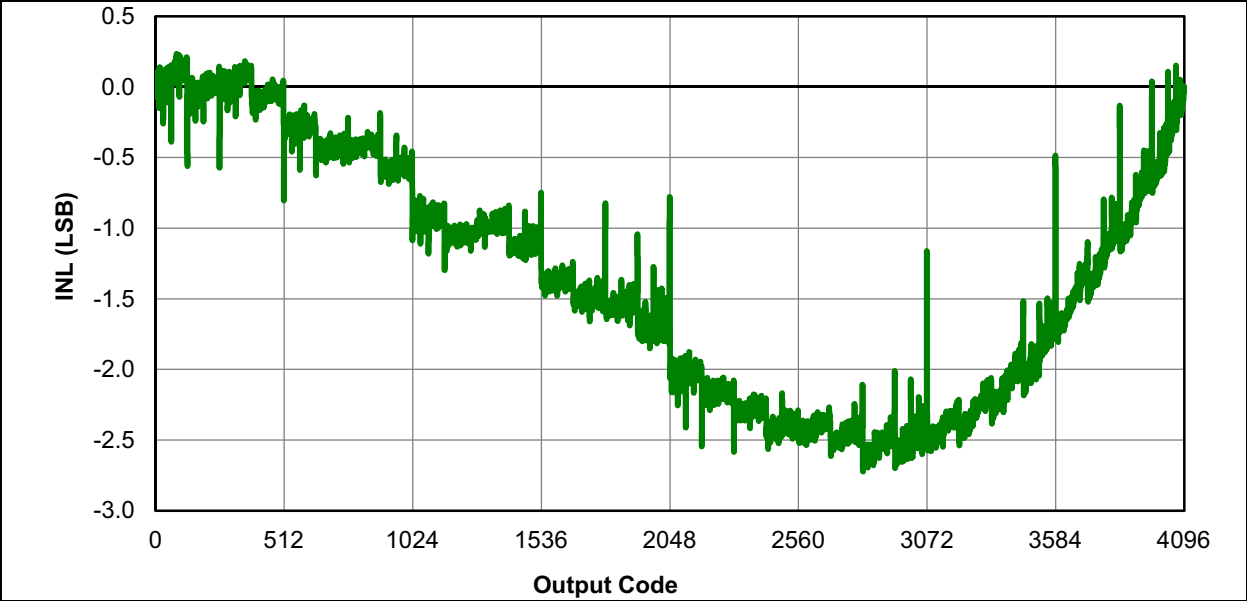
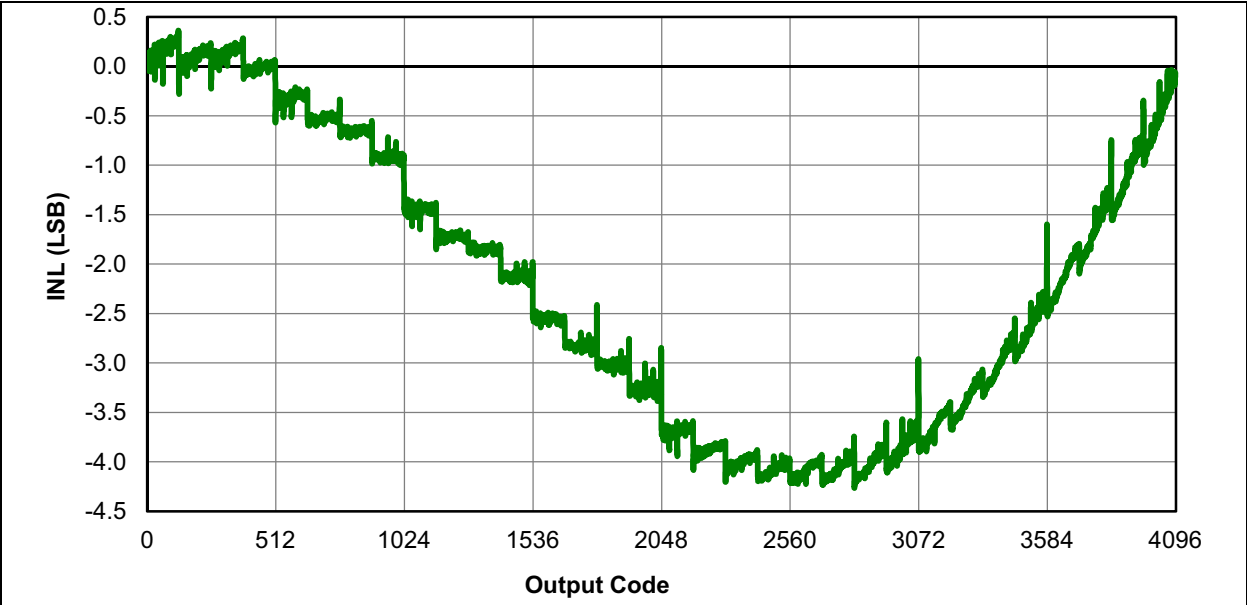
### 1.3 ADC INL (12-bit mode)

The ADC linearity is  $\pm 4$  LSb for the 12-bit mode. Below are typical INL graphs in 12-bit mode (See [Figure 1](#) and [Figure 2](#)).

None.

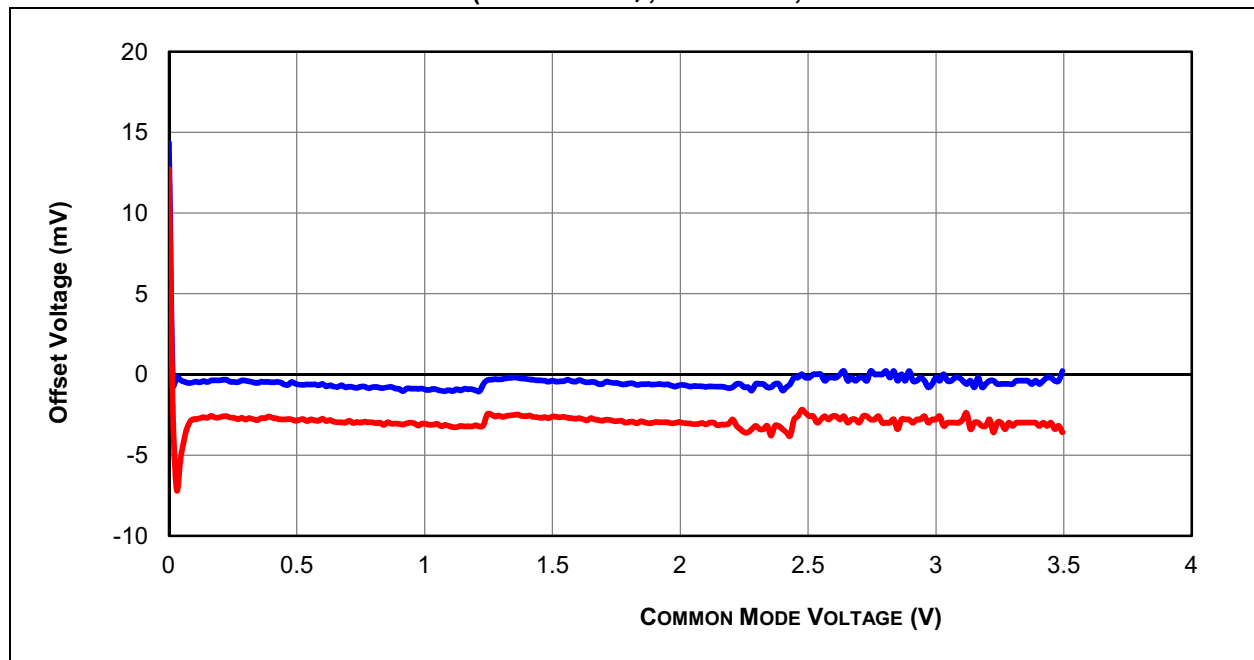
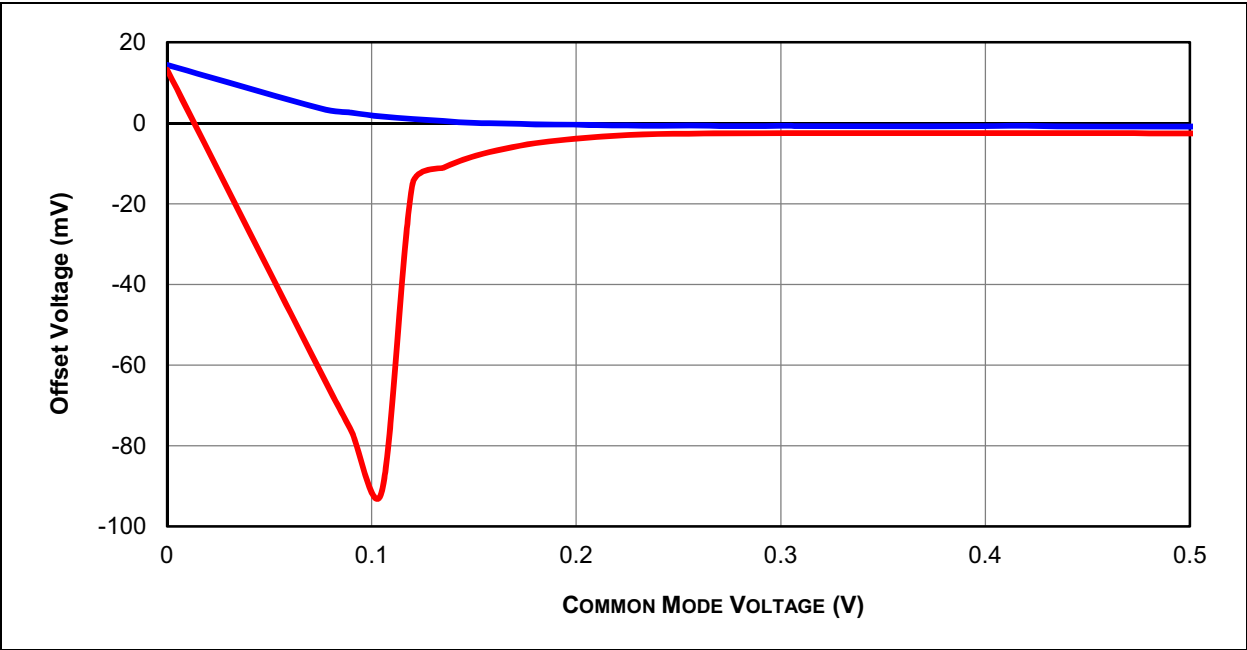
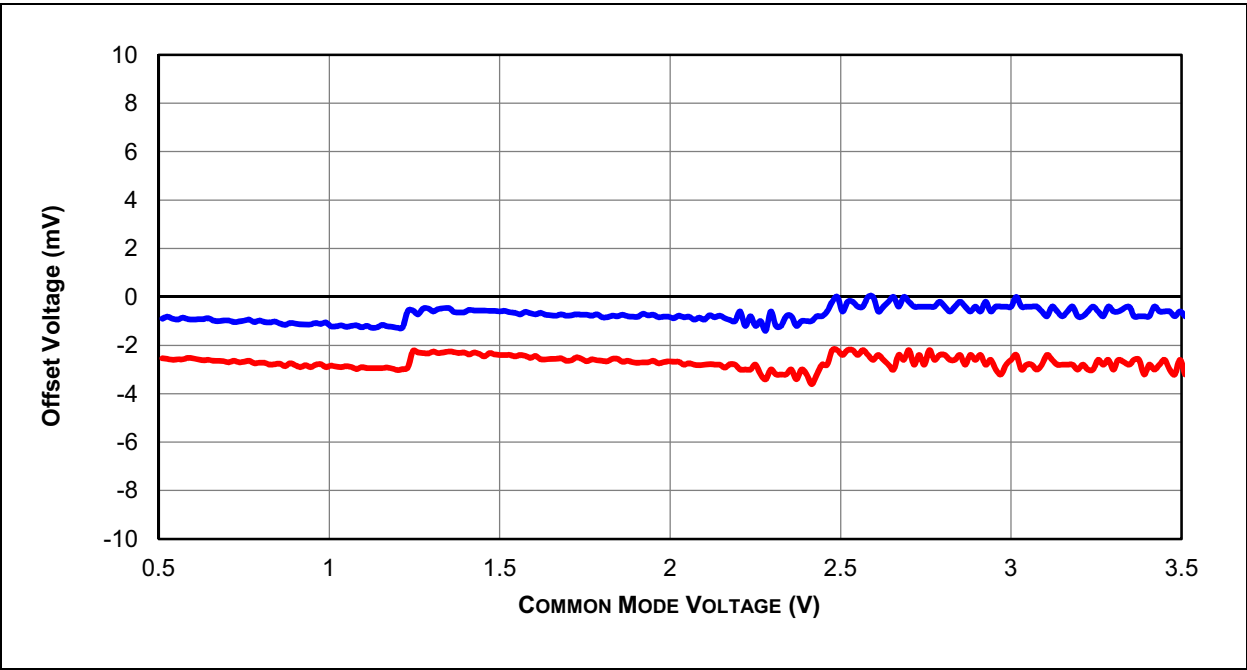
### 2.1 Offset at Low Common Mode

The op amp offset at Common mode input voltages below 200 mV increases with respect to temperature. Below are typical graphs showing the increase in offset (See [Figure 3](#), [Figure 4](#) and [Figure 5](#)).

None.

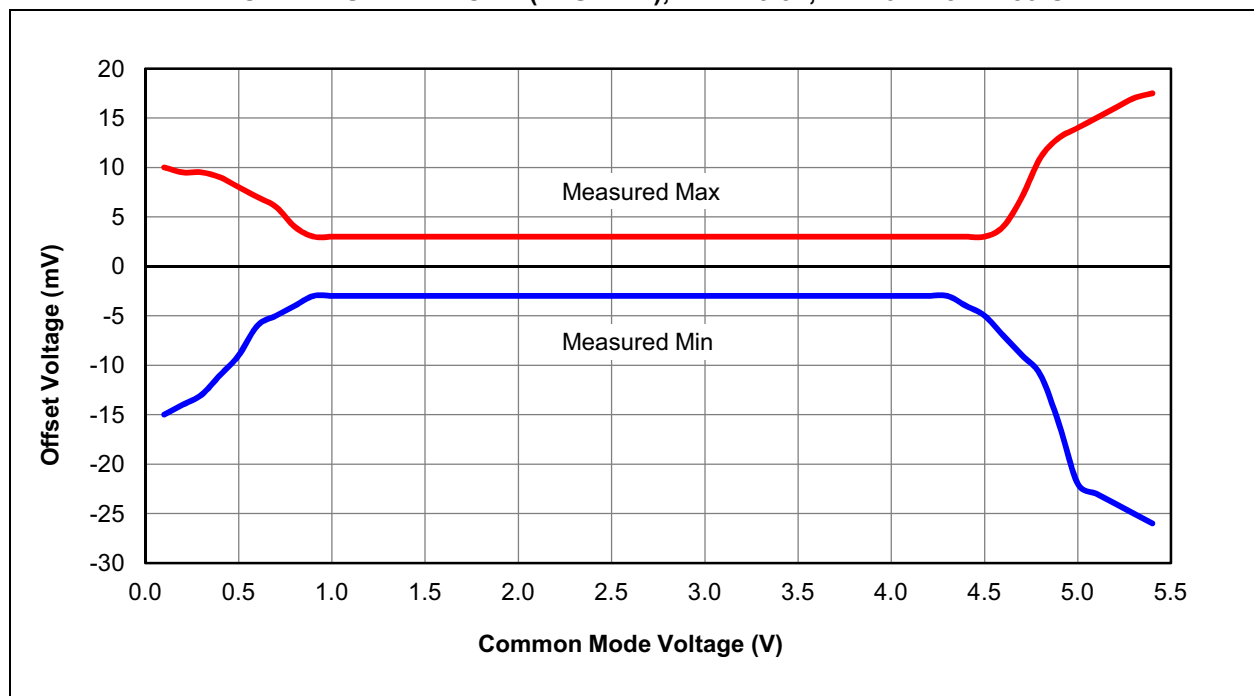
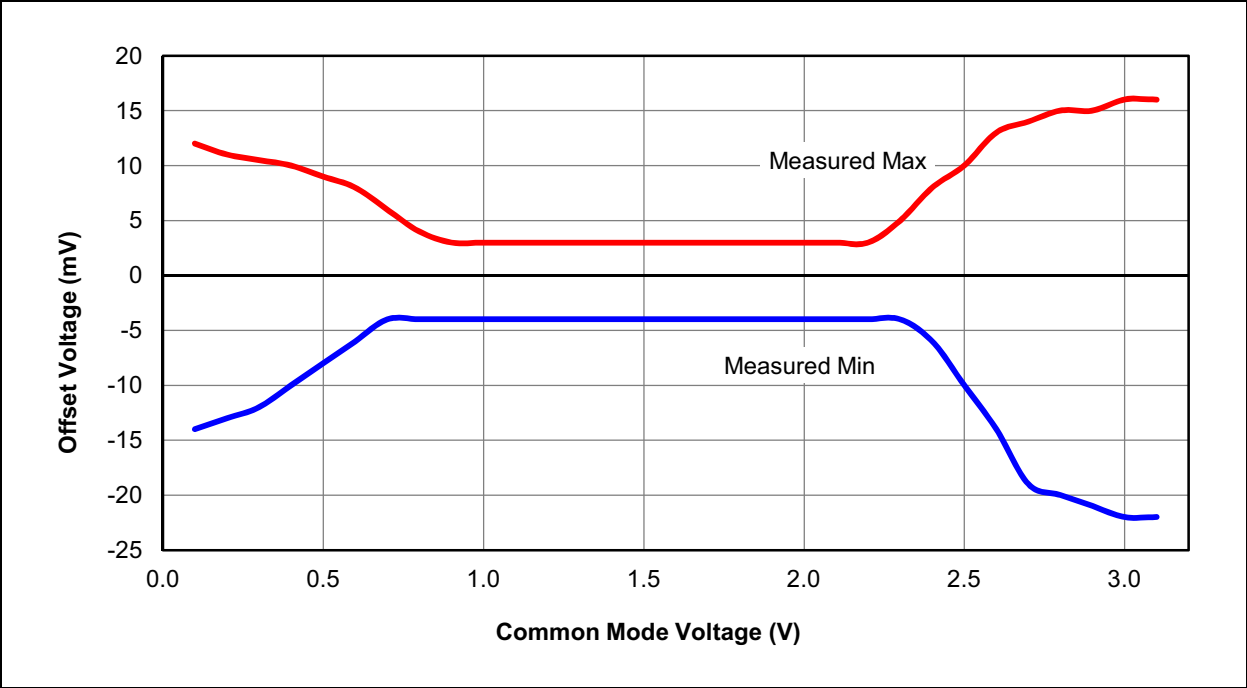
### 3.2 Typical Offset Performance

CMRR performance for the range of  $V_{SS} + 1V$  to  $V_{DD} - 1V$  is better than specified in the data sheet.

See [Figure 6](#) and [Figure 7](#).
