## LAN8740A/LAN8740Ai Silicon Errata and Data Sheet Clarification

This document describes known anomalies for functional revision A and B of the LAN8740A/LAN8740Ai device. The functional revision can be determined by its top marking as indicated in [Figure 1](#) and [Figure 2](#).

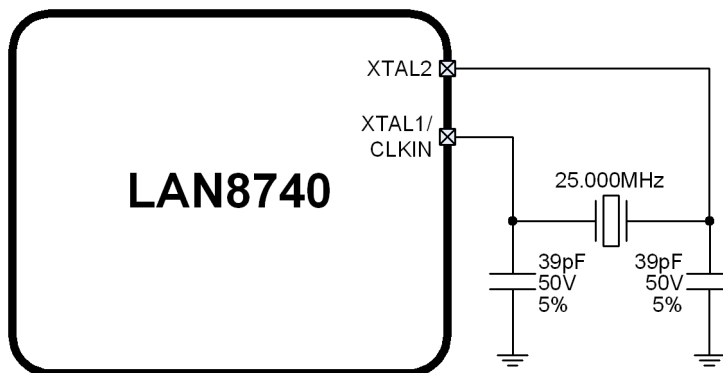
**FIGURE 3: EXAMPLE EXTERNAL CRYSTAL CIRCUIT**

In IEEE mode, the device may drop link when using a Broadcom BCM53125 link partner at cable lengths less than 20 meters.

When using a Broadcom BCM53125 link partner in IEEE mode, the device may drop link when using cable lengths less than 20 meters. The BCM53125 has exhibited a sensitivity to minute deviations in its link partner's transmit clock frequency during 100Mb IEEE operation. This issue is exacerbated at short cable lengths. This anomaly does not impact 10Mb or non-IEEE operation.

1. Utilize an Ethernet cable length of greater than 20m.
2. Increase the load capacitors on the LAN8740A/LAN8740Ai external crystal circuit to 39pF and exercise best practices for board layout. Refer to [FIGURE 3](#): for an example external crystal circuit.
