# dsPIC33FJ06GS001/101A/102A/202A and dsPIC33FJ09GS302

## dsPIC33FJ06GS001/101A/102A/202A and dsPIC33FJ09GS302 Family Silicon Errata and Data Sheet Clarification

The dsPIC33FJ06GS001/101A/102A/202A and dsPIC33FJ09GS302 family devices that you have received conform functionally to the current Device Data Sheet (DS75018C), except for the anomalies described in this document.

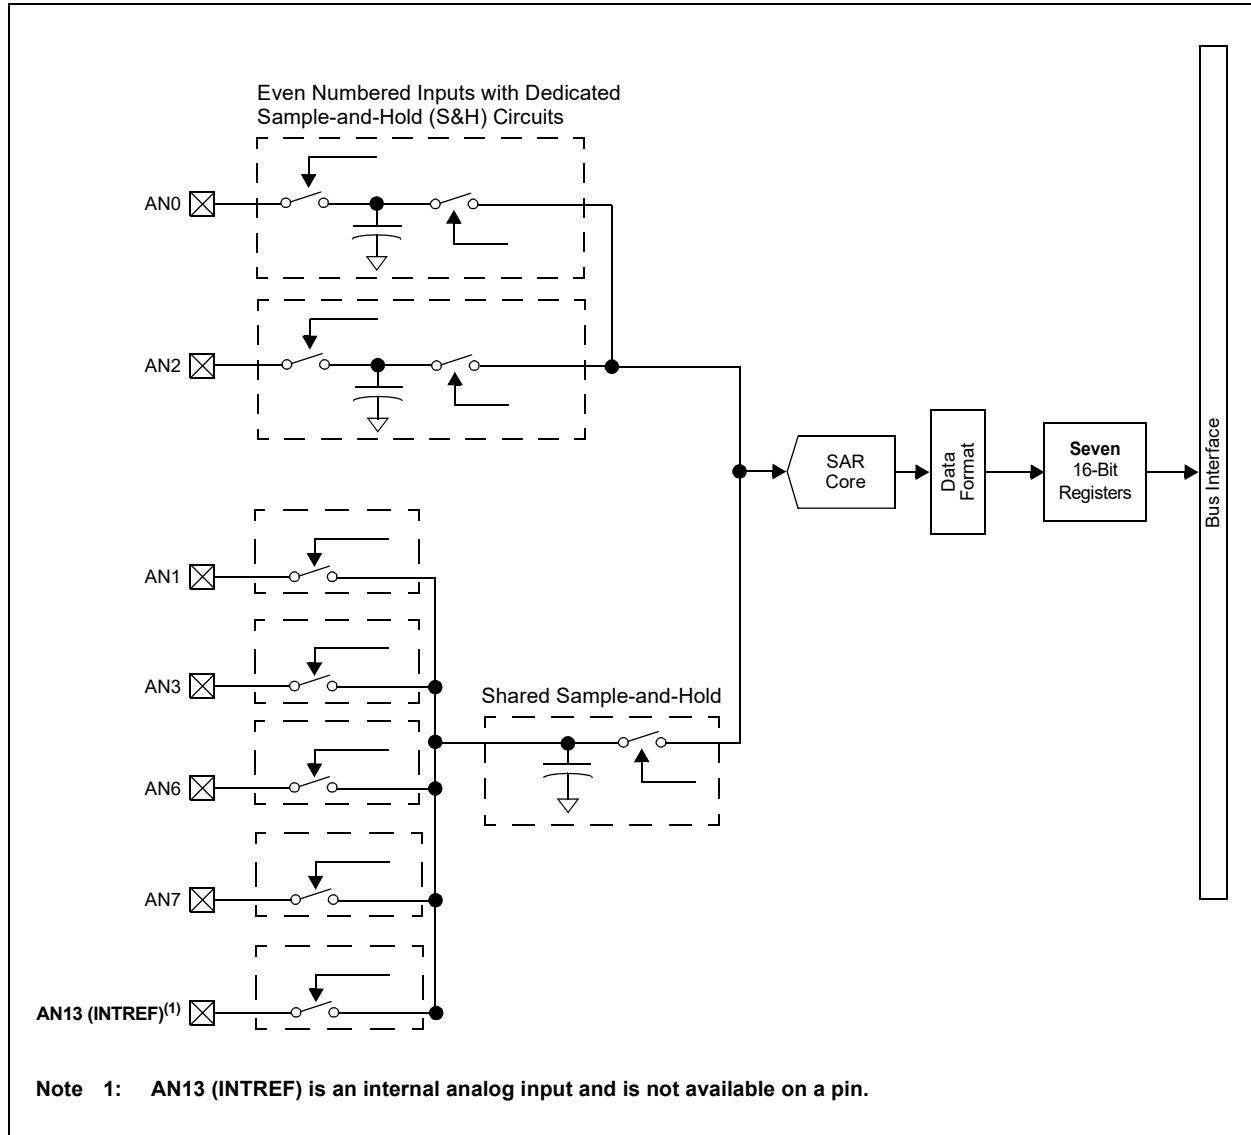
**FIGURE 19-2: ADC BLOCK DIAGRAM FOR THE dsPIC33FJ06GS101A DEVICE**

In [Figure 19-2](#) and [Figure 19-3](#), AN13 has been added and the number of output registers has been changed from eight to seven.
