# Chip Errata for the i.MX RT1060

This document details the silicon errata known at the time of publication for the i.MX RT1060 crossover processors.

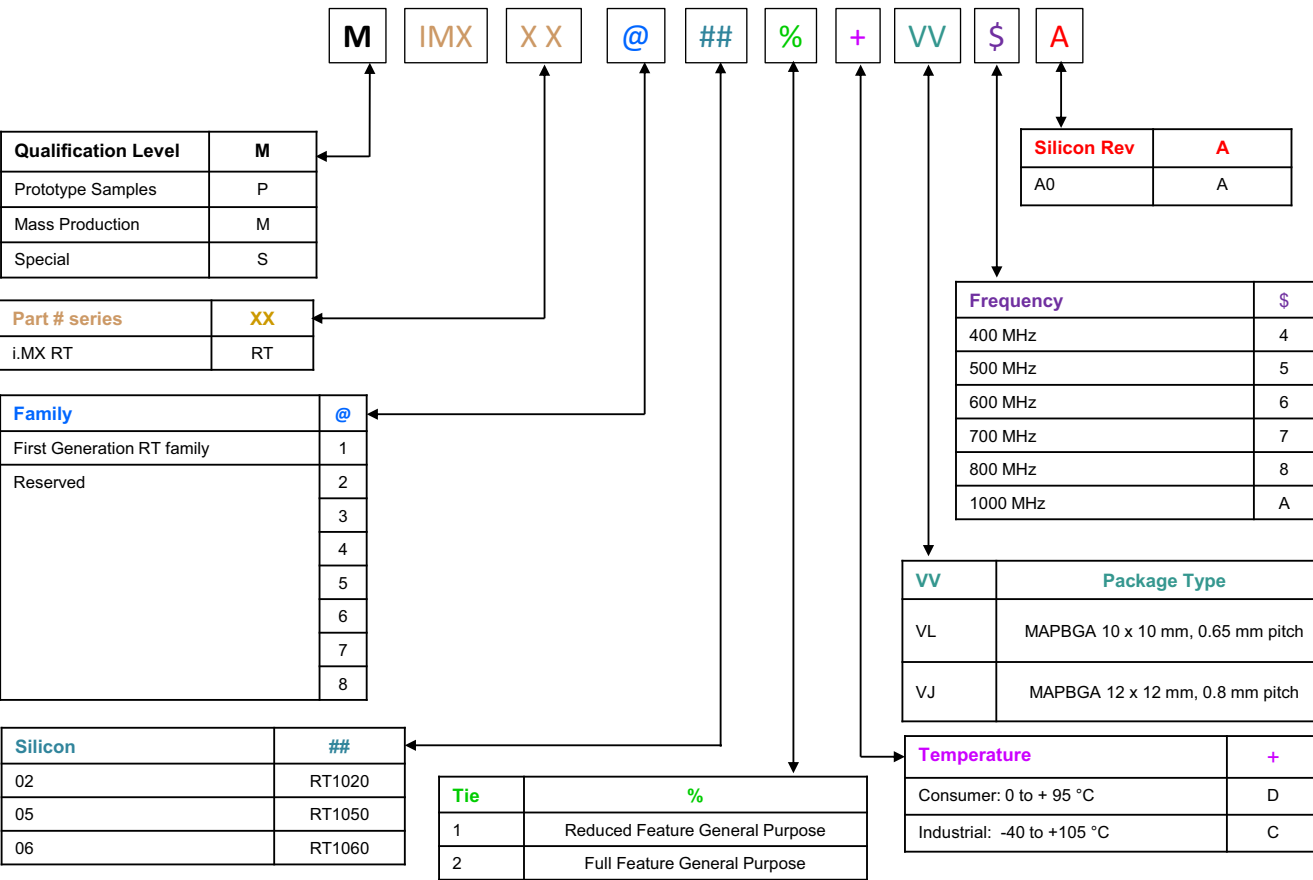
Figure 1. Revision Level to Part Marking Cross-Reference

Figure 1 provides a cross-reference to match the revision code to the revision level marked on the device.
