ATWILC1000/ATWILC3000

Wi-Fi Link Controller RTOS Driver Release Notes

This release note describes the software deliveries and features of the ATWILC baremetal driver/firmware.

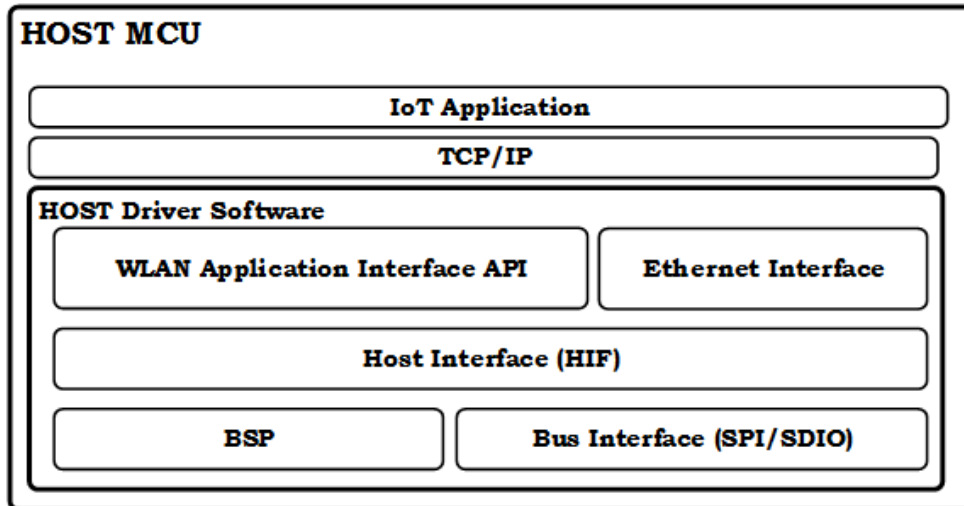
The following figures show the architecture of the ATWILC host driver software which runs on the host MCU.

Figure 1-1. Host Driver Software Architecture for Wi-Fi only Chipsets
