## KSZ8895/KSZ8864 Silicon Errata and Data Sheet Clarification

- KSZ8895MQX
- KSZ8895RQX
- KSZ8895FQX
- KSZ8895ML
- KSZ8895MLUB
- KSZ8864CNX
- KSZ8864RMNUB

The silicon errata discussed in this document are for silicon with silicon revisions as listed in [Table 1](#). The silicon revision can be determined by the device's top marking as indicated in [Figure 1](#). A summary of KSZ8895/KSZ8864 silicon errata, and the silicon revisions they apply to is provided in [Table 2](#).

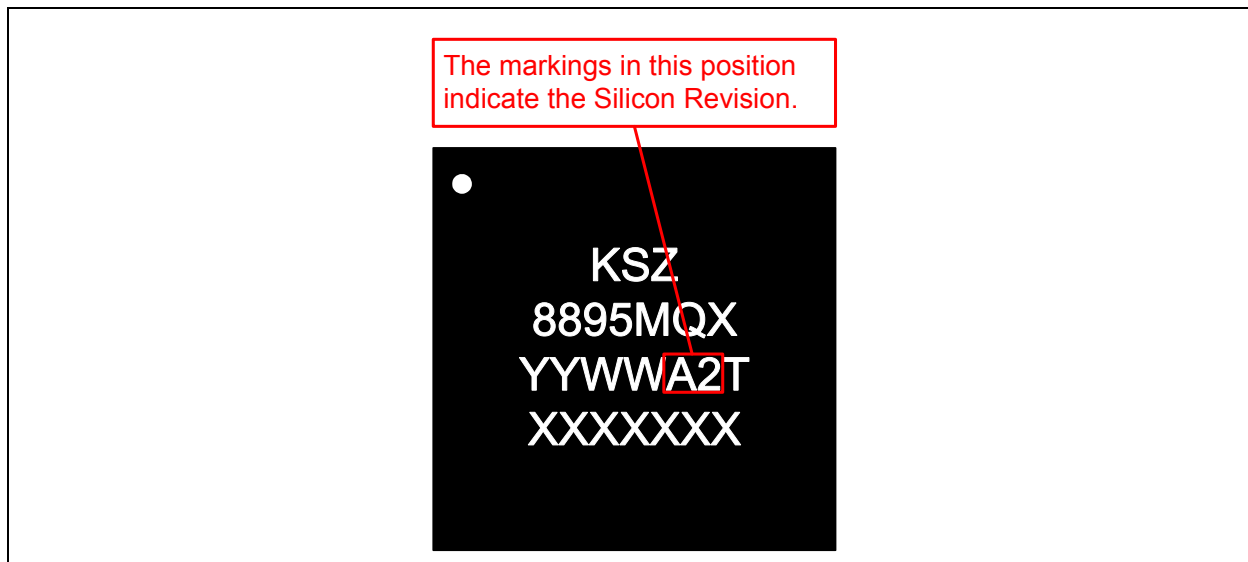
**FIGURE 1: TOP MARKING SILICON REVISION INDICATION**

**Note:** The purpose of [Figure 1](#) is to detail the top markings of an example part and highlight the location of the silicon revision. Other top marking values may differ (lot codes, location of manufacture, etc.).
