KSZ8051 Silicon Errata and Data Sheet Clarification

This document describes known silicon errata for the KSZ8051 family of devices, which includes the following:

- KSZ8051RNLU (Rev. A)

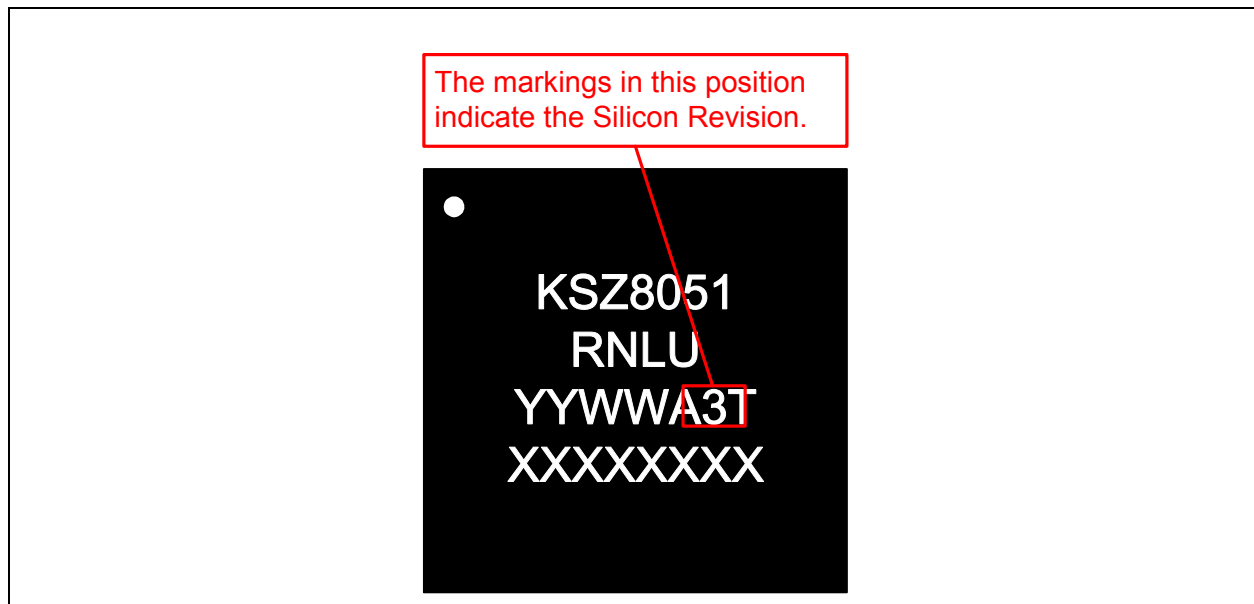
FIGURE 1: TOP MARKING SILICON REVISION INDICATION

Note: The purpose of [Figure 1](#) is to detail the top markings of an example part and highlight the location of the silicon revision. Other top marking values may differ (lot codes, location of manufacture, etc.).

The silicon errata discussed in this document are for silicon with silicon revisions as listed in [Table 1](#). The silicon revision can be determined by the device's top marking as indicated in [Figure 1](#), or by reading device register 3h bits [3:0] (0x0 for silicon revision A, 0x1 for silicon revision A3). A summary of KSZ8051 silicon errata is provided in [Table 2](#).
